# Hertfordshire County Council

## Flood Investigation Report

### Admirals Walk, Hoddesdon

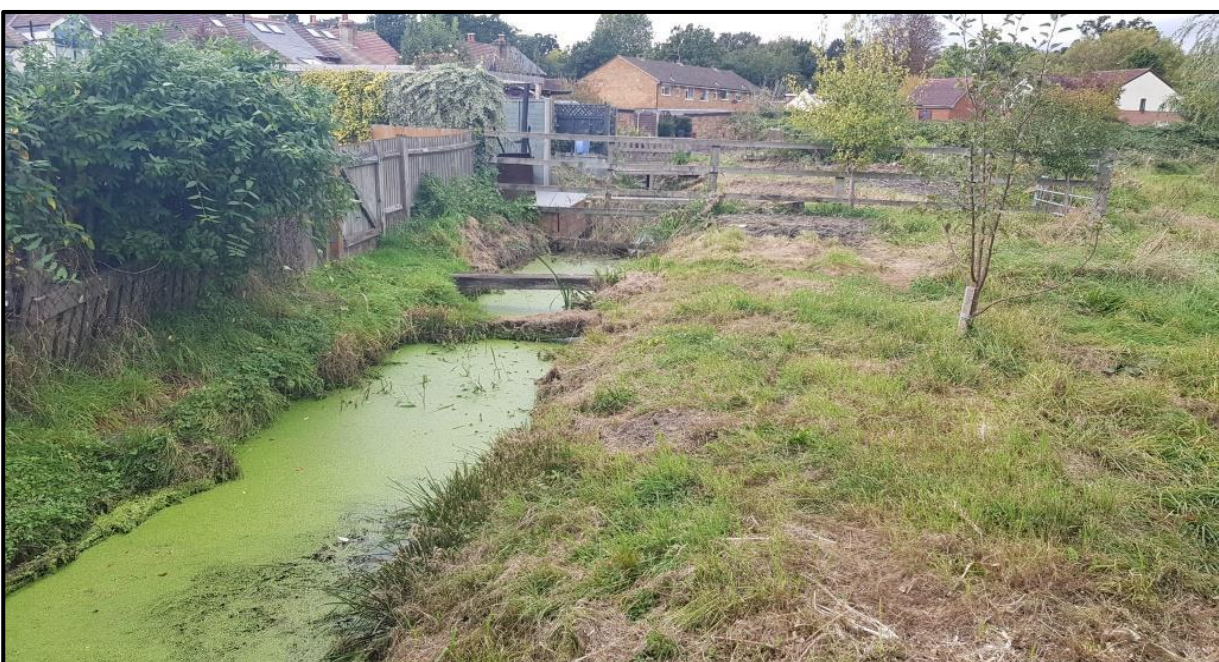
**Figure 1: Photograph of ditch between property and Admirals Walk Lake**

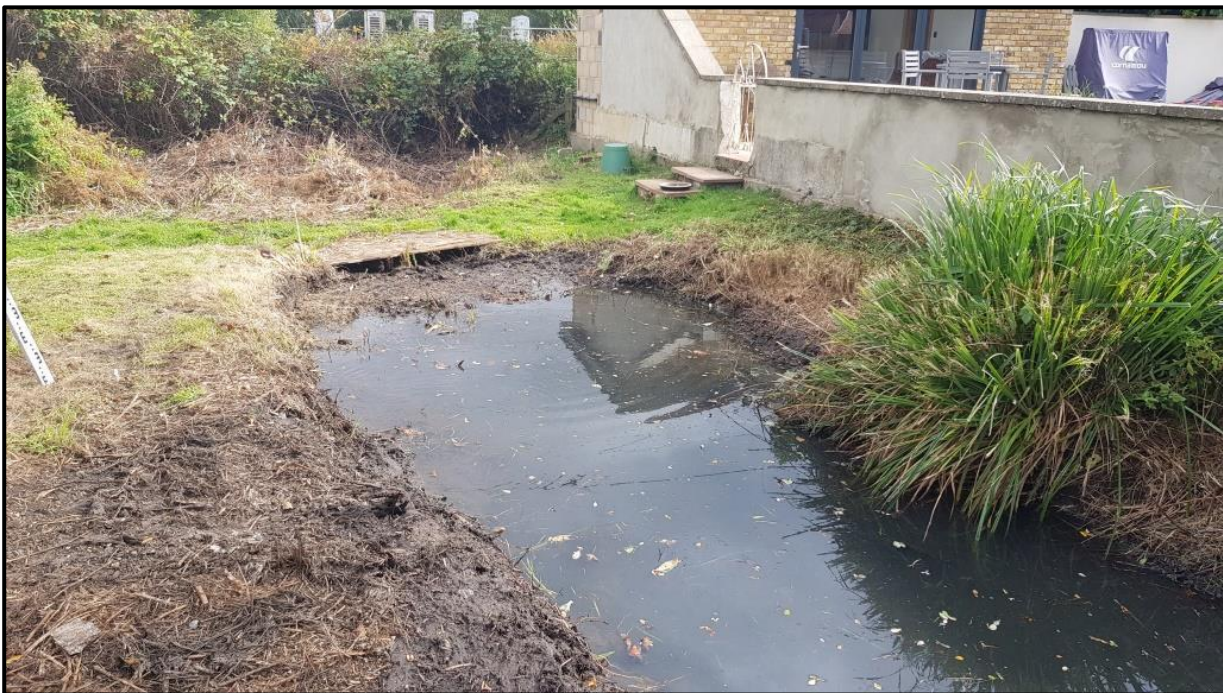
This investigation included studying historical maps that indicated that there may have been a connection to the River Lynch (see Figure 4), but this could not be found on site and there was no records on the Network Rail Asset Database.

**Figure 3: Location where the ditch is severed**

1. The high groundwater level due to the presence of Admirals Walk Lake which will influence infiltration;
2. The ditch is assumed to have been severed as shown in Figure 3 at the railway track at the downstream end of the ditch and for that reason at this moment there is no positive discharge from the ditch.

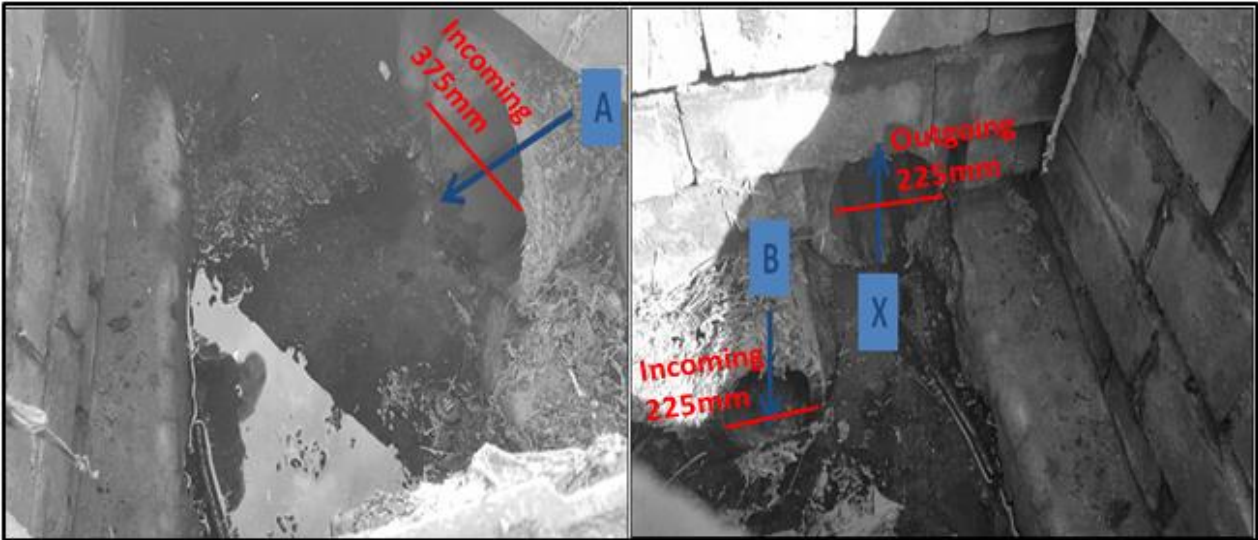
There is a manhole chamber at the junction of Admirals Walk and Pallett Court, which was not plotted on TWUL asset maps (marked as 1 on the map of Figure 7). It was found that there are two incoming pipes (identified as A and B in Figure 8) and one outgoing pipe (signalled as X) and the incoming pipes sizes are larger than the outgoing pipe.

**Figure 8: Incoming and outgoing pipes in manhole chamber 1 at the junction of Admirals Walk and Pallett Court**

The changing of pipe sizes (smaller outfall pipes than the incoming) is uncommon in urban drainage and usually attributed to holding water back as a storage mechanism, as it can cause a throttling effect. However, in this catchment, the hydraulic constriction of the flow will impede the ability of water to drain from the highway as water will back up within the surface water pipe network, where the highway drainage discharges. This surcharging will occur in the lowest available point, which is the gully next to the junction that is located outside properties in Admirals Walk (see Figure 10). This gully is also located at a lower level compared with the surrounding gullies, which increases the risk of surcharging and flooding occurring.

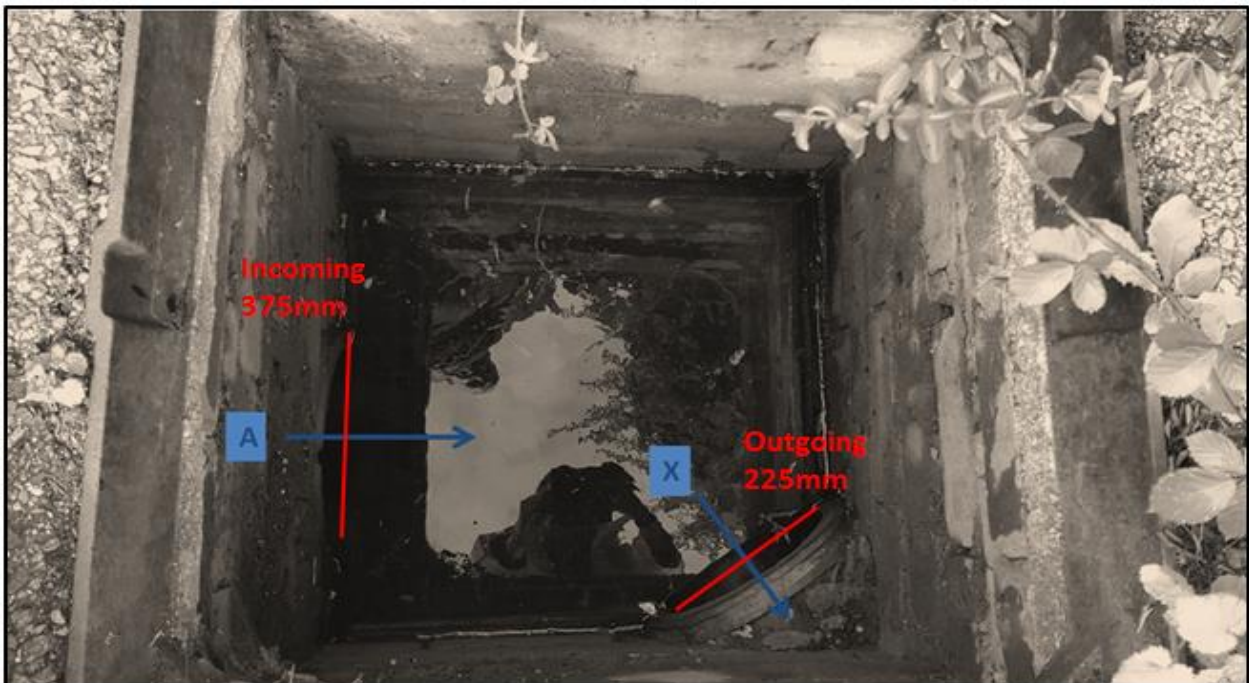
In the second manhole chamber (marked as 2 on the map of Figure 7), an incoming pipe was found (identified as A in Figure 9) which is larger than the outgoing pipe (identified as X). The outfall pipe was also found to be much higher than the incoming, suggesting that this was done to allow the chamber to store water and/or sediment.

**Figure 9: Incoming and outgoing pipes in manhole chamber 2 in Pallett Court**

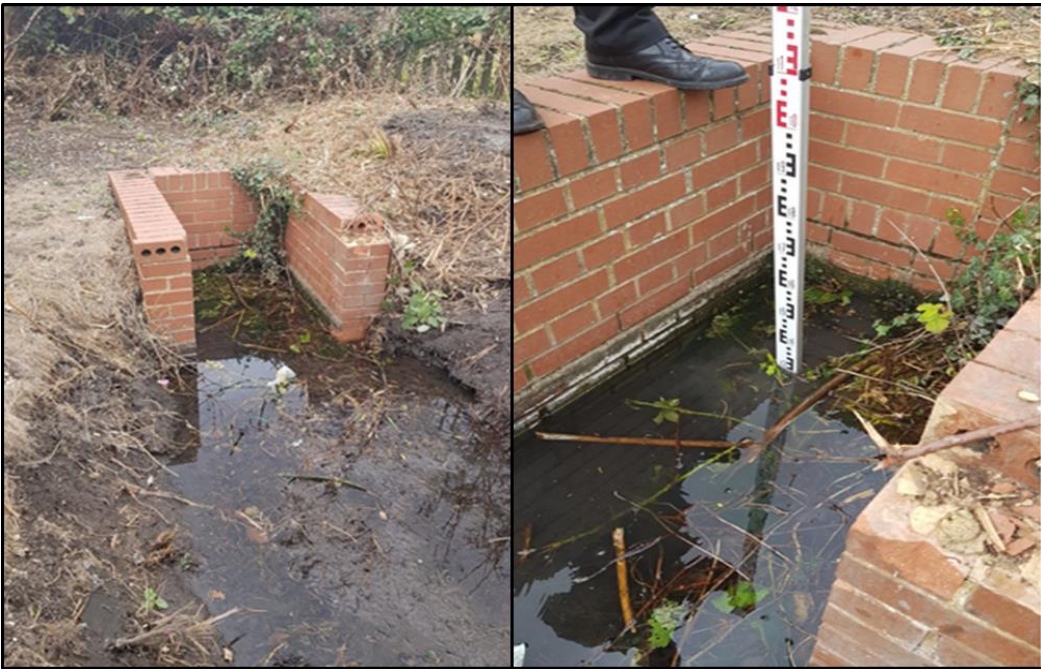
It can now be confirmed that the northern outfall is totally submerged in standing water (see Figure 11) and is likely to have been like this for a considerable period of time. There are also high volumes of silt in the channel near the outfall and immediately downstream (see Figure 12). This standing water and the high volumes of silt on the ditch bed will impact the ability for water from the outfall to discharge efficiently and contribute to the flooding upstream which will run overland down towards the flooding at the junction of Pallett Court.

**Figure 11: Outfall discharge point at the top of the ditch submerged**

As shown on Figure 11, the top outfall following the clearance of the site was found to be submerged which objectively impacts on the effectiveness of the discharge rate from the surface water sewer. The ditch also was found with large volumes of silt (see Figure 12), high water level, high concentration of nutrients and with several flow blockages due to the over passages built by the residents as it is shown in Figure 14.

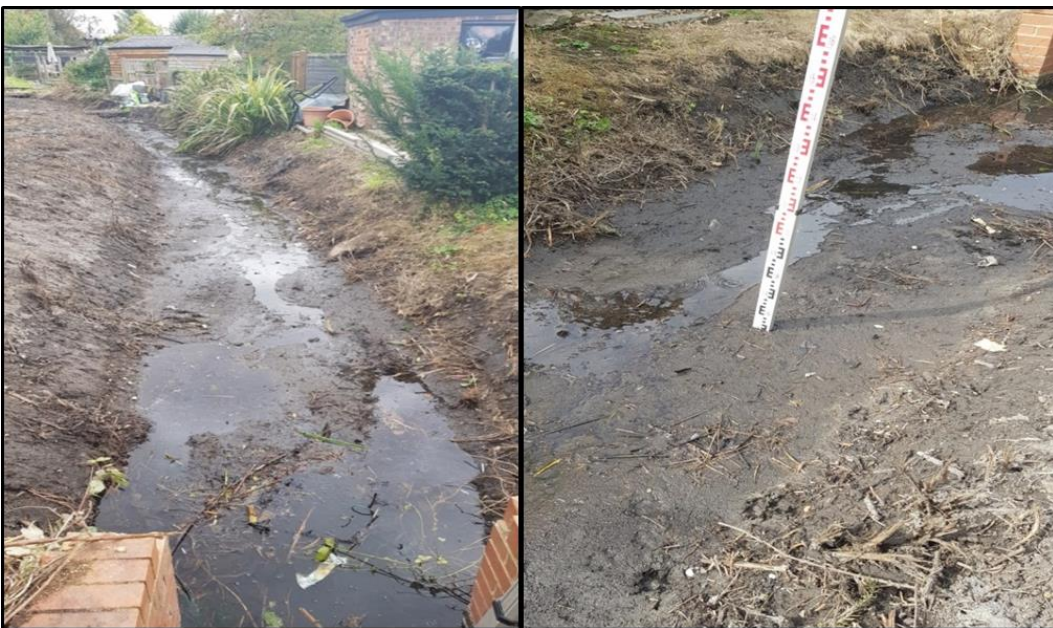
**Figure 12: High levels of silt within the ditch**

The silt volumes in the ditch are a major constraint, however the level of water within the ditch also contributes to the submerging of the outfall. The high water level is unlikely to drop due to two main reasons:

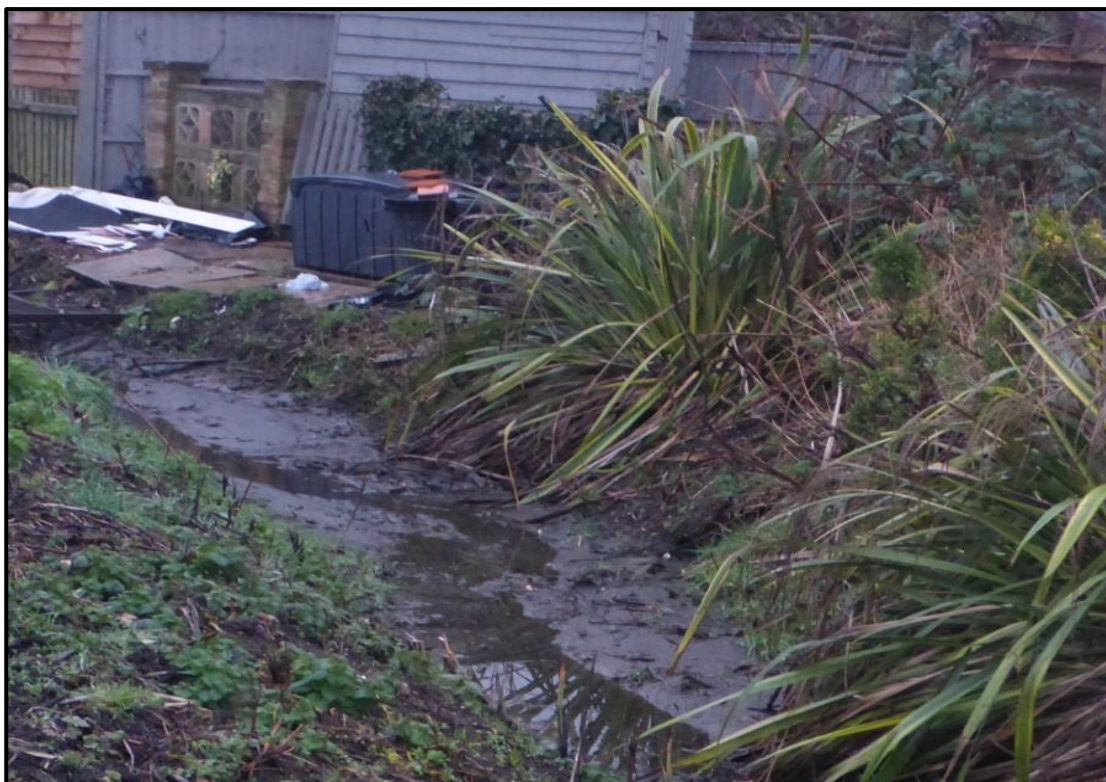
The second surface water sewer outfall, located towards the middle of the ditch, drains the southern area of Admirals Walk (see Figure 2). Due to the high silt and water levels in the ditch, this outfall could not be seen and is presumed to be completely submerged (see Figure 13).

**Figure 13: Potential discharge point for southern outfall**

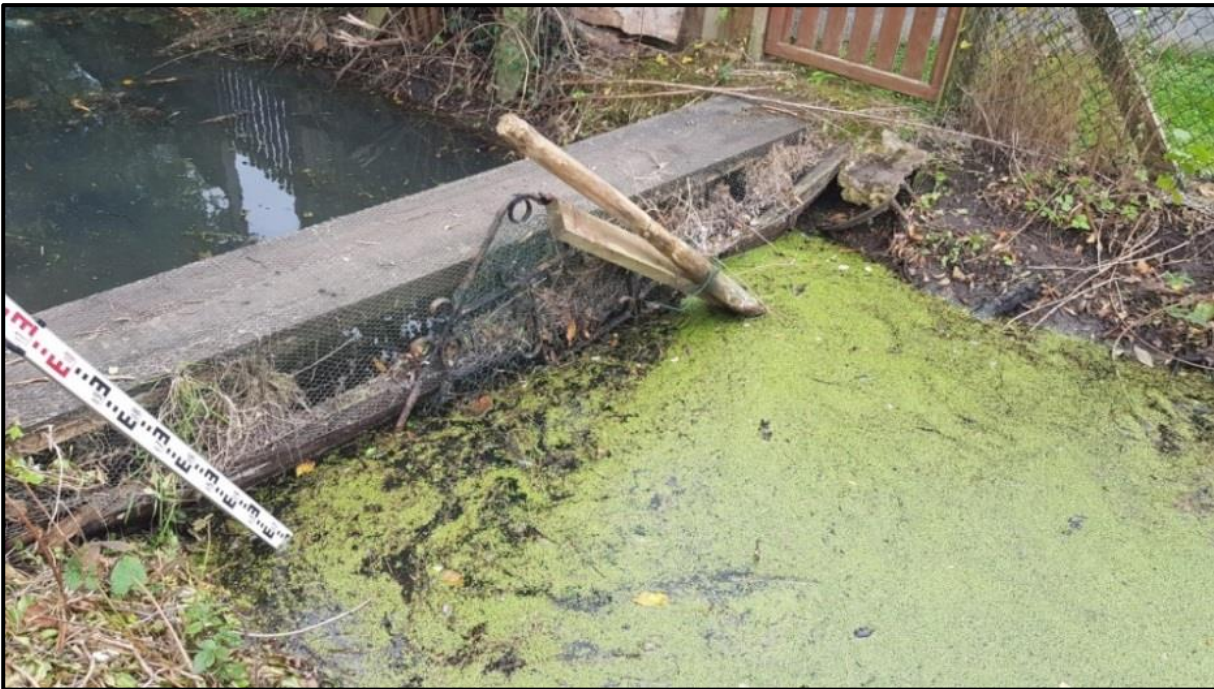
**Figure 14: Existing blockages along the ditch**

The overall poor condition of the ditch impacts not only the ability for the surface water drainage to discharge but it also affects the storage capacity of the feature.

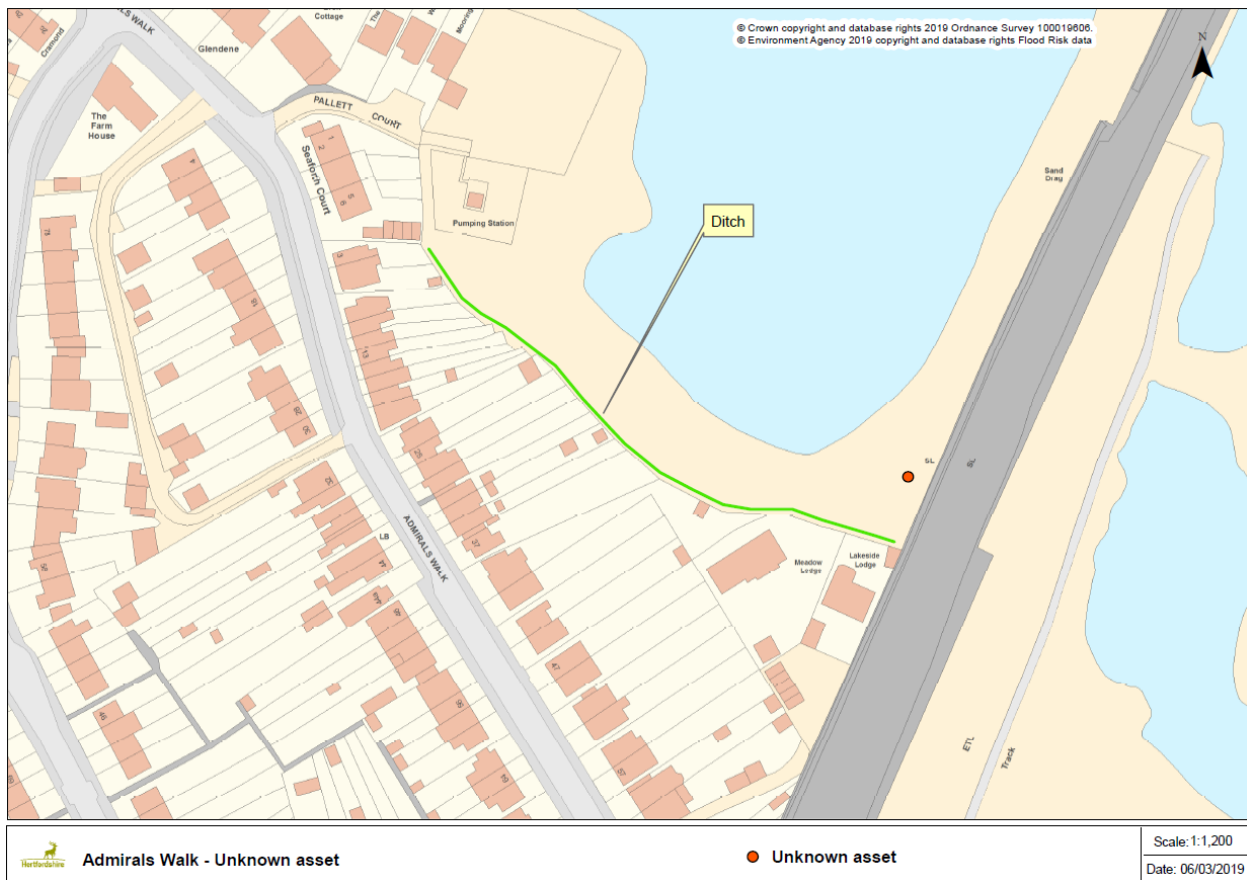
The LLFA contacted TWUL in order to obtain information regarding the unknown asset that was found, however there is no information in TWUL registers regarding this.

**Figure 15: Unknown asset location**

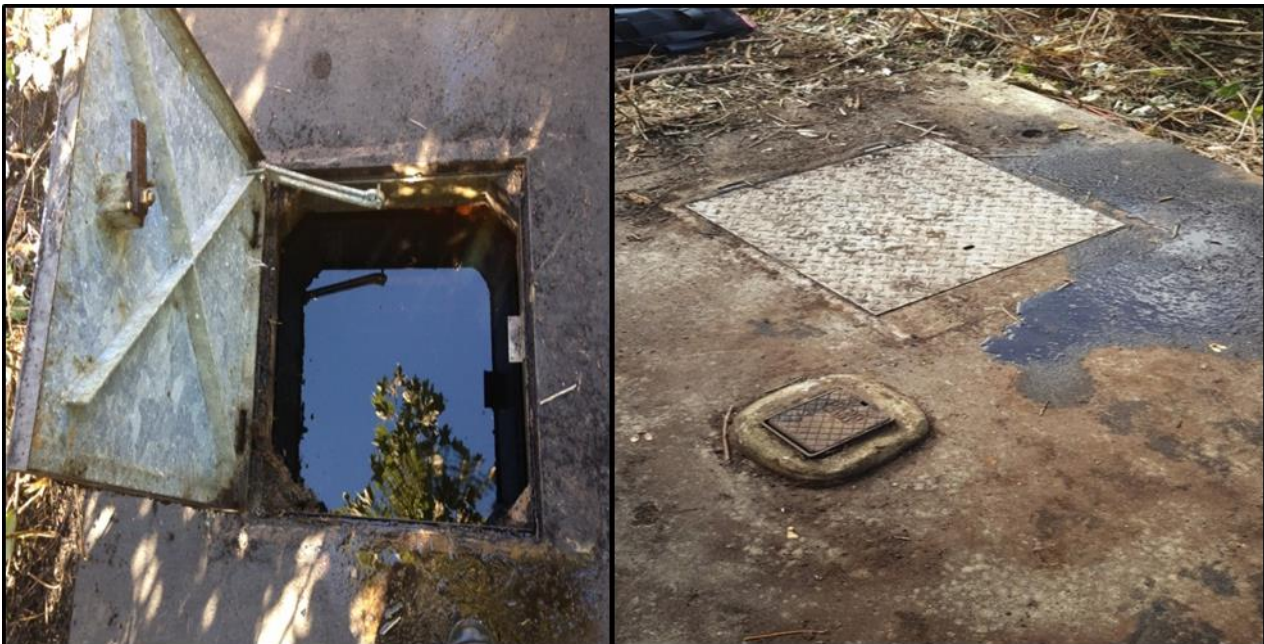
**Figure 16: Unknown assets**

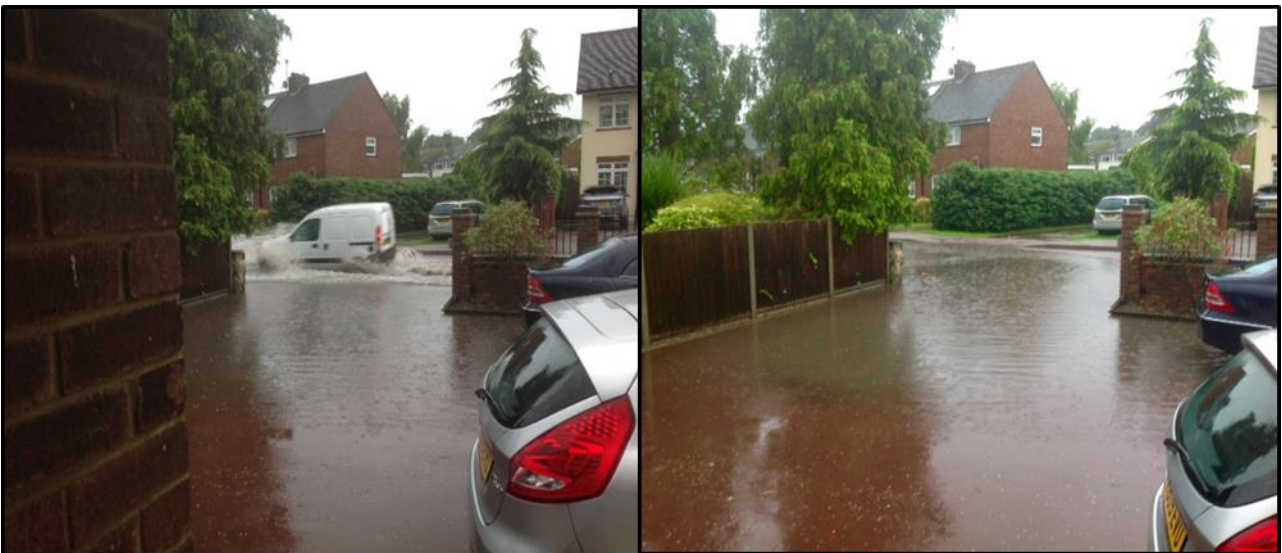
A resident has supplied photographs that show pooling water on the road and external extents of their property (see Figure 17 to Figure 18). After the water has drained away from the highway, a considerable amount of silt and debris is left behind (see Figure 19).

**Figure 17: Photographs of flooding on 16 September 2015**

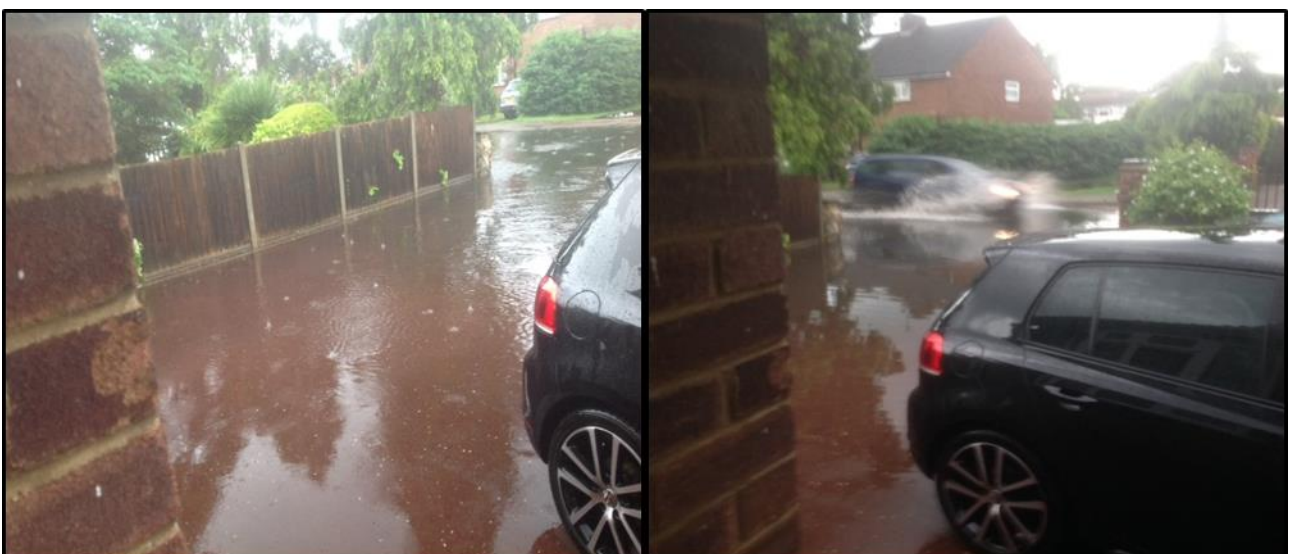
**Figure 18: Photograph of flooding on 12 June 2016**

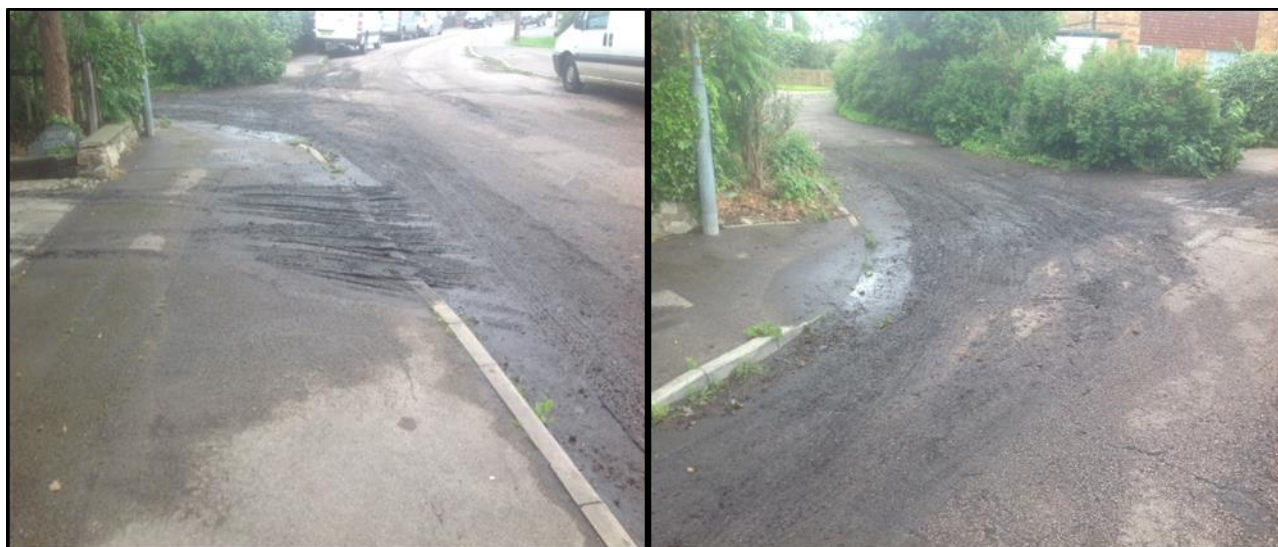
**Figure 19: Photographs following flooding on Admirals Lake and surrounding area on 13 June 2016 following rainfall event on 12 June 2016**
