BRAGBURY LANE

Bragbury End

Technical Assessment Report to support
Section 19 Flood Investigation

Project No: 0469
Date: October 2014

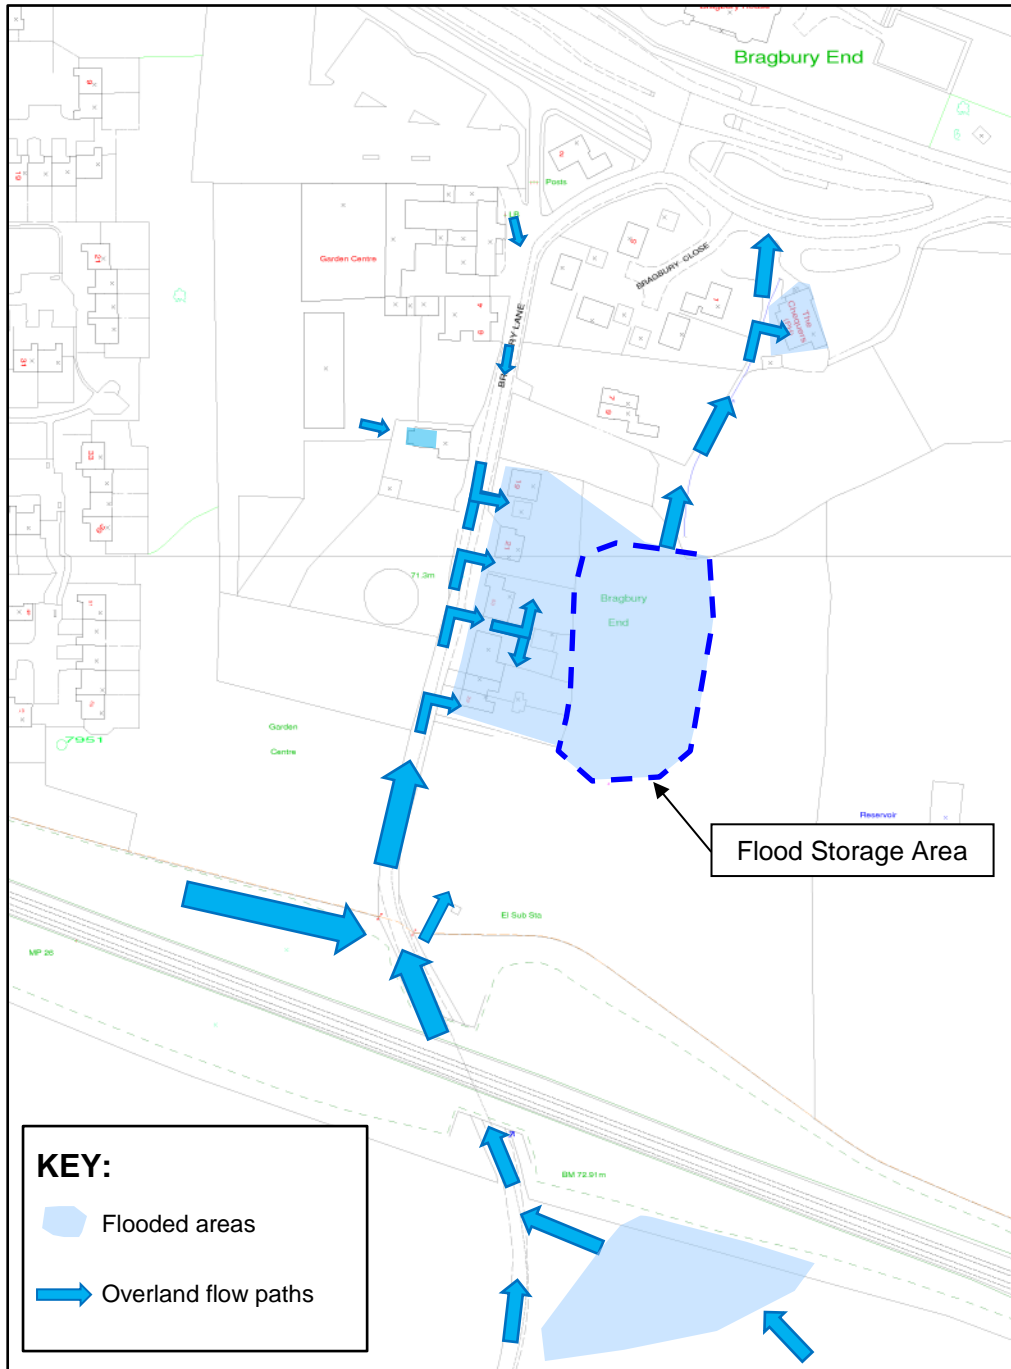
Figure 2: Flooding Mechanism - Overland Flow Paths

There were two discreet areas affected by the flooding as illustrated in Figure 2 below. The first of these included a row of six residential properties on Bragbury Lane. The second location involved one commercial property in Bragbury Close.

There were two distinct flooding issues in Bragbury Lane.

The first area affected involved a single residential dwelling on the western side of the road and was the result of local runoff from higher ground behind the property. Surface water runoff followed the local ground slope from the development site (former gardening centre) and flowed into the property.

The flooding of these properties was the result of two principal flow paths off the contributory catchment as illustrated in Figure 3 below. It is unclear whether floodwater from the large field system in the south west part of the catchment spilled over onto Bragbury Lane upstream of the railway tunnel. There is evidence that substantial and prolonged flow emerged from the downstream side of the railway embankment in this general location. This extensive flow could potentially have been the result of runoff from the fields passing through the railway embankment onto lower ground the other side and then onto the road surface. Flow that came through the railway tunnel and that from the railway western embankment combined at a point just downstream of the railway tunnel and then flowed along the road surface towards the six properties to the east of Bragbury Lane. These properties are situated at the lowest point of the road, which then rises towards the A602 to the north. The floodwater flowed off the road and into the front gardens of the six residential properties. Floodwater affected the front gardens of all six properties and caused damage to the gardens. The floodwater was of sufficient depth to enter some of the properties through airbricks or over the front door threshold as summarised in Table 1 below. The water also entered garages from the front and in some properties it spilled over interconnecting doors into the rear of the property. Outside the dwellings the water migrated around the building from the front into the rear garden flowing down the garden towards the lower level area across the rear of all six properties. This area is a flood storage area built as part of the Hertford Road development as a balancing pond to restrict the rate of surface water runoff from the new development into the River Beane. Its operation is described in Section 5.3.2.1. The water meadow filled and eventually overtopped the low height bund across its downstream end. The overspill water entered a small natural watercourse located immediately downstream of the bund. This watercourse flows into Bragbury Close where it enters a culvert under the A602.

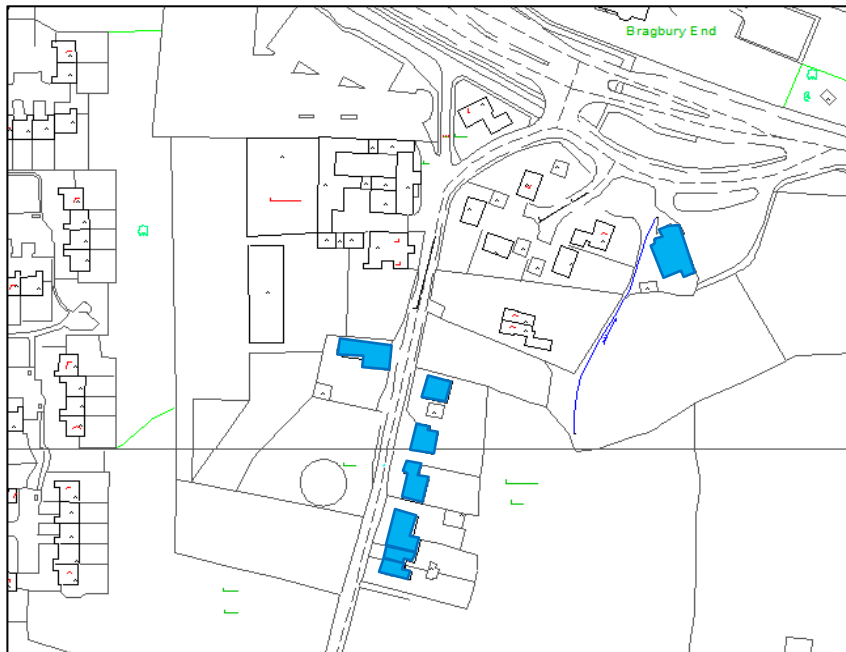
Figure 3: Flooded Properties

Property	Internal Flooding	External Flooding
Bragbury Close	Yes (through rear door)	Yes
Bragbury Lane - west	Yes	Yes
Bragbury Lane - east	Yes (through front door)	Yes
Bragbury Lane - east	Yes (through front door)	Yes
Bragbury Lane - east	Yes (through garage and into utility room)	Yes
Bragbury Lane - east	Yes (through front door)	Yes
Bragbury Lane - east	Yes (through airbricks)	Yes
Bragbury Lane - east	No	Yes

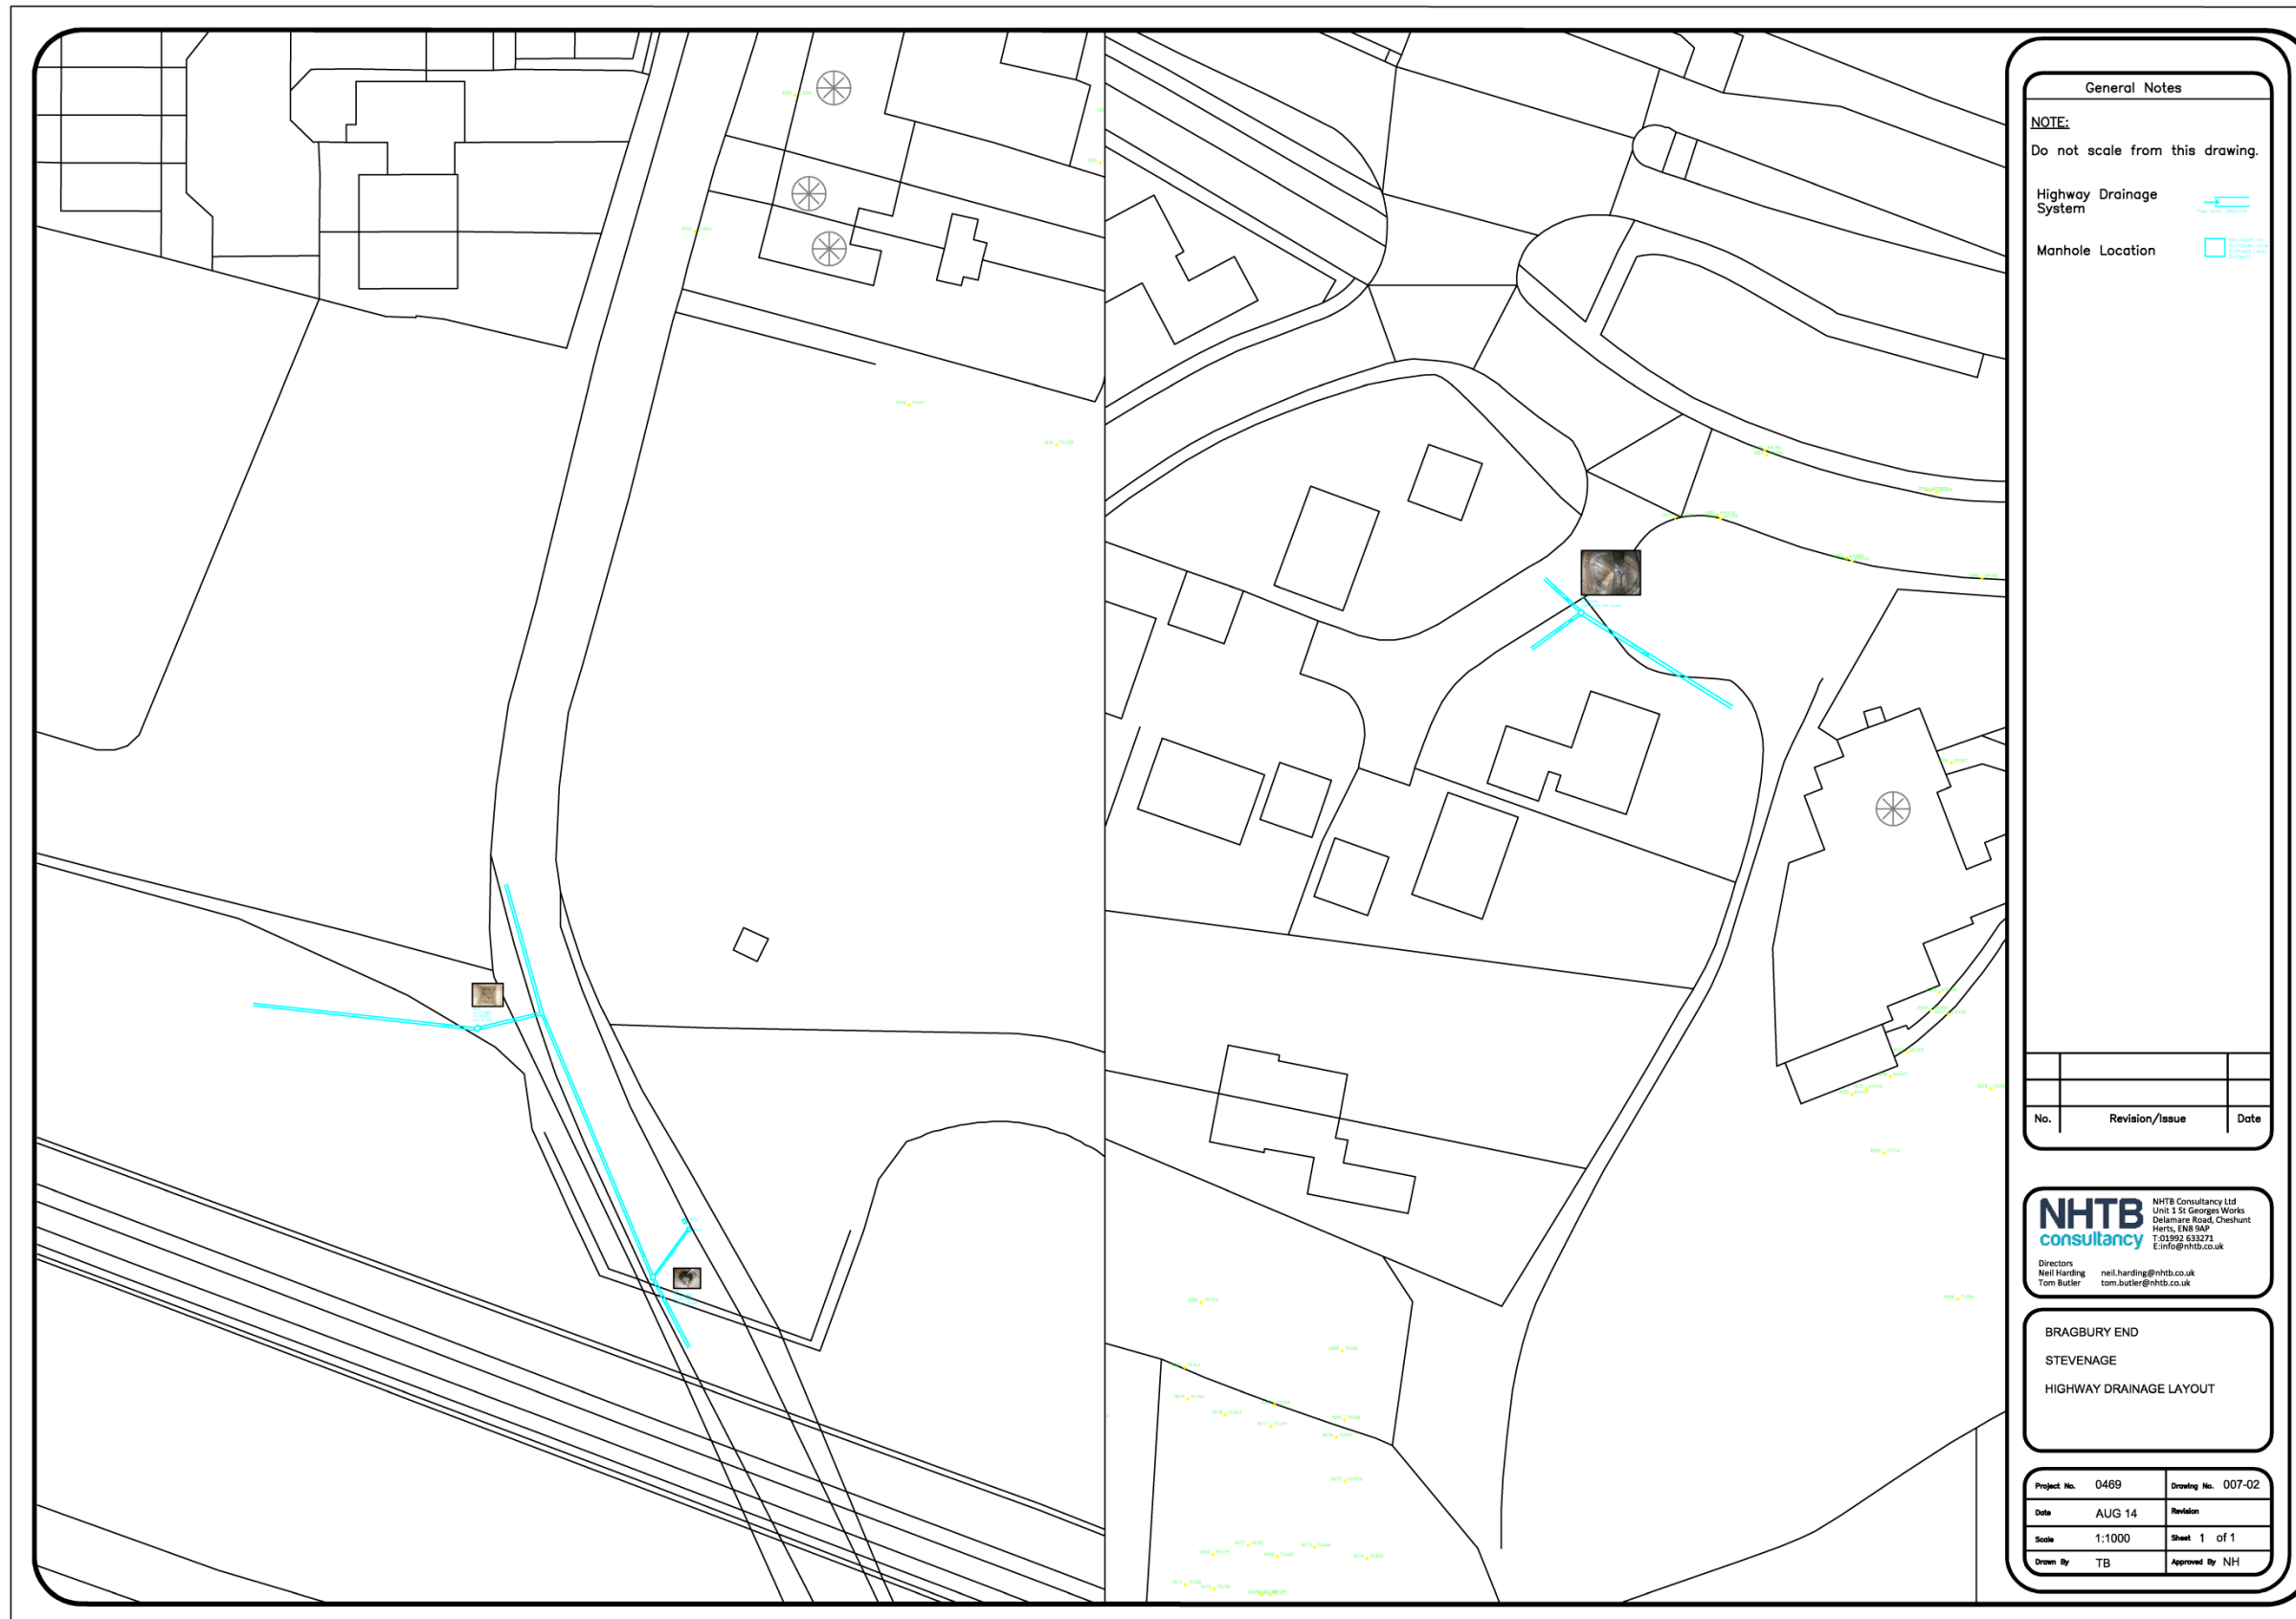
Figure 6.2: Highway Drainage System

- Under normal conditions surface water runoff from farmland immediately adjacent to the road and from the railway embankment to the west of Bragbury Lane flows onto the road surface. Surface flows are conveyed along the road following the topography in a northerly direction and under the railway. In extreme storm conditions there can be a significant rate of surface water runoff from the farmland and railway embankment onto the road surface at a point just north of the railway tunnel. There are three road drainage gullies (one double plus a single) between this point and the location of flooding in Bragbury Lane. The surface water runoff from the agricultural land is exacerbated by issues with the land drainage system serving the fields (see Section 5.3.3.1 below).

The existing highway drainage infrastructure is representative of that which is found in edge of town / rural areas. The gullies can become blocked easily by debris blown from the farmland to the south, straw from farm vehicles and by leaves off nearby trees and bushes. The effect of these conditions is that surface water runoff from the road, and any from adjacent ground (see below) will be conveyed along the road surface, being unable to enter the highway drainage pipes below ground. The fall along Bragbury Lane will convey flows to the lowest point in the road outside the properties to the east of Bragbury Lane. Normally highway drainage is designed for storm conditions that are less severe than the exceptional weather that occurred over the winter of 2013-14. The highway drainage system would not have been able to accommodate all of the surface water runoff from the extreme conditions experienced, even if each component part was operating to its optimum performance. As an illustration, the theoretical capacity of the

- All of the highway drainage system should be cleaned and an internal CCTV inspection carried out to ascertain any structural defects and hydraulic restrictions.

The existing highway drainage system is ineffective and offers little protection against flooding. It is recommended that the entire system is cleaned using high pressure jetting and a CCTV survey conducted to establish any serious structural defects that are inhibiting optimum hydraulic performance. A programme of routine inspection and reactive maintenance of gullies should be introduced. These actions should be implemented by Hertfordshire County Council Highways Department.

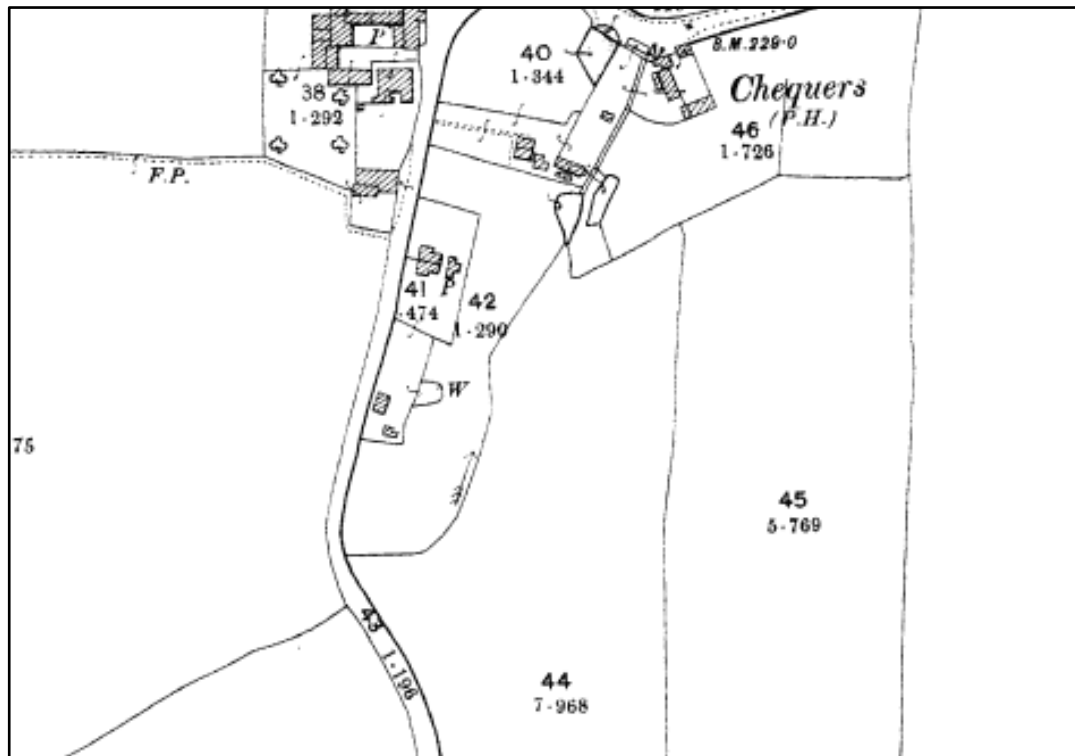
Figure 6.2a: Historical Map showing Land Drainage Prior to Construction of the Railway

The image below shows the lower part of Bragbury Lane prior to construction of the railway and, specifically, it includes a probable ditch from Bragbury Lane towards where the balancing pond is now located. It is probable that this ditch was used to convey surface water runoff from Bragbury Lane into the receiving natural watercourse system.

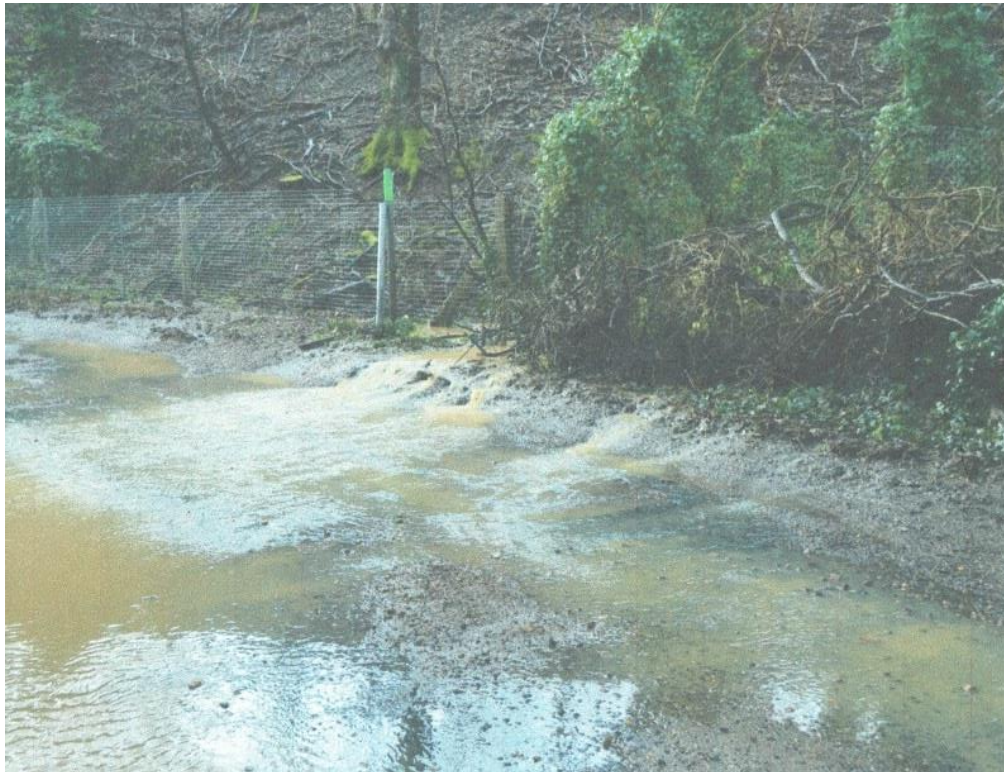
Figure 9: Surface Water Runoff from the Railway Embankment (in distance) and adjacent Permeable Open Space - in foreground (west of Bragbury Lane)

There is an extensive area of railway embankment that sheds water onto adjacent ground alongside the Hertford Road development. There is an area of grassed open space within the development at the south eastern corner and this probably generates surface water runoff that merges with that from the railway embankment. All the runoff flows onto Bragbury Lane where it is conveyed northwards towards the properties that flood. Photographic evidence from the flood-affected residents showed water continuing to flow from this location after the storm had abated and water had ceased to flow down Bragbury Lane from the fields to the south as illustrated in Figure 9 below.

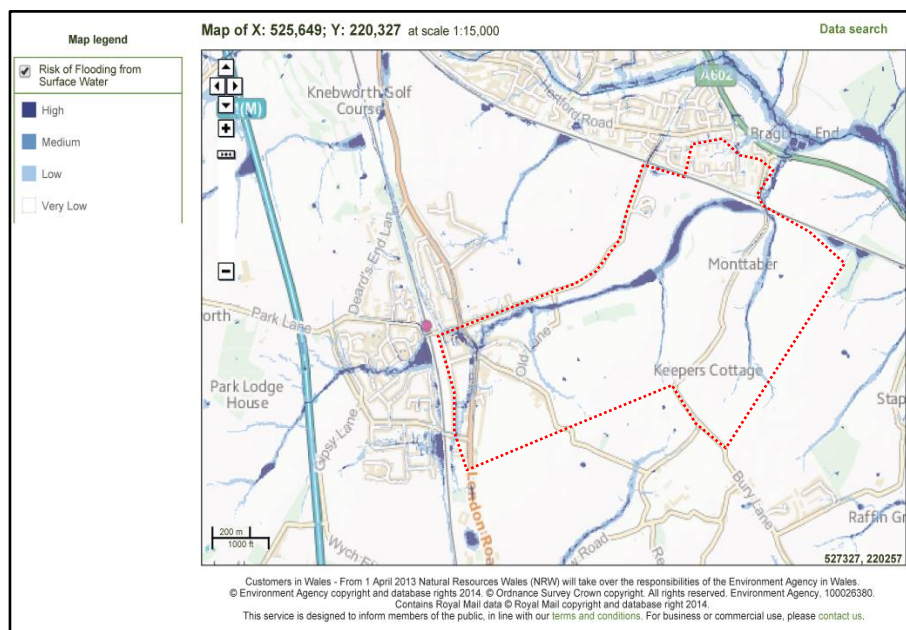
Figure 10: Environment Agency Surface Water Maps

The results of the analysis undertaken by the Environment Agency are illustrated below in Figure 10. They show a reasonable correlation with the surface water runoff witnessed by local residents on 7 February 2014. The map does not show how surface water from adjacent fields in the southern part of the catchment would stay on Bragbury Lane and conveyed to where the houses flooded and this was the key mechanism that resulted in the flooding to properties. The map indicates that surface water runoff from the large field system to the south-west of the catchment would flow onto Bragbury Lane south of the railway tunnel. Overland flow at this location was not witnessed by those interviewed as part of this investigation; it might have occurred but because the storm took place in darkness and the residents were occupied with clearing up after the flooding no observations were made in this area. The map does show the presence of 3 large natural surface storage ponds in low spots along the flow path in this area and there is evidence of their existence in aerial photographs.
