Hertfordshire County Council

Section 19 Flood Investigation Report

Chapel Lane, Long Marston

December 2018
Version 5

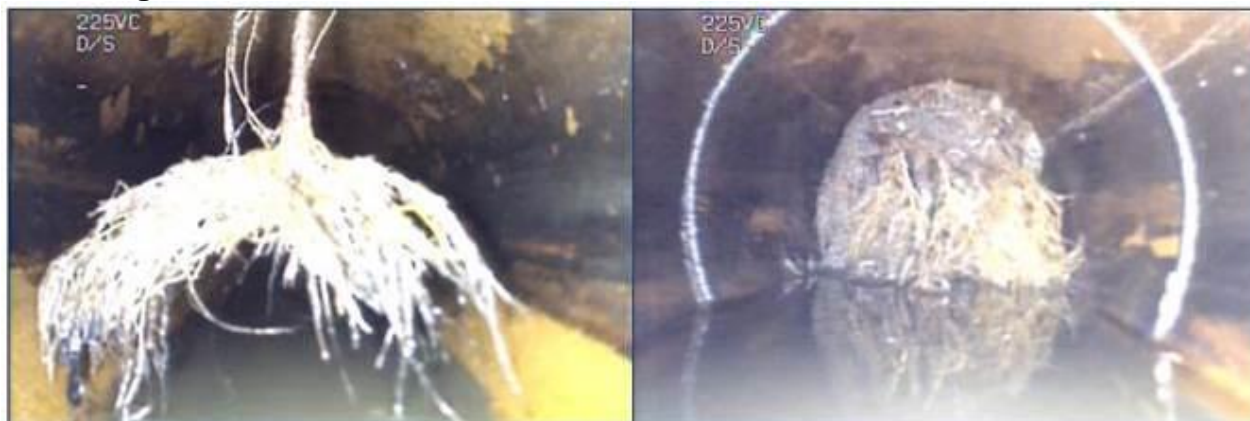
As part of the original investigation it was reported that a manhole to the rear of a property that flooded internally surcharged during the February 2014 flood event. An attempt to conduct a pipe condition survey (CCTV crawler unit) took place on the 17 October 2014; however the survey was not able to be completed as of a result of blockages within the pipe (see Figure 1). In conjunction with this, a detailed hydraulic modelling study was taking place in the catchment, which was evidencing that overland flows were also contributing to flooding in Chapel Lane. A decision was taken by HCC not to resurvey the chamber and connecting pipes, but to concentrate on the pre-feasibility study and wider catchment issues.

Figure 1: Images of failed CCTV Survey (25/11/2014). Root penetration visible in both images

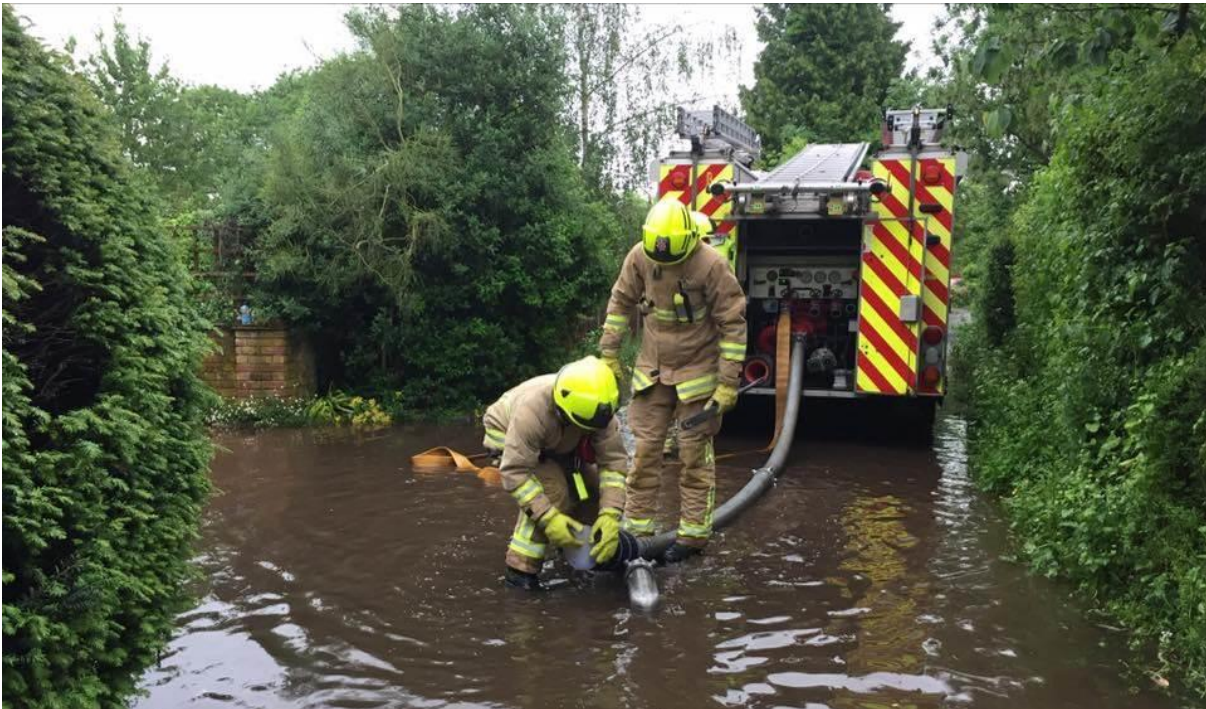
result of excess water entering the foul network. Both mechanisms led to the Fire & Rescue service being called to respond and pump water away from properties Figure 2.

Figure 2 HCC Fire and Rescue attending flooding to Chapel Lane 30 May 2018

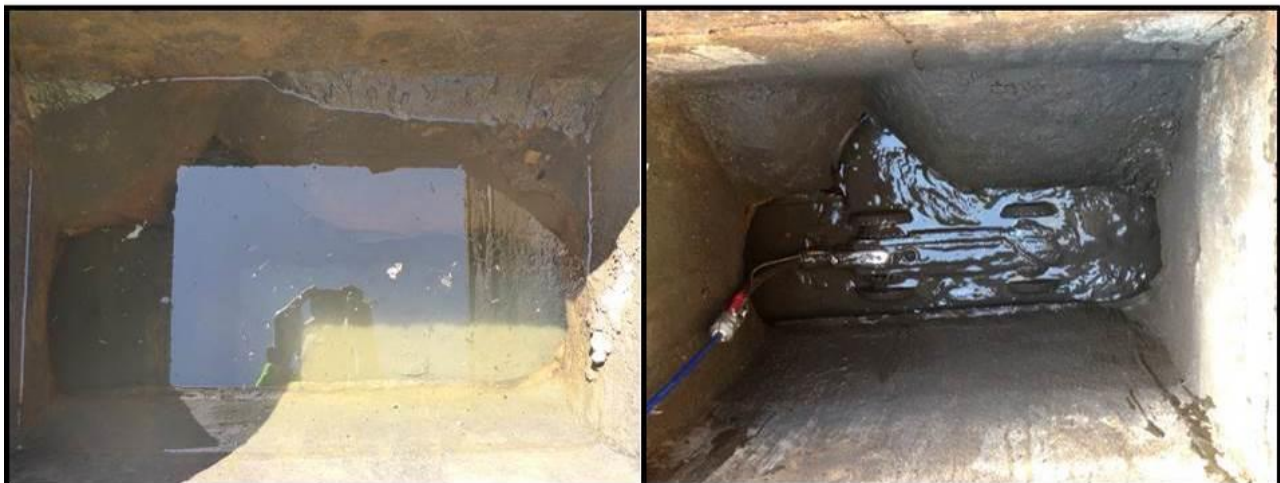
On being notified of the flood event, a site visit took place with the impacted property owners and the LLFA on the 22 June 2018. The manhole chamber to the rear of their garden was lifted and was 30% full of clear water. This manhole cover was also lifted in 2014 and connections in the chamber were all visible (see Figure 10). This indicated that there has been a change in circumstances, either more water was draining to the orphaned asset or water could now not drain away.

Figure 10 Standing water in the manhole chamber of the flooded property (Left image 2018, Right image 2014)

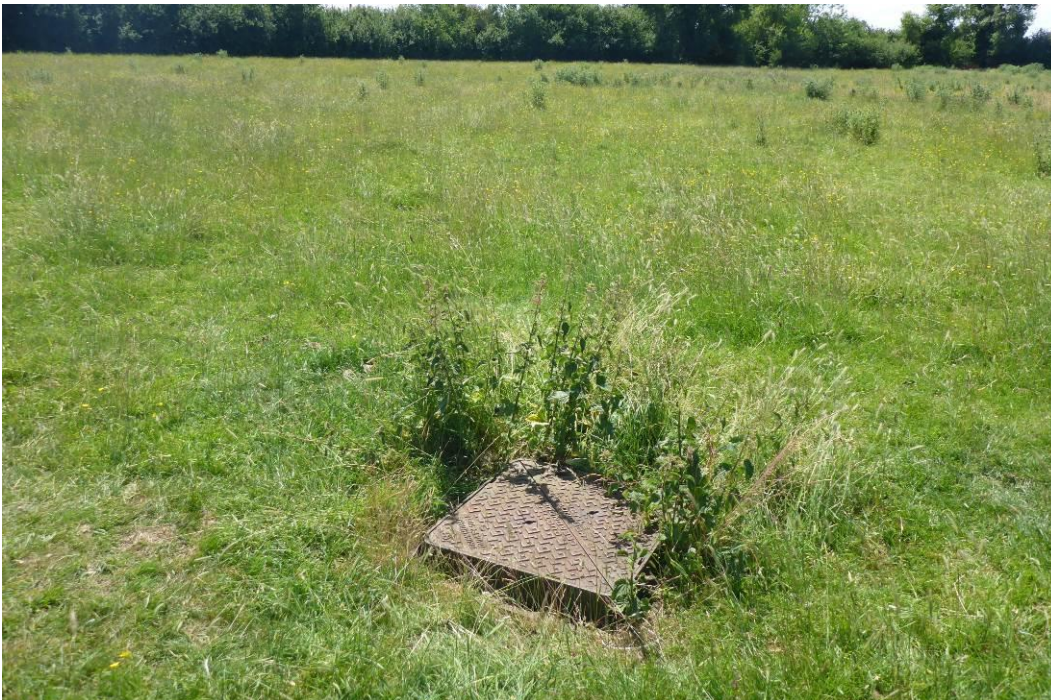
Figure 12 An example of a raised manhole through the farm near the pipe outlet

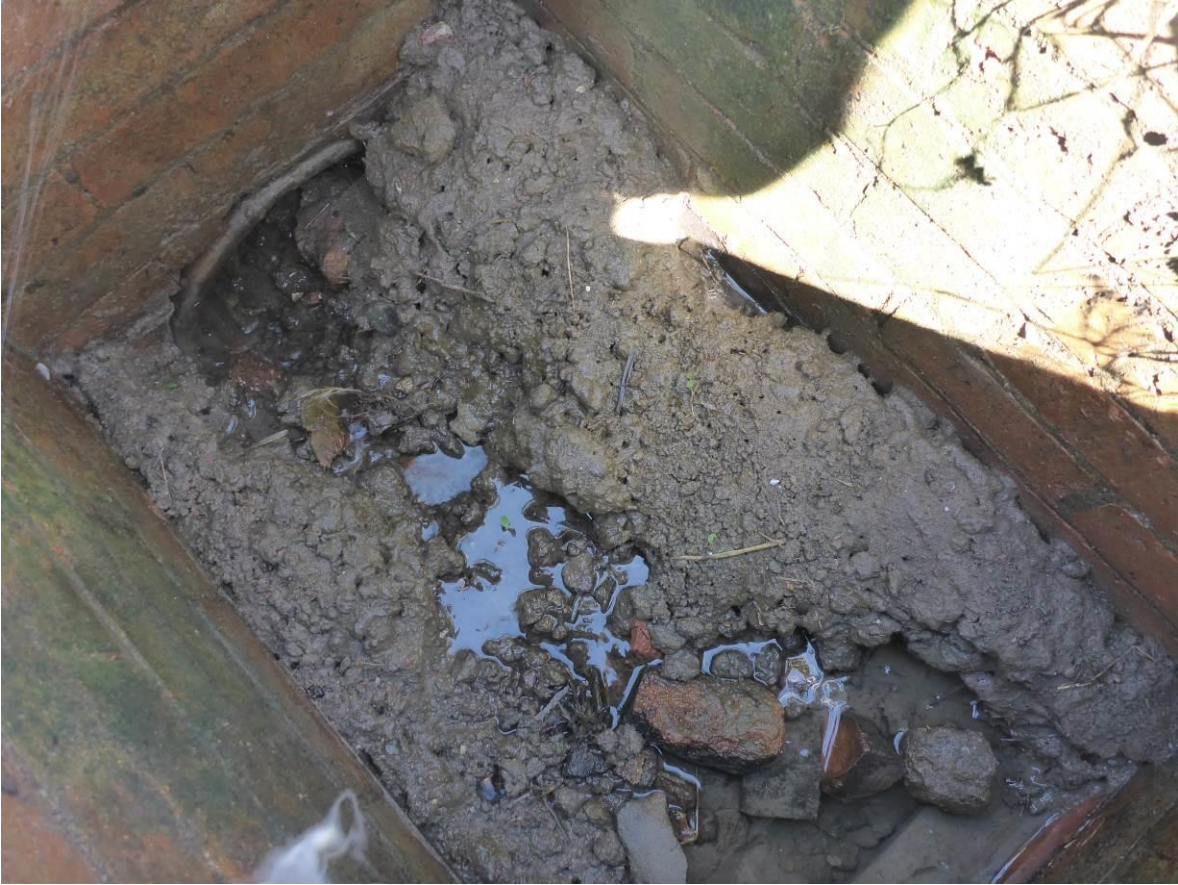
After talking with other local residents, it was identified that the downstream route discharged to the Tring Bourne, as it used to carry sewage to a defined sewage farm. This is later confirmed and evidenced on the 3rd edition Ordnance Survey map (see Figure 11). This meant that the pipe crossed a farm to the north-west of the properties on Chapel Lane. After visiting the farm, a number of raised manholes were located (See Figure 12 for an example). It was noted during this site visit that the manholes were not benched in properly; allowing silt and debris able to easily enter the chamber and block flow through the orphaned asset (see Figure 13).

Figure 13 Silt and debris entering a chamber within the farmers field near the outlet

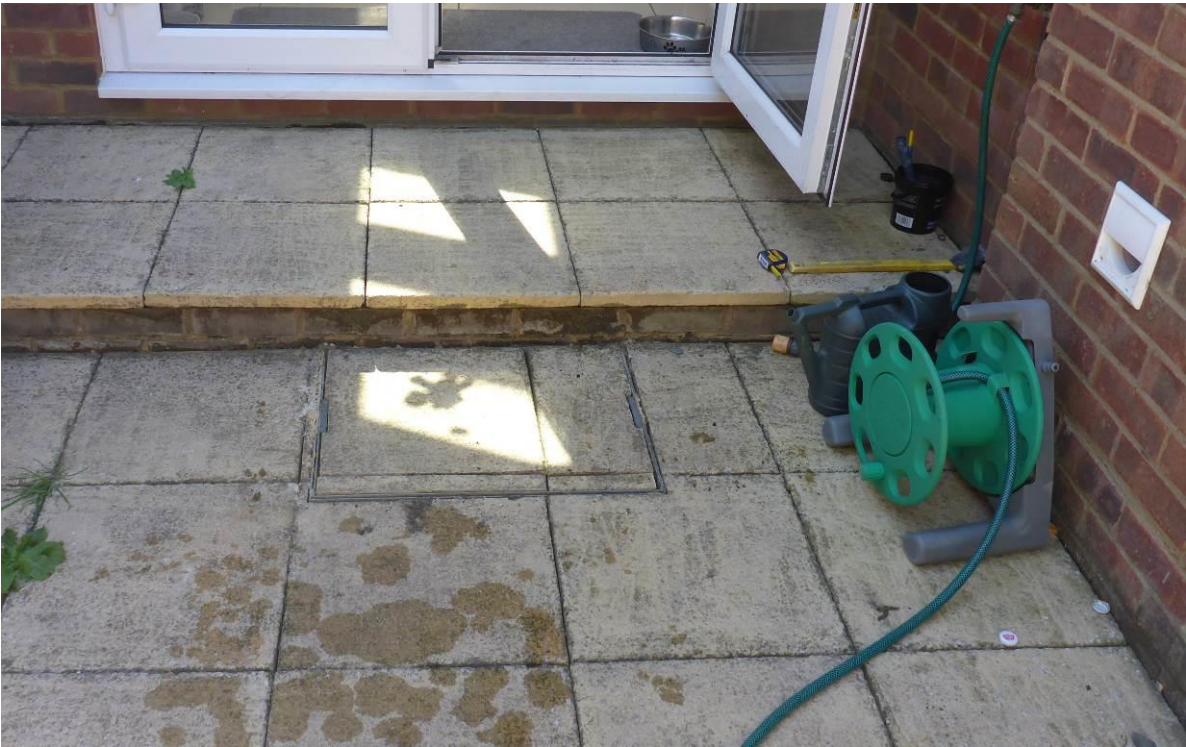
Figure 14 Manhole found upstream of flooded property

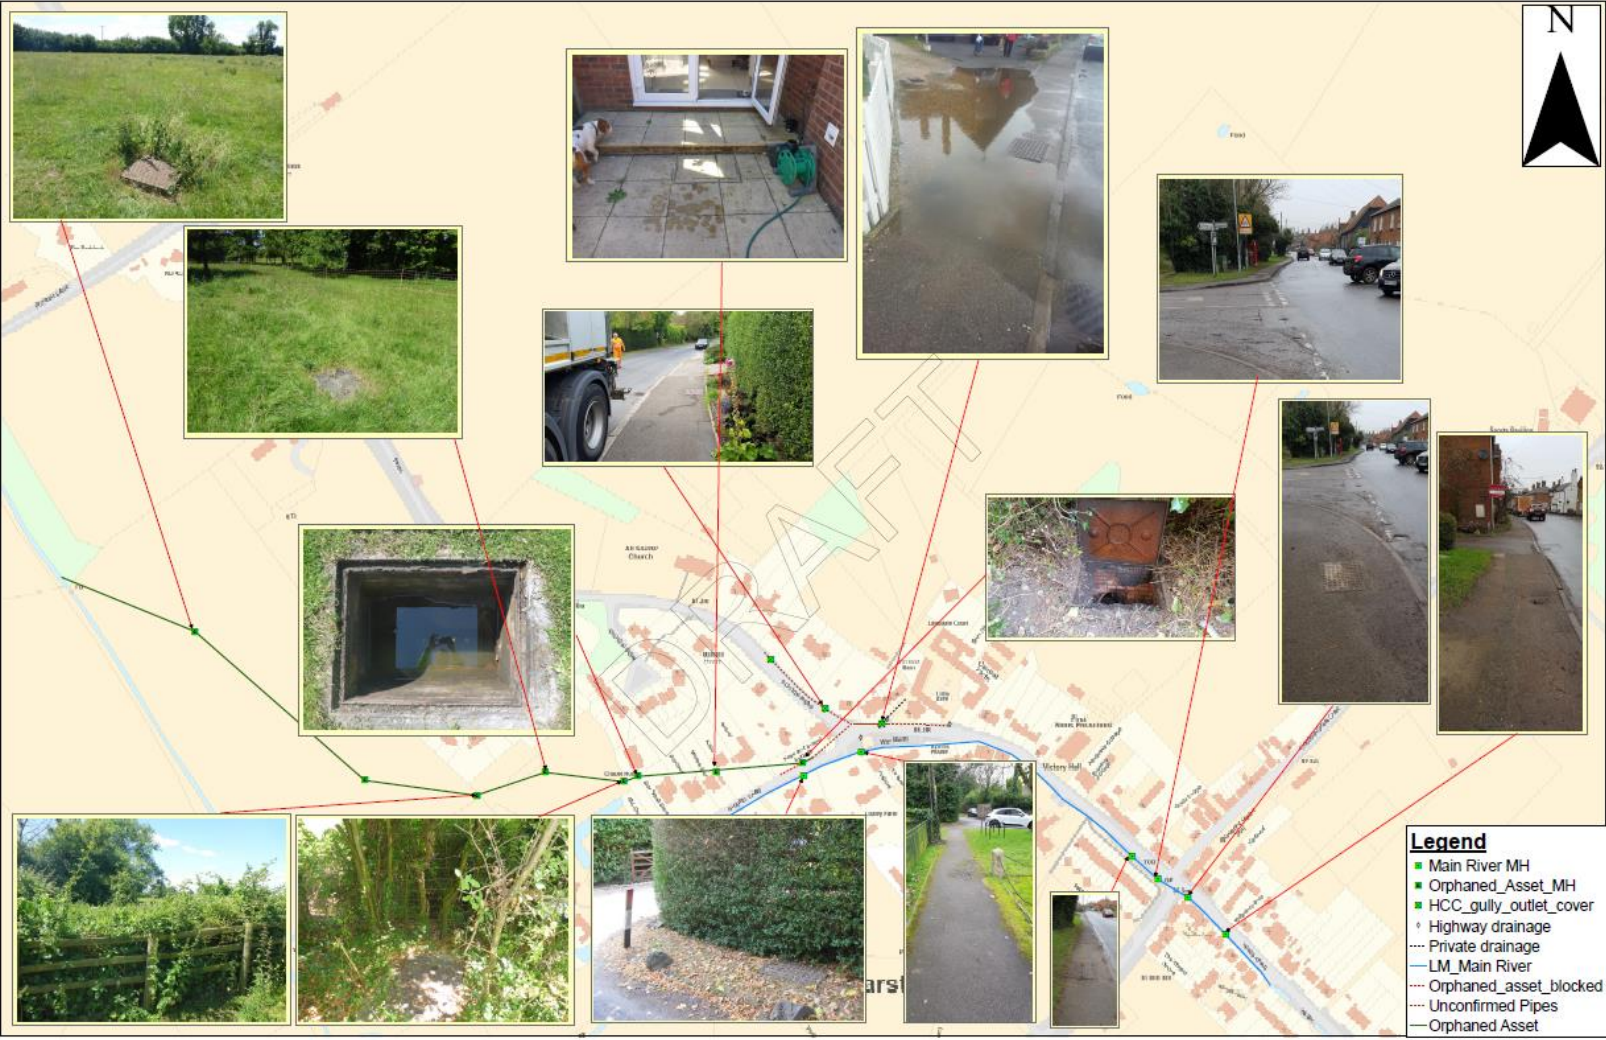
The connectivity of the pipe was established through a combination of CCTV surveys, dye testing and electronic location equipment to establish the route of the pipe. See Figure 15 for a connectivity map establishing what could be ascertained from the survey.

Figure 15 Results from the Connectivity Survey

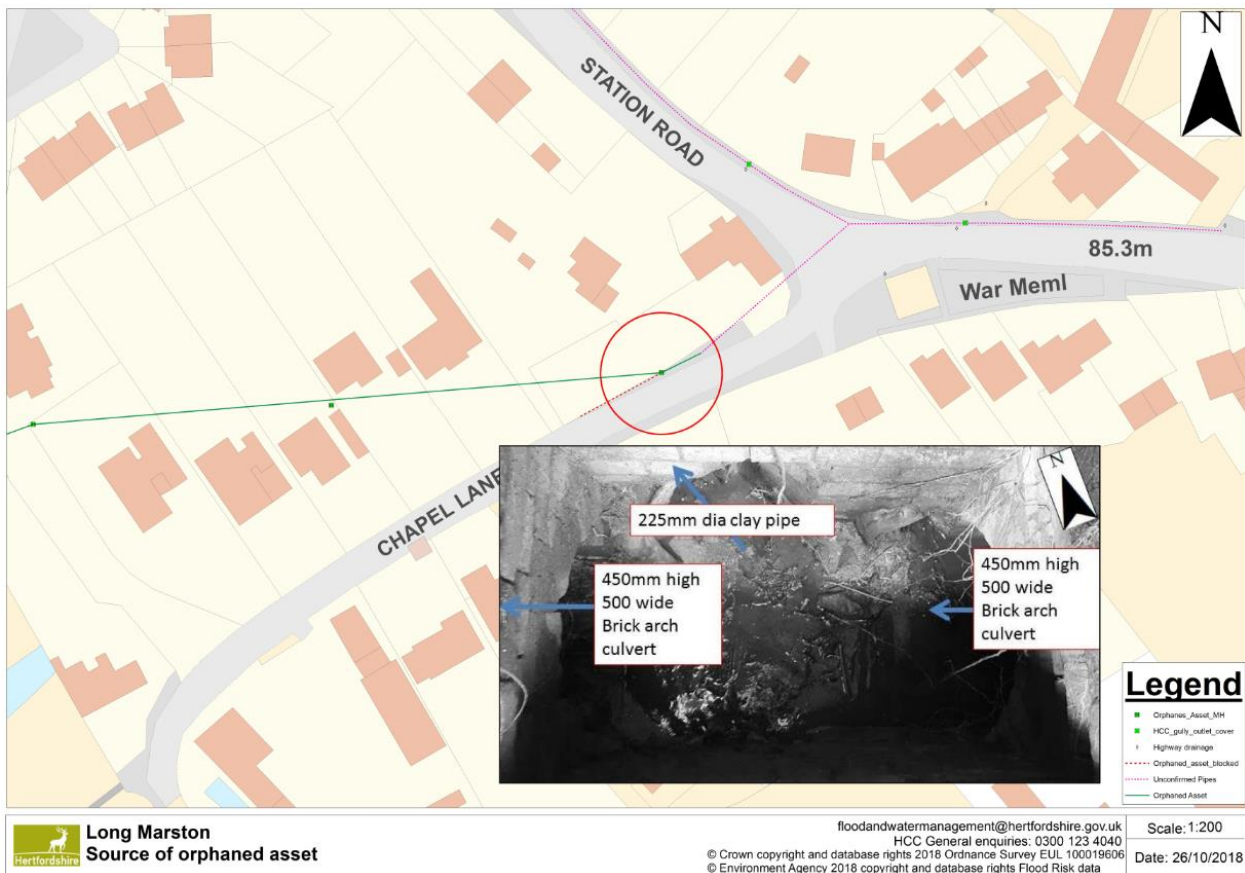
Upstream of the flooded house was traced to a manhole within the verge along Chapel Lane (see Figure 16). This manhole chamber had very old brick arches on the incoming and outgoing connections, therefore establishing that the orphaned asset was likely to be retrofitted at some point due to the change in construction (to a clay pipe).

Figure 16 Manhole chamber where the source of the orphaned asset originates with internal photograph

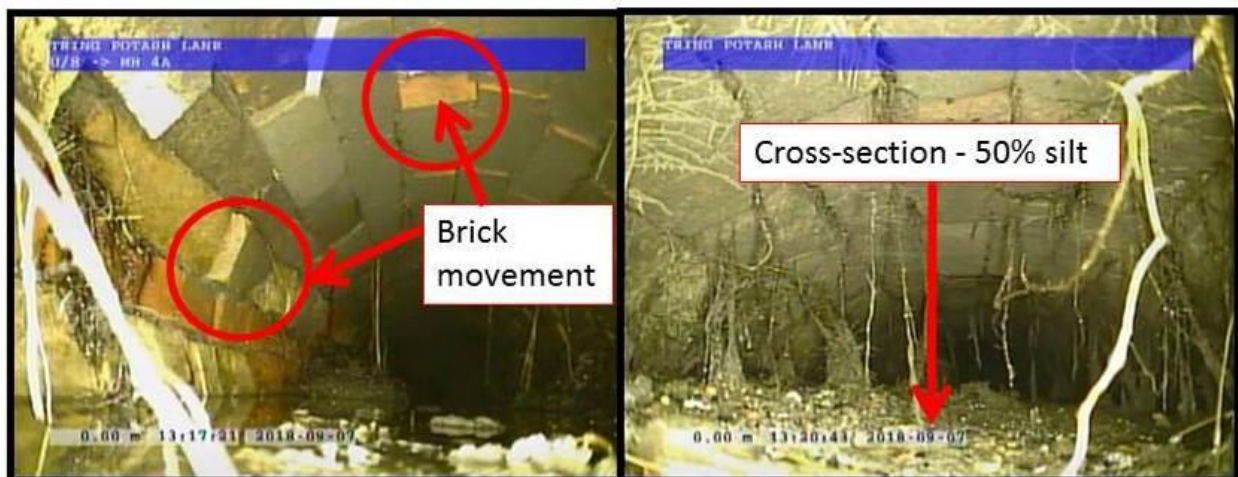
Both of the brick arch culverts were heavily silted with root penetration visible from the inlet and it appeared the culvert in poor condition (see Figure 17). The pressure generated from cleaning culverts can cause older culverts to collapse, therefore it was decided that the risk was too great for these culverts and the survey was abandoned.

Figure 17 Silt and issues of structural integrity in culvert

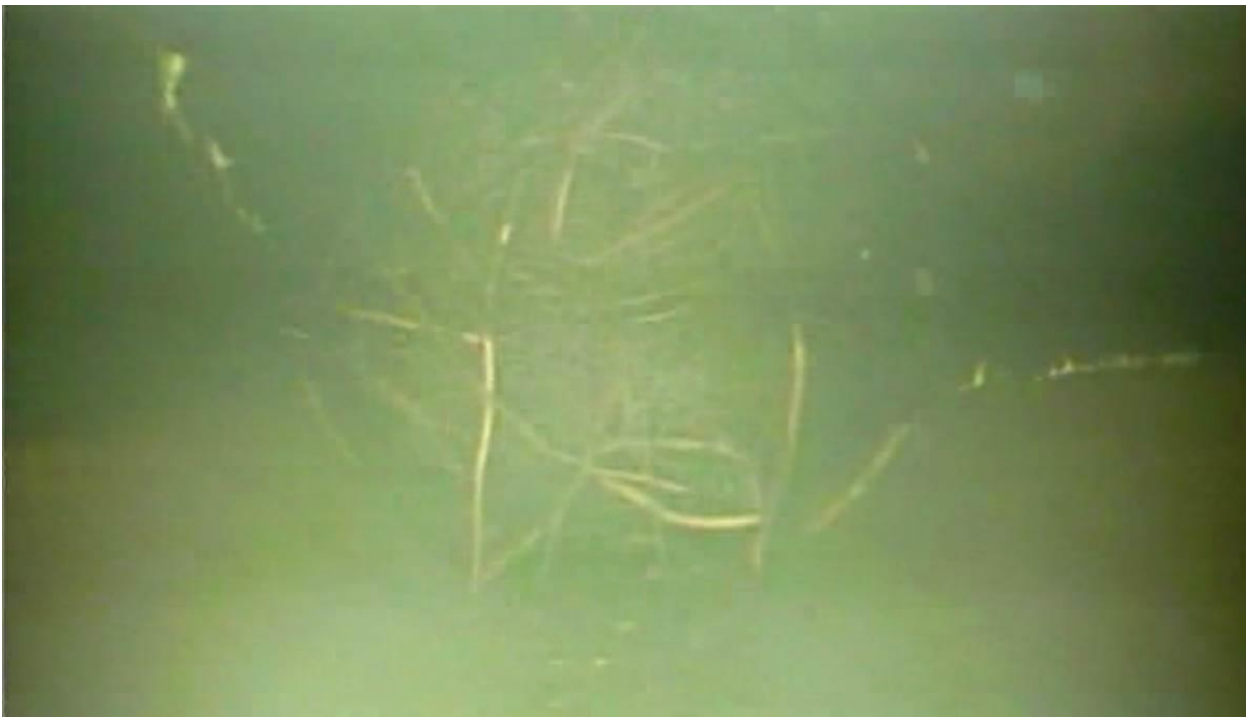
From the flooded property, the culvert goes a considerable distance before it discharges to the Tring Bourne. The clay pipe was in poor condition throughout, with many areas totally submerged due to root penetration and collapses in the pipe (see Figure 18). The pipe was attempted to be cleaned to be able to complete the survey; however as the pipe was

Figure 18 Pipe totally submerged and 100% blocked

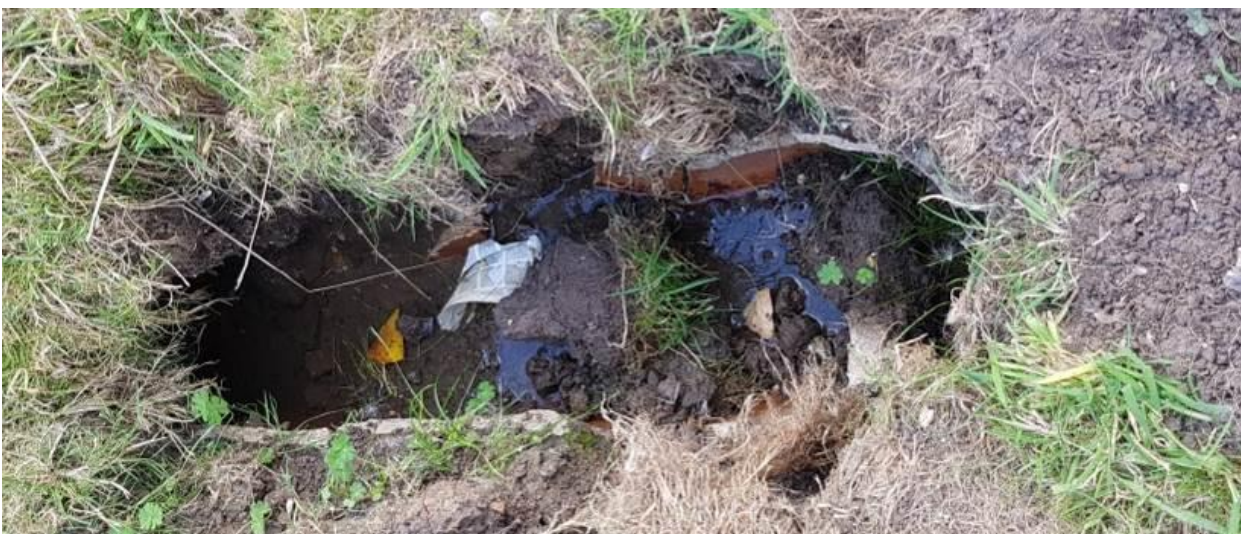
lying very close to the surface (See Figure 19), the pressure of the jetting unit caused the pipe to break when it was attempted. The survey was once again abandoned due to the risks that this posed to the integrity of the pipe.

Figure 19 Collapse of soffit during the investigation

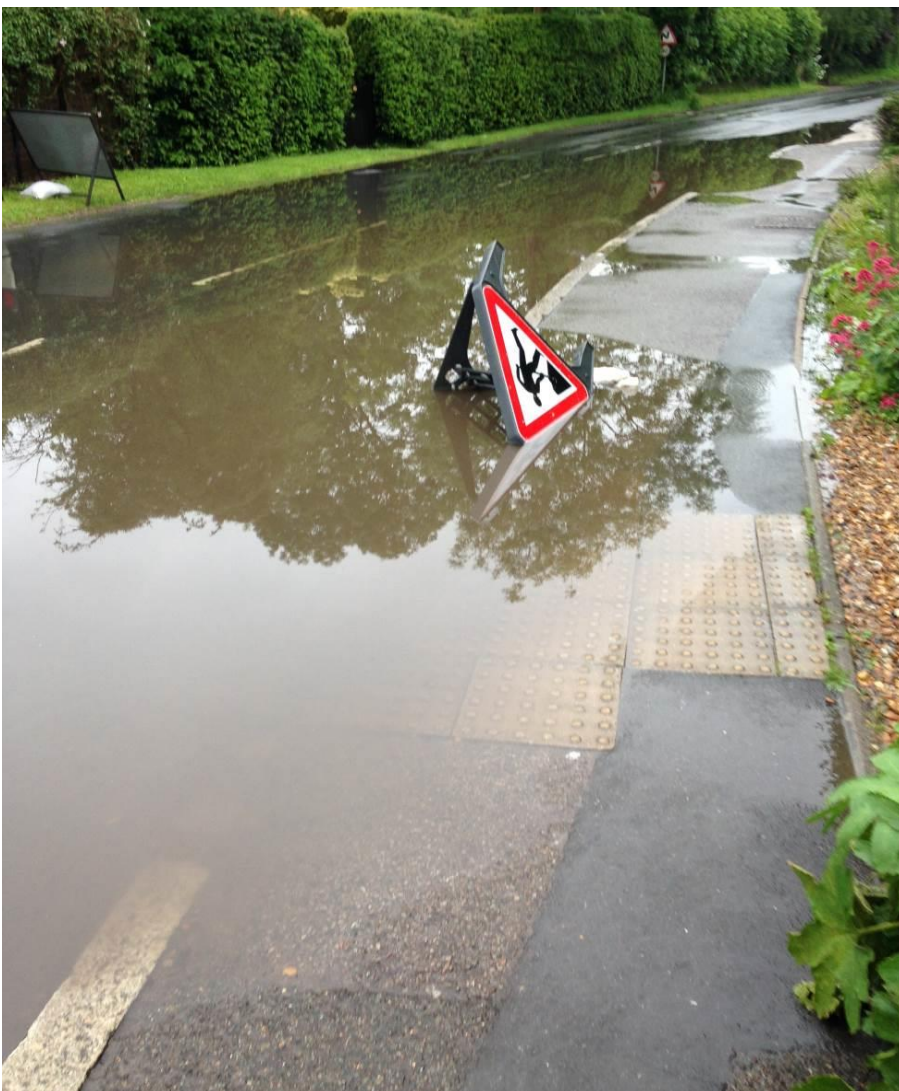
Highway flooding has only been reported after heavier rainfall events and not on each rainfall occurrence. A site visit was conducted with the Highway Authority to discuss the findings of the dye test survey (see Figure 20). After walking the catchment, it was clear that further investigation would need to take place to ascertain the following:

Figure 21 Standing water on Station Road on 27 May 2018
