# Flood Investigation

Section 19 Flood and Water Management Act 2010

## Green Street, Chorleywood Hertfordshire

Date: 30 June 2014  
Reference: ERP-INV-01  
Revision: 03

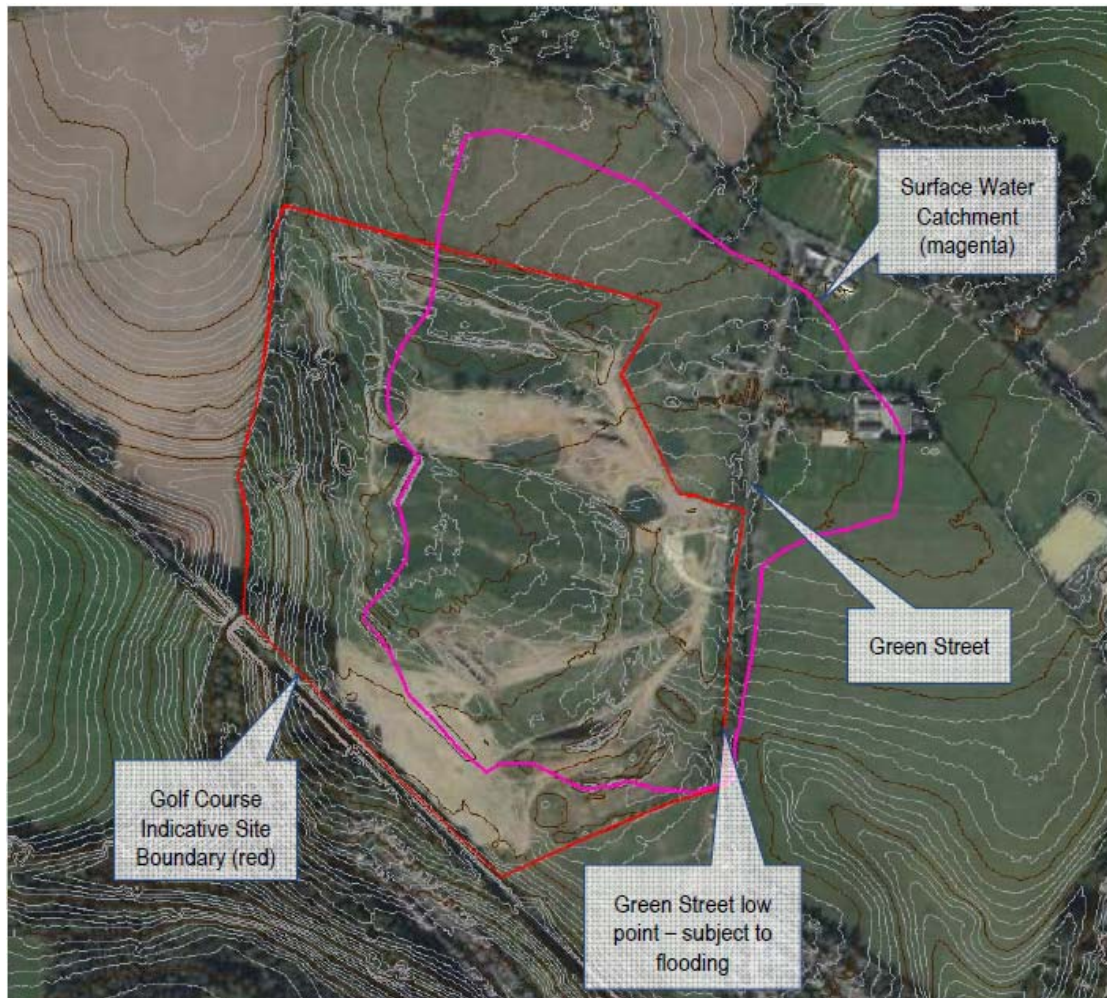
Map 3: Green Street surface water catchment map

Overland surface water flows onto Green Street, Chorleywood led to frequent and prolonged flooding of the highway in 2013 and 2014. There have also been other highway related flood events reported between 2002 and 2012. This has sometimes necessitated the closure of Green Street by HCC Highways and the Emergency Services due to the risk of vehicles being driven into the flooded area and becoming immobilised. The extent of the surface water catchment for Green Street can be seen in Map 3.

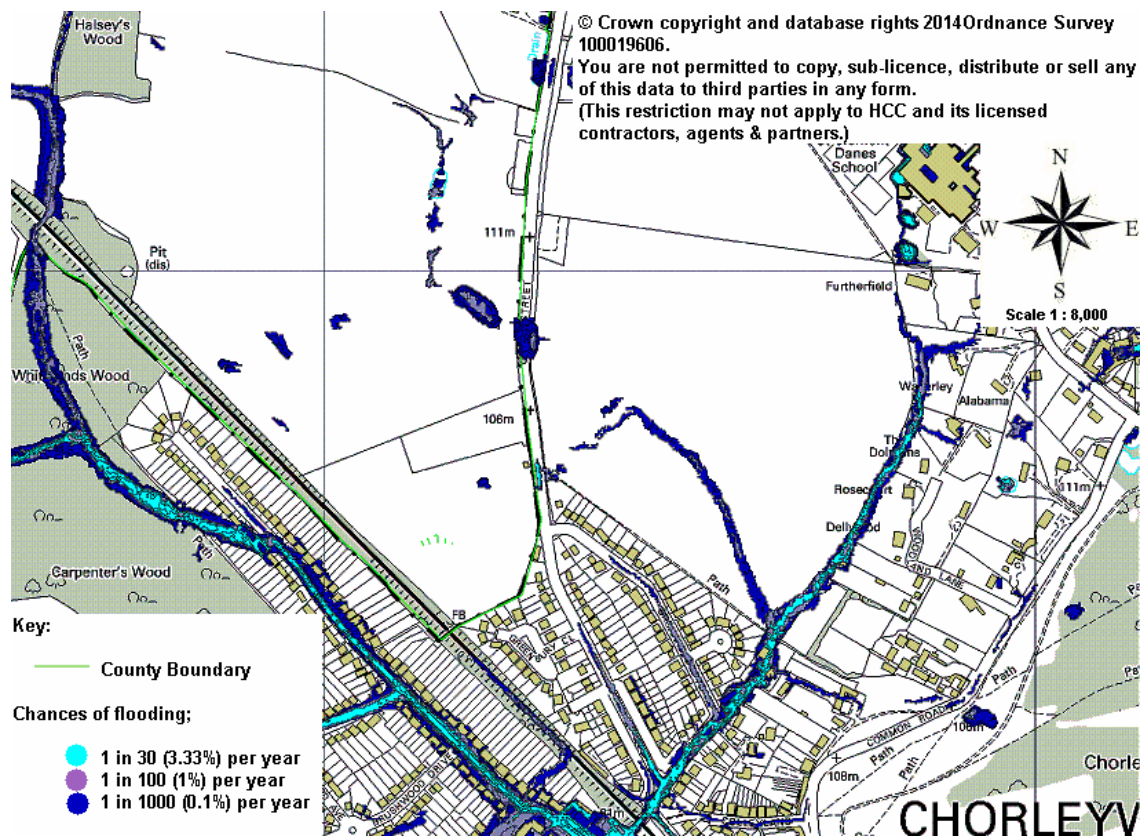
Map 4: Environment Agency Surface water flood map for Green Street, Chorleywood

This flood investigation has found that there is a primary overland flow route which flows from the north-west to the south-east (see map 4). The primary overland route starts with runoff from the rural catchments north, north-east and north-west of a golf course and includes a new housing development on Stubbs Farm to the north-east

Following heavy and prolonged rainfall events, surface water overtops and flows from the built surface water drainage ponds (built as part of a golf course development) and down the highway itself, collecting within a well defined natural dip in the road. Due to an earth embankment on the eastern side of Green Street, the water stays within the highway and is unable to flow into the adjoining field to the east.

On the other side of the embankment, to the east, there is a well defined valley, where water has been observed (by residents) to flow when the level of the flooding rises above the embankment. This then spills over into the eastern field. There are residential properties at the bottom of the valley. No reports of flooding beyond the boundary of this field, which flows to the south eastern corner, have been received.
