Hertfordshire County Council Flood Investigation Report Long Marston, Hertfordshire

Hertfordshire County Council Flood Investigation Report

Friday 24 October 2014
Revision 2 - Draft

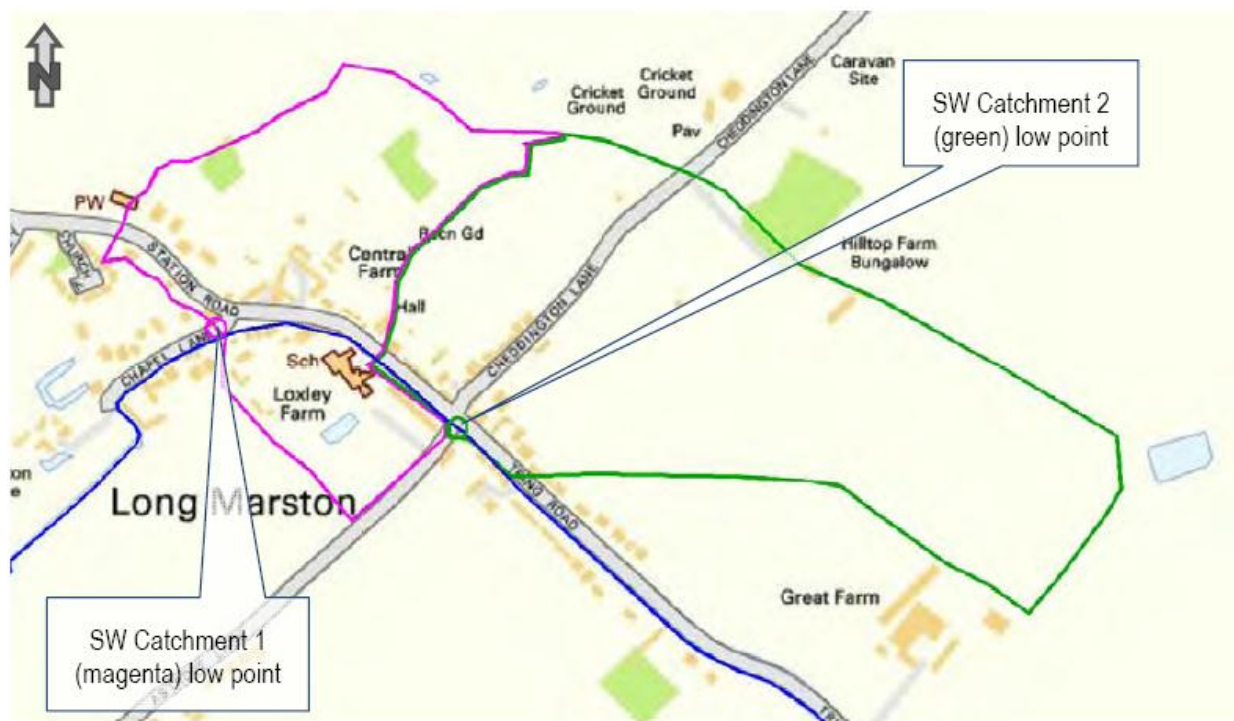
Figure 3.1 Long Marston surface water catchments

The surface water catchments of the two main areas affected by historical flooding coincide with localised depressions that would essentially form “pinch points” for overland flooding from any source. These have been identified and are shown in figure 3.1. The pinch point locations identified are as follows:

- SW Catchment 1 – Junction of Station Road and Chapel Lane

- SW Catchment 2 – Village Crossroads (Junction of Station Road, Cheddington Lane, Tring Road and Astrope Lane)

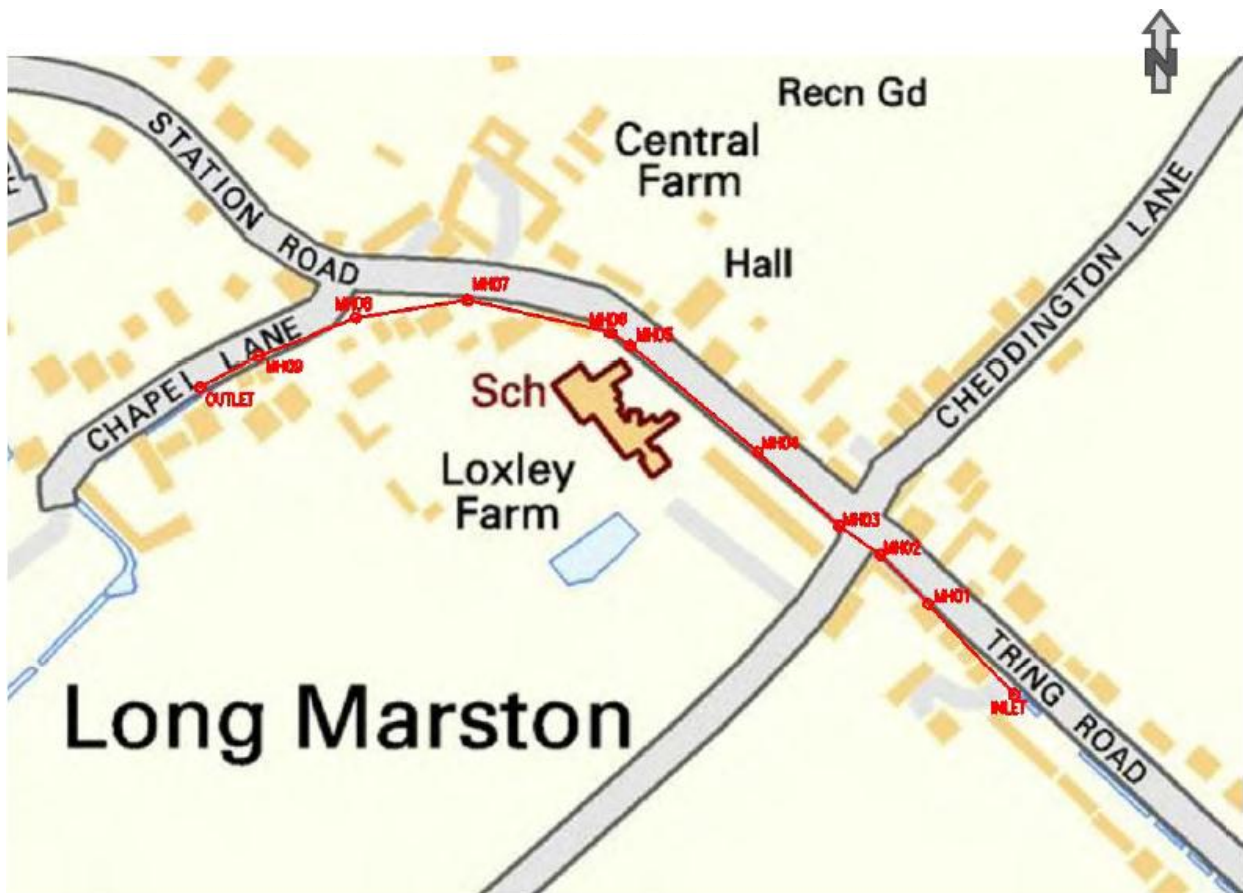
Figure 3.3 Tring Bourne main culvert route through Long Marston

The main structure located in Long Marston is the culvert that takes the main river (Tring Bourne) through the village from Tring Road and outfalls in to open channel again in Chapel Lane (see figure 3.3). This structure was last inspected by CCTV in September 2010 and defects identified were recorded. To date no remedial works have taken place on this culvert and any identified defects have not been rectified. Responsibility for the maintenance of this culvert lies with the relevant riparian owners of the main river along its course. However it is unclear as to whether the riparian owners are aware that they have these responsibilities or whether they even know that a main river passes through their land.

- The existing river network capacity, and in particular the main culvert capacity, is likely to be insufficient to convey the rate/volume of floodwater caused by the events immediately preceding and on 7 February 2014, this situation will have been exacerbated by the lack of maintenance.

- The lack of culvert capacity (due to culvert size and efficiency) is likely to have had a number of consequences including; out of channel flooding at its inlet; direct flooding due to surcharge of manholes and the failure of surface drainage networks (where present) to cater for direct runoff to due to surcharge / incapacity in the system.

3.	Investigate the Tring Bourne culvert upgrade	<p>Carry out a feasibility study as to the upgrade / replacement works necessary on the main river culvert through Long Marston. Any scheme would need EA agreement/consent. Any proposal for works would need to be beneficial and not increase flooding elsewhere.</p> <p>A feasibility study would require an assessment to ensure there would not be an increase to flood risk downstream. If culvert capacity is increased, additional attenuation may be required in combination with the culvert upgrade.</p> <p>May require FDGiA funding subject to a successful bid being submitted and partnership funding.</p>	<ul style="list-style-type: none"> • Environment Agency • Hertfordshire County Council – Lead Local Flood Authority
