Technical Assessment Report

to support Section 19 Flood Investigation

Long Marston, Hertfordshire

September 2014

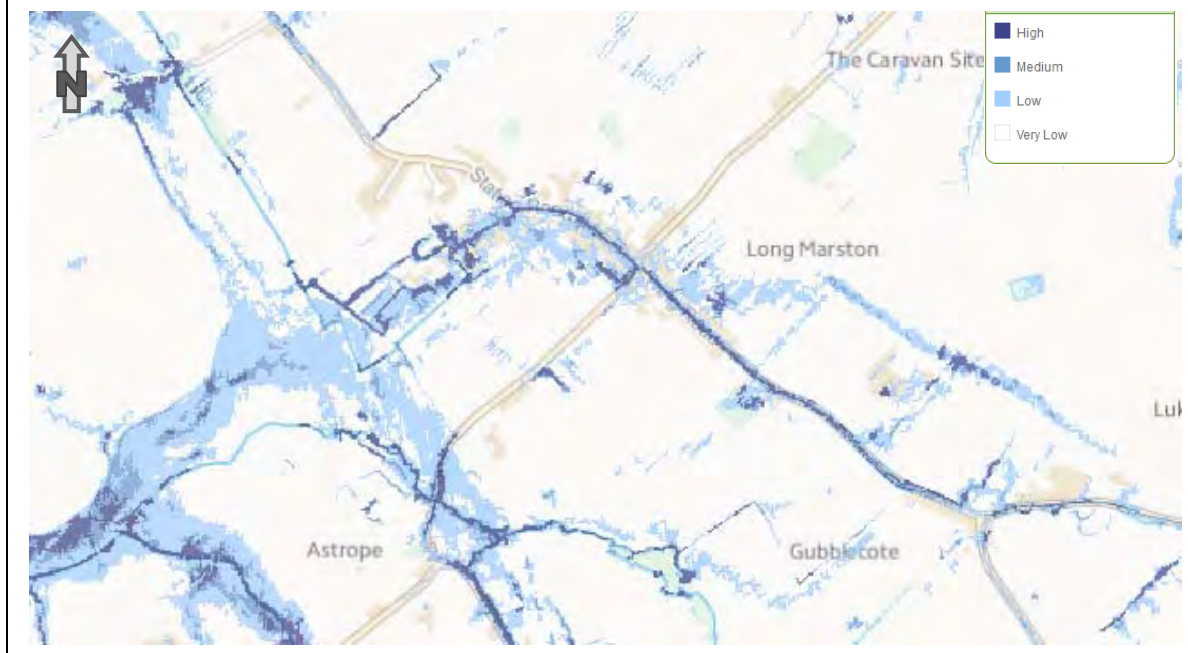
Figure 3.2: Environment Agency Risk of Flooding from Surface Water

Figure 3.2 is taken from EA 'Risk of Flooding from Surface Water' mapping, available online, and indicates that much of the village is at risk from surface water flooding. Much of the high risk areas coincide with Tring Bourne that flows through Long Marston with significant high risk areas noted at the western end of Chapel Lane.

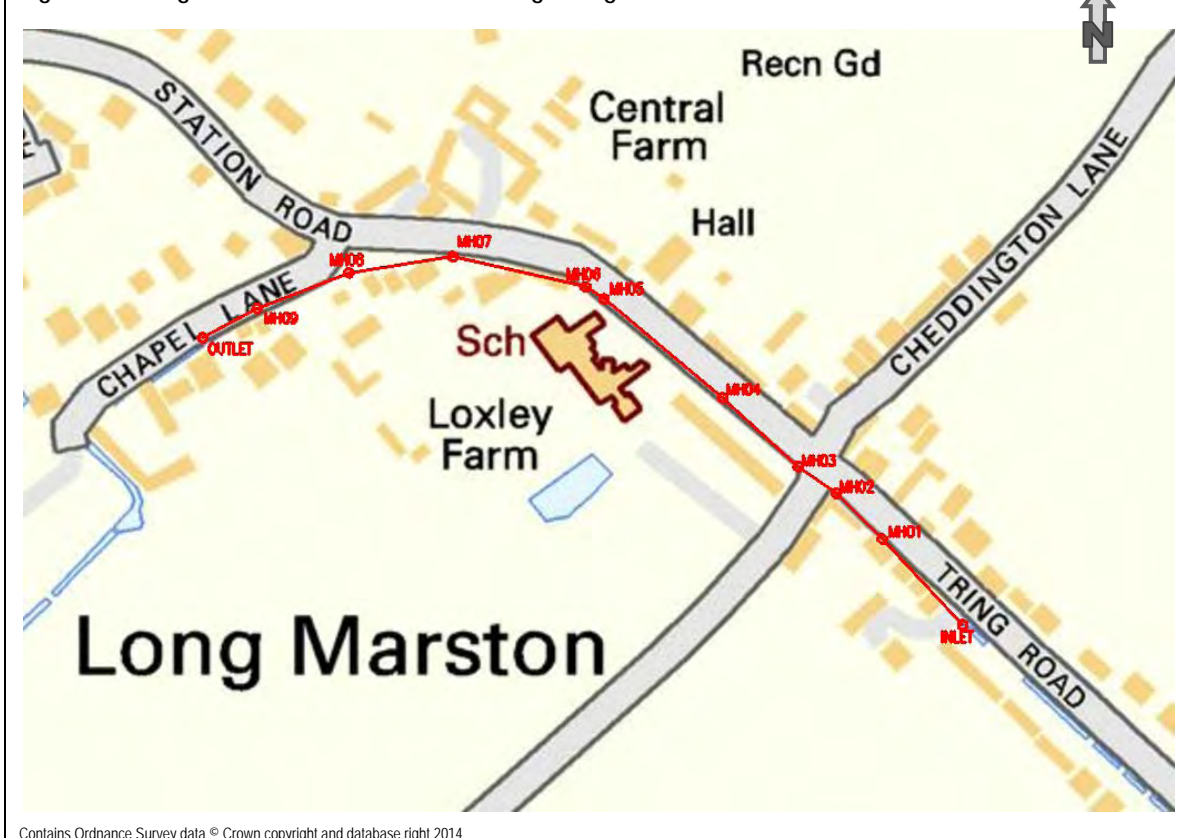
Figure 3.3: Tring Bourne main culvert route through Long Marston

- Eight of the ten pipe lengths are classified as Grade 5 for 'Service / Operational Defects', the lowest defect grade description, indicating that 'rehabilitation is urgent and short-term in order to prevent further damage'.
- Six of the ten pipe lengths are classed as Grade 4 or 5 for 'Structural Defects' indicating that 'rehabilitation procedure is urgent' and needs to be completed within 'one to two years' and 'in the short-term' respectively.
- The survey could not be completed between MH05 and MH06 due to obstruction within the culvert (grout obstruction at joint).

In general, the survey revealed that the Tring Bourne culvert through Long Marston is in very poor condition and in need of urgent repairs. No evidence or record of any subsequent rehabilitation work having been carried out to rehabilitate the service condition of the culvert has been established during the course of this assessment.

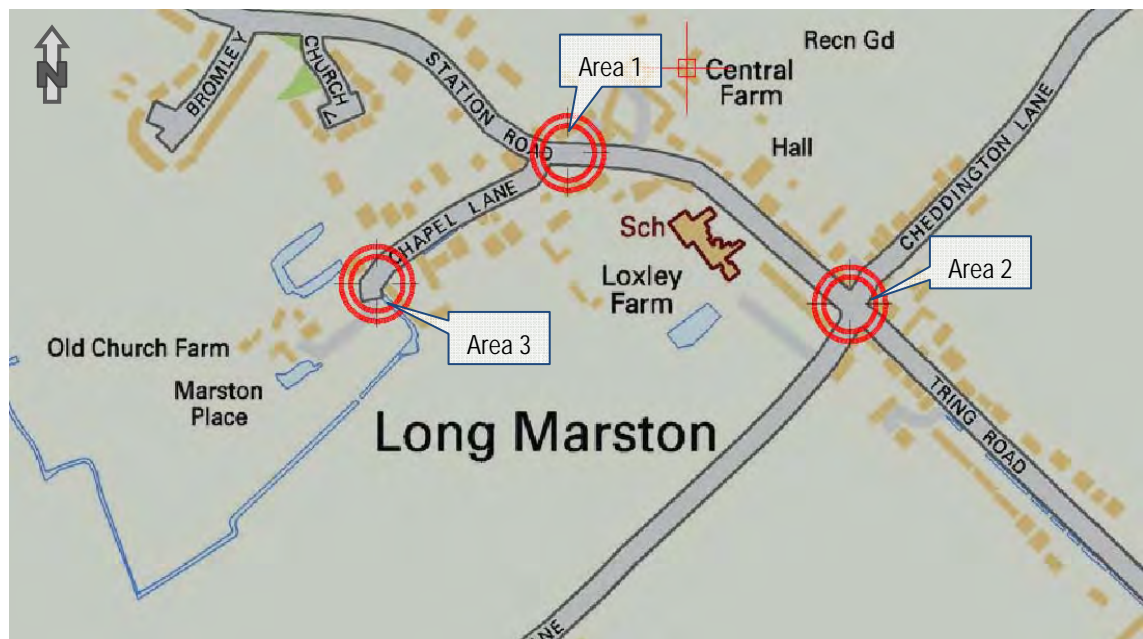
Figure 4.1: Long Marston – Historical Reported Flooding Areas

Note that this list is not exhaustive and other areas of flooding may exist, however, the listed areas are those known to HCC. Therefore, these areas will form the focus of this assessment in terms of flooding locations within Long Marston. It is noted that the areas listed are consistent with EA surface water flood mapping.

In addition to the affected properties listed by HCC, Tring Rural Parish Council have commented that an additional property on Chapel Lane has flooded on several locations. Marsworth recreation field, located between Watery Lane and Grand Union Canal, is also reported to have flooded. The cause of the flooding of the recreation field was reported during a Marsworth Parish Council Meeting of 12th March 2014 to be a blocked drain at the south-east corner of the field causing water to flow onto the recreation field.

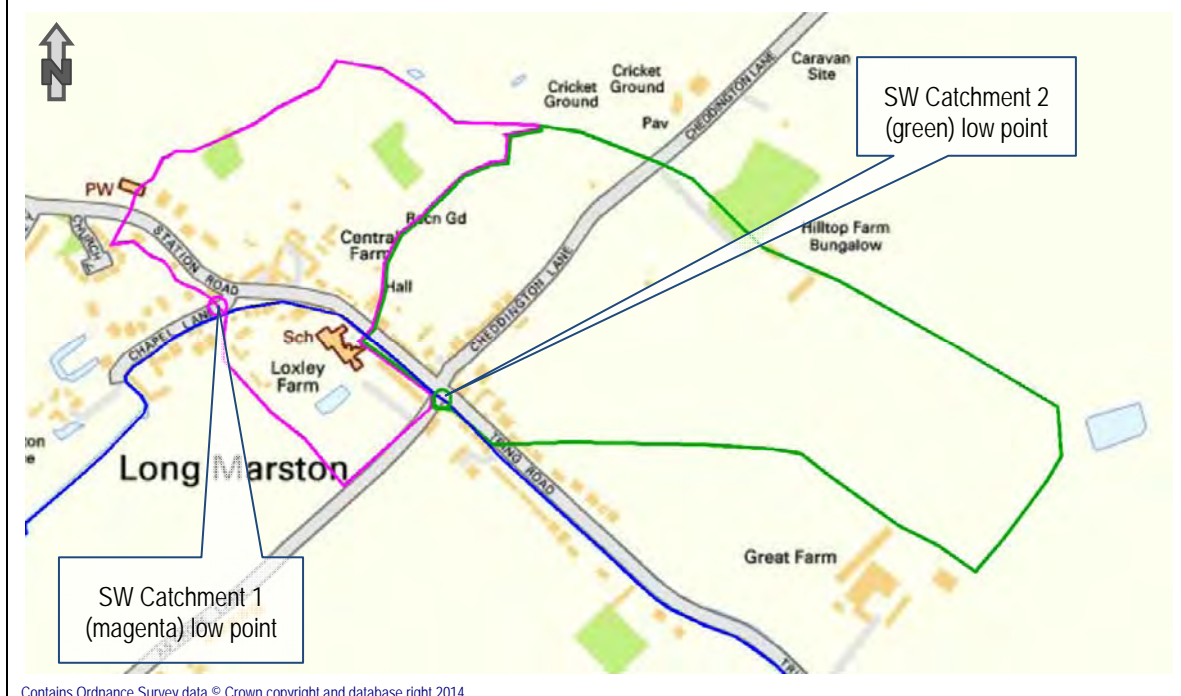
Figure 5.2: Long Marston Surface Water Catchments

As shown in Figure 5.2, the main crossroads in Long Marston (SW Catchment 2) has a significantly larger surface water catchment than that for Chapel Lane / Station Road (SW Catchment 1). Surface water catchments are included to demonstrate that overland flow has the potential to cause flooding directly without any contribution from fluvial or other sources.

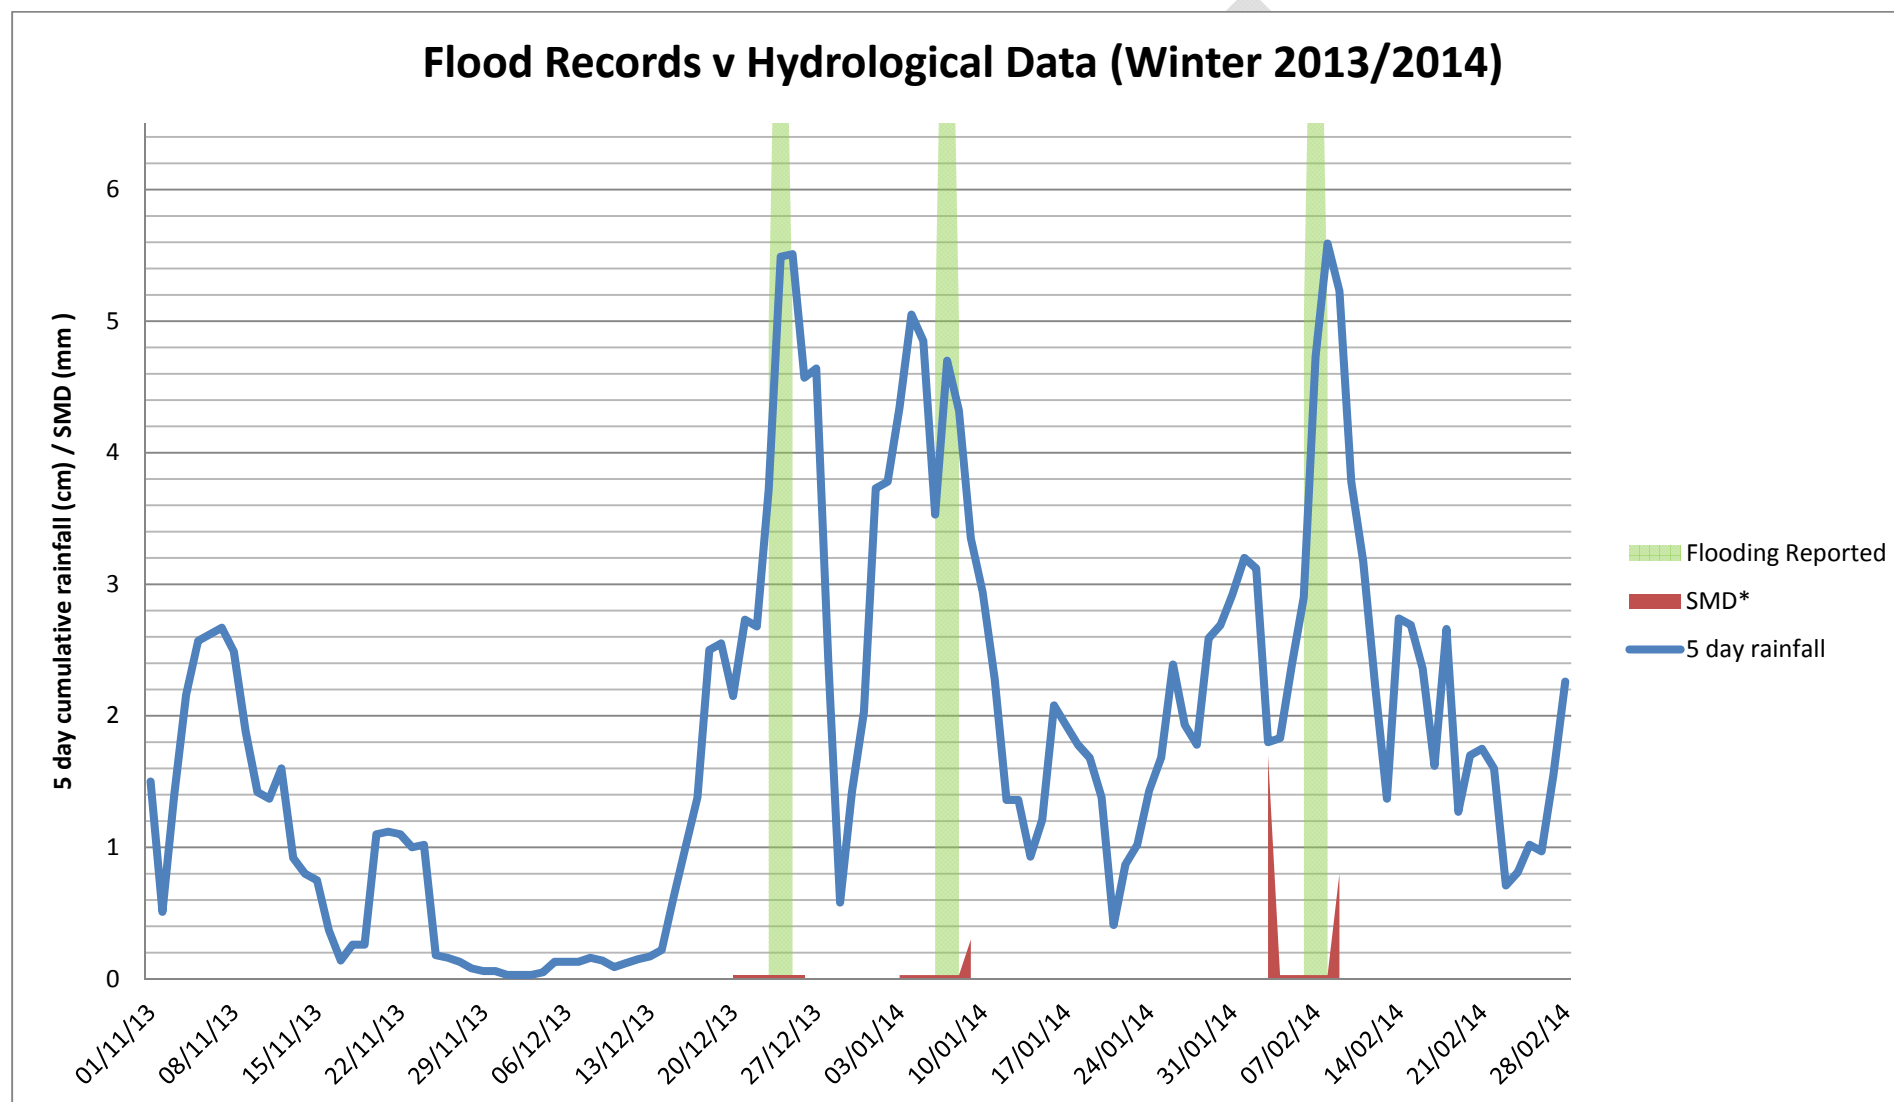
Figure 5.3: Graph of Flood Records v Hydrological Data (Winter 2013/2014)

The river catchment contributing to the site is small with a high proportionate runoff particularly when the catchment is saturated, and is initially considered likely to react in a spate / flashy nature when the catchment is subject to heavy rainfall. A hydrological analysis to determine a typical time to peak flood in the village (following a rainfall event) has been undertaken, based on Flood Estimation Handbook (FEH) Revitalised Flood Hydrograph (ReFH) with catchment parameters adjusted to allow for the antecedent catchment wetness experienced in 2013 results in a time to peak of c. 2 hours. This estimate tallies with local residents reports that on the 7th February, heavy rainfall was observed at 2am and flooding commenced at approximately 4am.

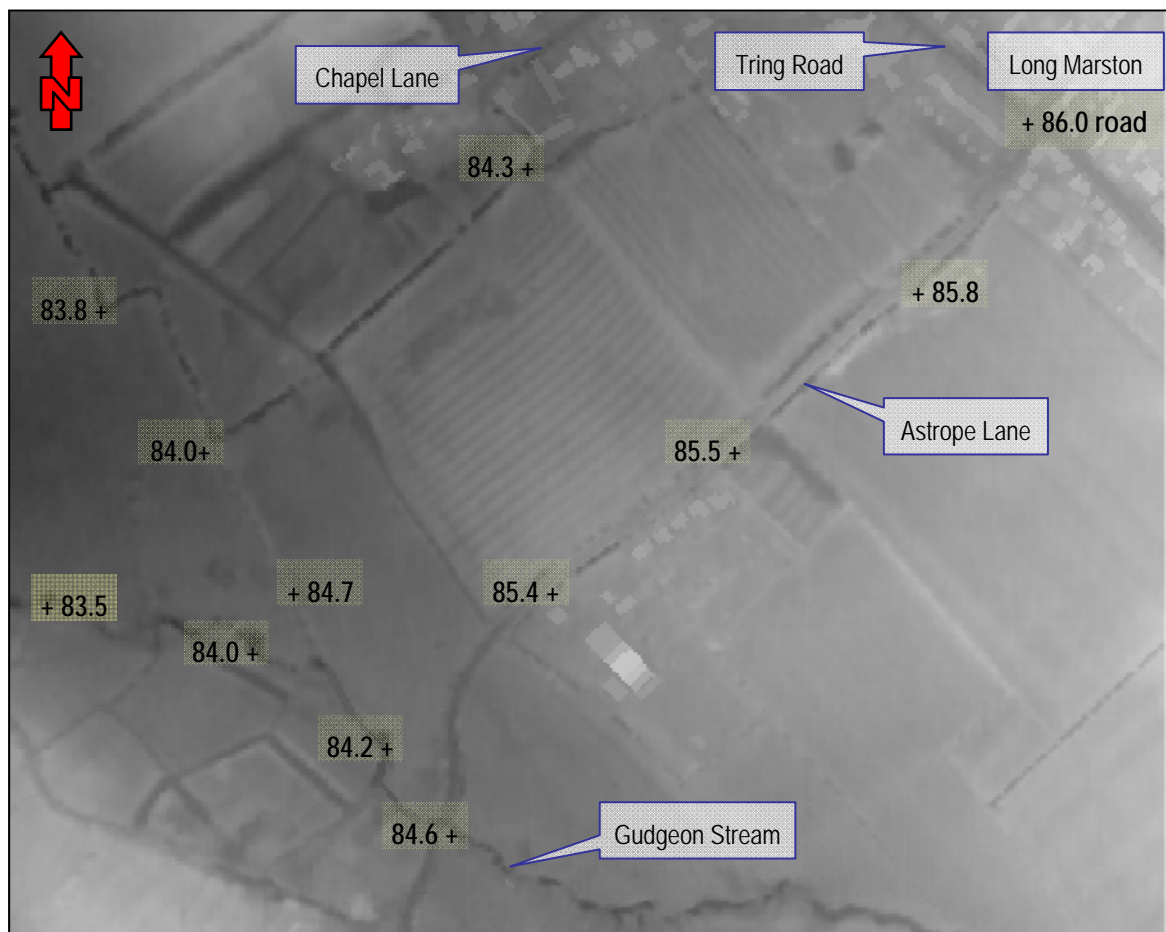
Figure 5.7: DTM Level Map, Astrope & Long Marston

Gudgeon Stream flows in a northerly direction and under Astrope Lane road via a culvert. There are anecdotal reports of run-off from Astrope Lane flowing into Long Marston, therefore an assessment has been undertaken to determine if high flows from Gudgeon Stream could flow into Long Marston. Figure 5.7 shows the lowest levels of streams and ditches in the Astrope Lane area. The figure demonstrates that the bed level of Gudgeon Stream is a minimum of 1.2 metres lower than the lowest point in the roadside ditch of Astrope Lane near Long Marston, therefore flows from Gudgeon Stream would not flow into Long Marston via this route.

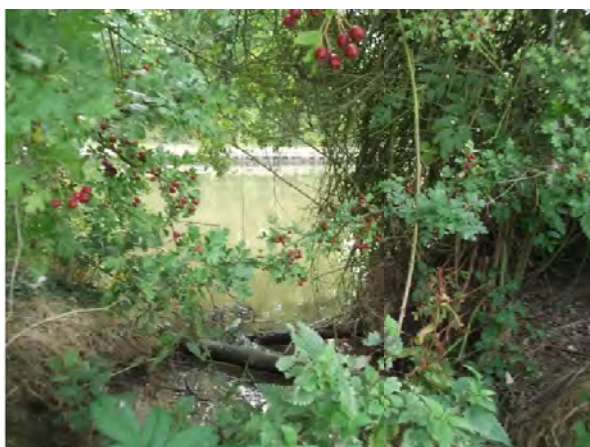
**Photo 11: Low bank level canal**

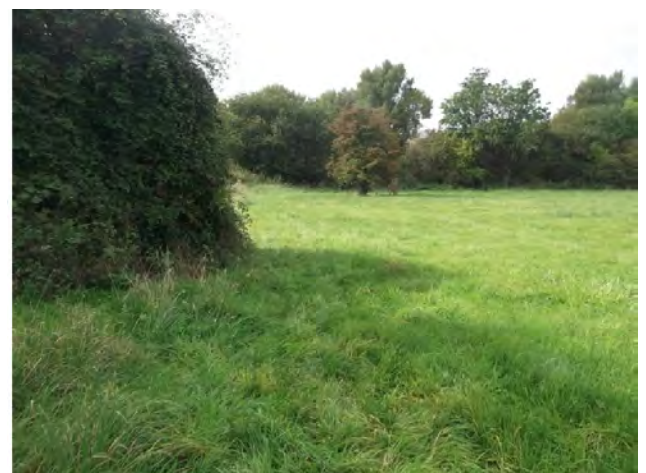
**Photo 12: View immediately adjacent to low bank area (possible canal overspill breach location)**
