Hertfordshire County Council Section 19 Flood Investigation Report Northwood

Hertfordshire County Council Northwood Flood Investigation Report

April 2018
Version 5

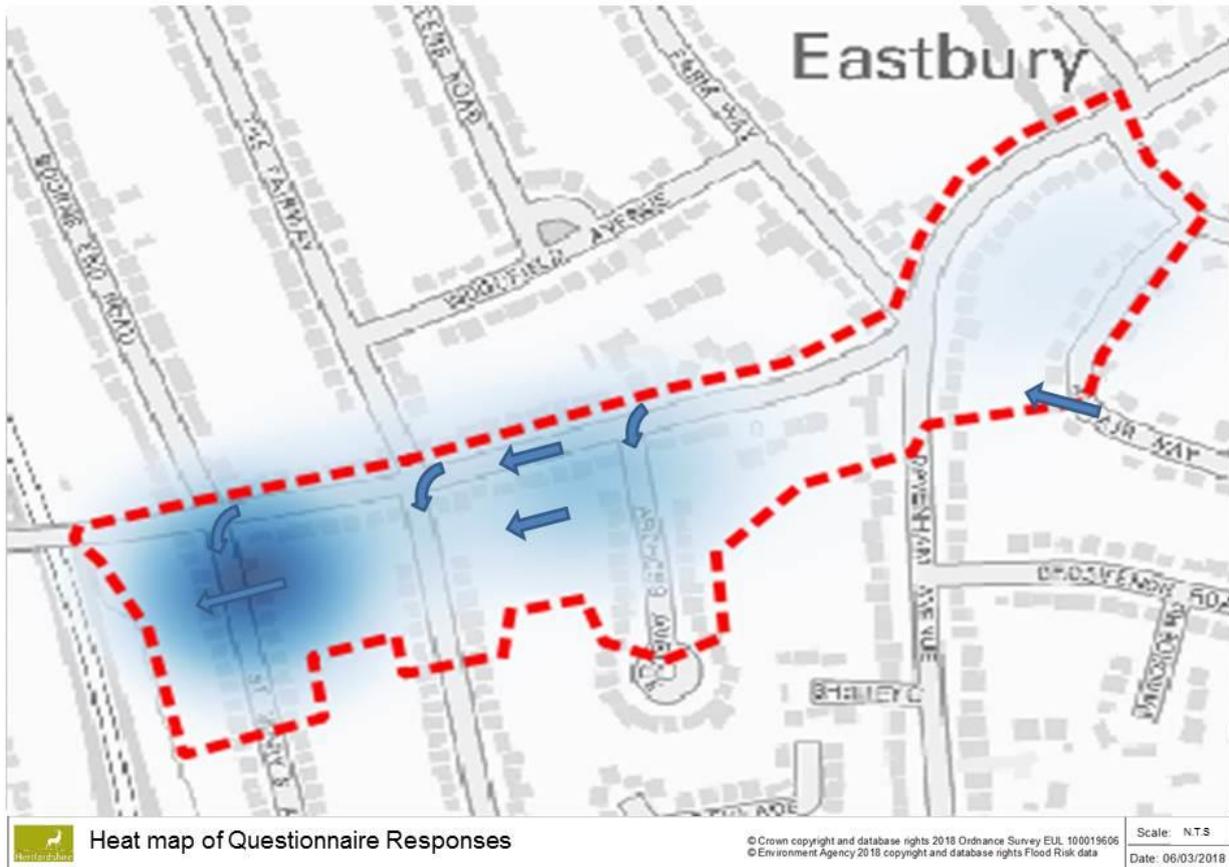
Figure 5: Flood incident questionnaire results heat map

The flood depths and flow directions reported via the flood incident questionnaires are displayed on Figure 5 in the form of a heatmap (with the most severe a darker colour). This shows the flood depths with the arrows representing the flow direction and the darker areas showing the greater depth of flood water. Flood depths were deepest at St Mary's Avenue, at the lower extent of the investigation area; this was closely followed by the area in the vicinity of the junction between Ardross Avenue and Batchworth Lane. Flood water was also reported trackside within TfL land, impacting the Metropolitan tube lines. Trains were delayed while water drained away through the ballast and track drainage. The railway is designed to flood during extreme events so was not unexpected.

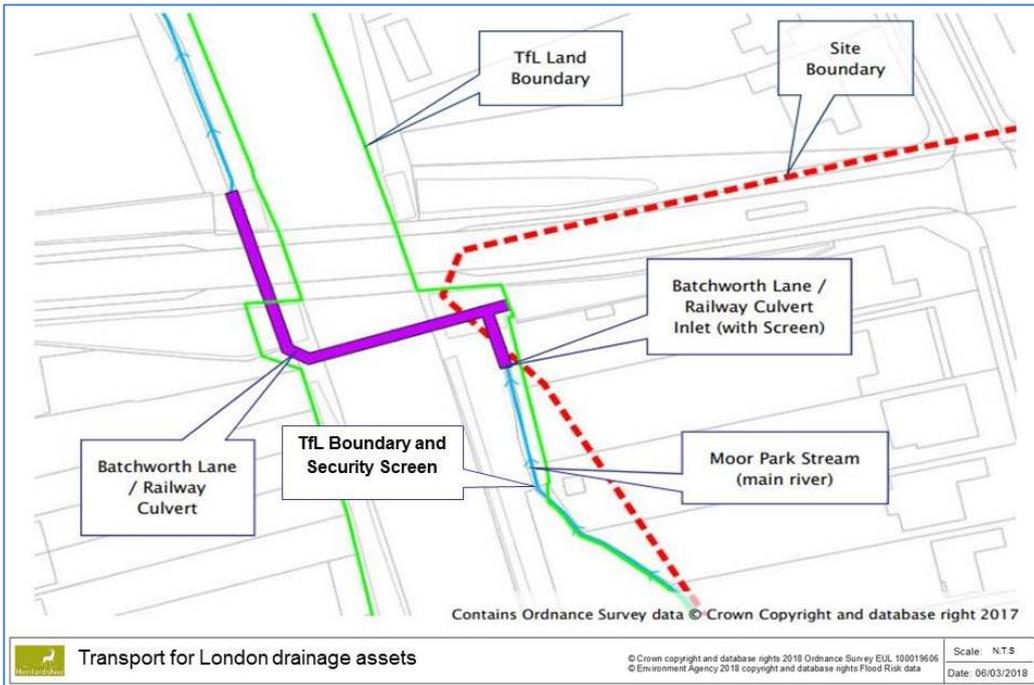
Figure 10: Transport for London watercourse / drainage assets

- **Watercourse blockage** – The Moor Park Stream flows into TfL land. TfL has provided information on key drainage assets within its land holding, as shown on Figure 10 There are two structures immediately upstream of the Batchworth Lane Culvert inlet headwall that are impacting flow; a security screen 20 metres away from and a trash screen bolted onto the headwall (see Figure 12 and Figure 13). A resident stated on their questionnaire that they regularly clear the security screen due to a lack of maintenance from TfL. Residents have indicated that there was debris on both screens during and following the flood event however that water was able to pass through.

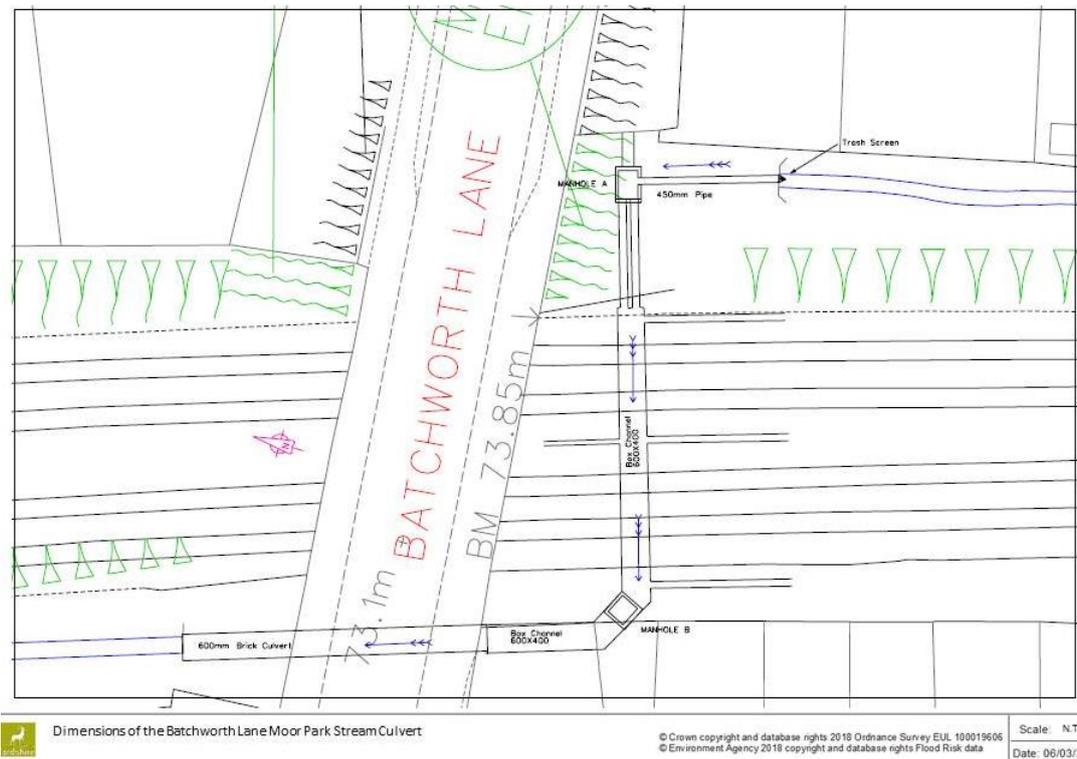
Figure 11: Approximate culvert dimensions at Batchworth Lane Culvert

Have conducted a CCTV survey of the Batchworth Lane Culvert and have shared the initial findings with HCC. This includes details of the pipe sizes through the culvert length (

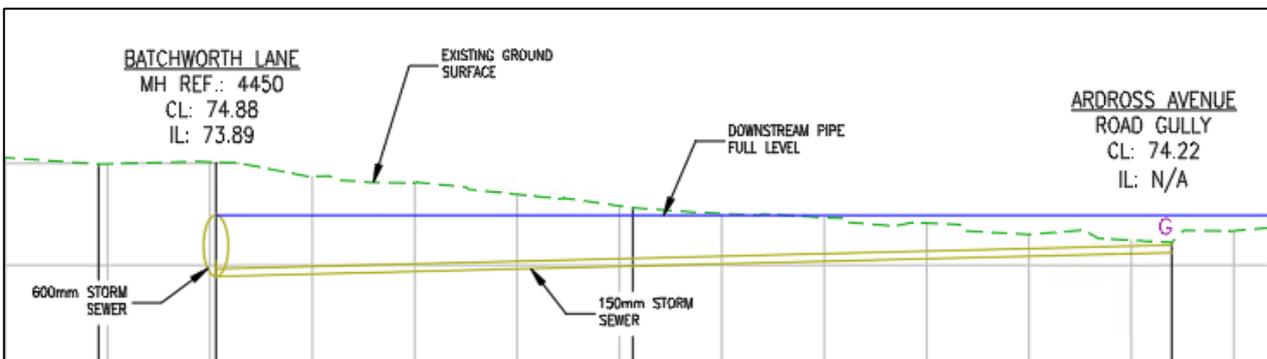
Figure 15: Storm sewer surcharge at Ardross Avenue

The surface water sewer beneath Batchworth Lane did not have the capacity for the volume of rainfall event on 23 June 2016. Therefore, water within the sewer will have surcharged where there were smaller areas of storage within manhole chambers. Figure 15 demonstrates how the surcharged surface water sewer flowing at full capacity on Batchworth Lane would have the potential to cause out of sewer flooding at Ardross Avenue¹. Flooding emerging on Ardross Avenue via this mechanism would tend to follow the overland flow path indicated by the EA Risk of Flooding from Surface Water (RoFFSW) map, as shown in Figure 16.

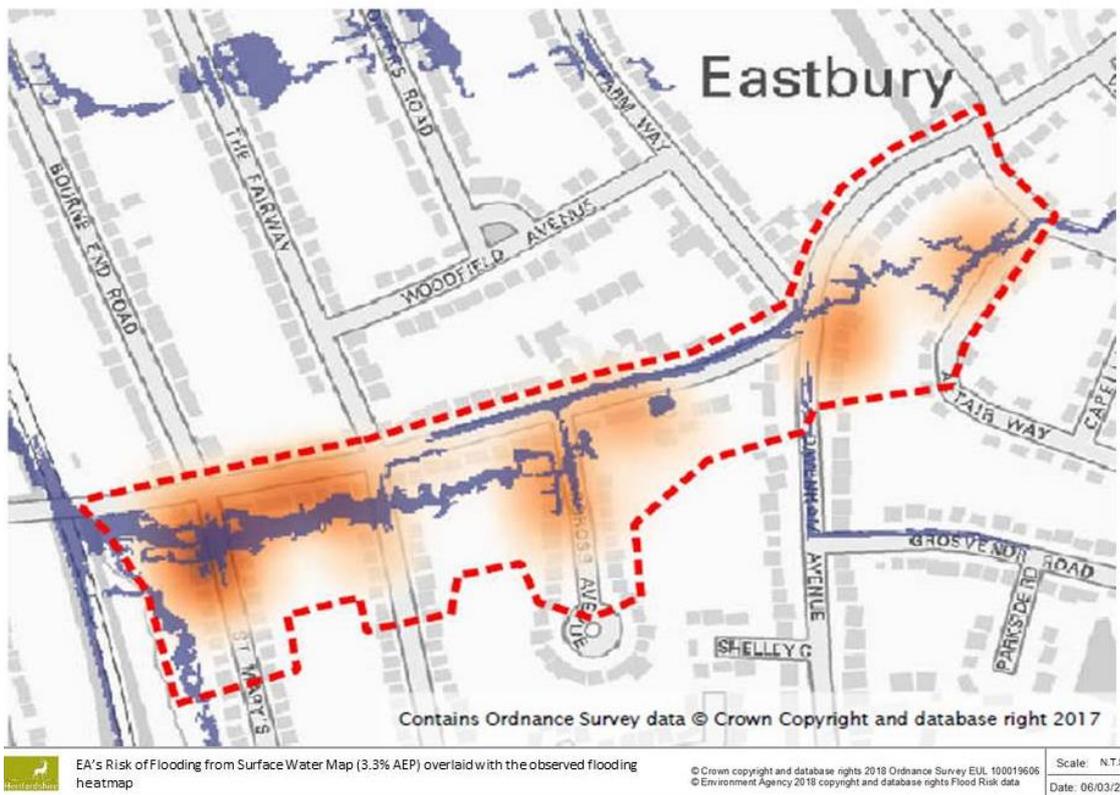
Figure 17: EA's RoFfSW (3.3% AEP) overlaid with the observed flooding heatmap

Considering the estimated return periods of the recorded rainfall on 23 June 2016, a surface water flood event similar to that shown on the 3.3% AEP extent on the Risk of Flooding from Surface Water Map (which is published on the GOV.UK website) would have occurred. Figure 17 shows the EA predicted surface water flood extent resulting from a rainfall event with a 3.3% AEP in any one year overlain with the 'heatmap' of observed flood depths.

Given the strong correlation between the recorded rainfall, observed flooding, and associated surface water flood extent mapping, it can be reasonably concluded that surface water flooding was a significant contributing factor to flooding experienced on 23 June 2016.

The local surface water sewer network was not designed for rainfall events of this magnitude. The flooding in this flood event was also influenced by river levels in the Moor Park Stream. A combination effect of higher river flows and structures impeding access will have limited the ability of the surface water sewers being able to discharge efficiently.

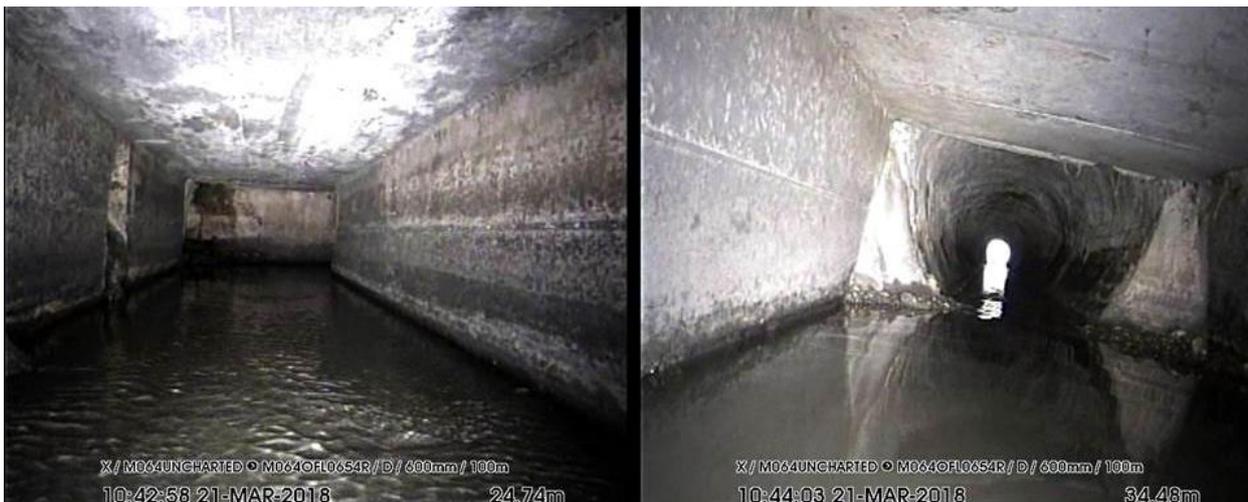
Figure 18: Images from CCTV survey conducted March 2018

- Figure 11) as well as pictures within the culvert (Figure 18).
