# Hertfordshire County Council Flood Investigation Report

Robbery Bottom Lane, Welwyn, Hertfordshire

## Hertfordshire County Council Flood Investigation Report

Tuesday 16 December 2014

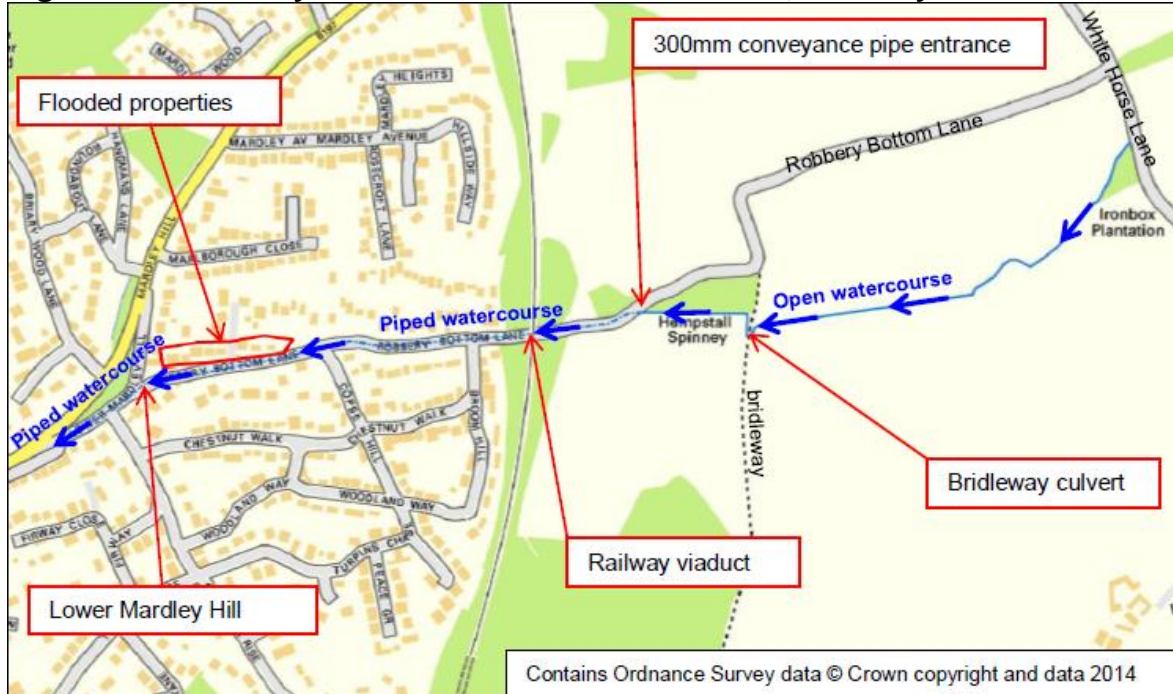
**Figure 2 Ordinary watercourse natural flow route, Robbery Bottom Lane**

Robbery Bottom Lane lies at the centre of the valley in which an ordinary watercourse flows west through a field from the junction of White Horse Lane and Robbery Bottom Lane. The watercourse then travels through a culverted bridleway into another field. At the edge of this second field the water enters an inlet which directs the water through a culvert downhill and west under Robbery Bottom Lane. From the west of the lane the culvert continues to carry the watercourse under the road until it reaches the east side of Great North road where it becomes open again. The watercourse then travels through various culverts before discharging to the Mimram.

*Map of water flow in the area of Robbery Bottom Lane, blue arrows show flow direction down the valley*

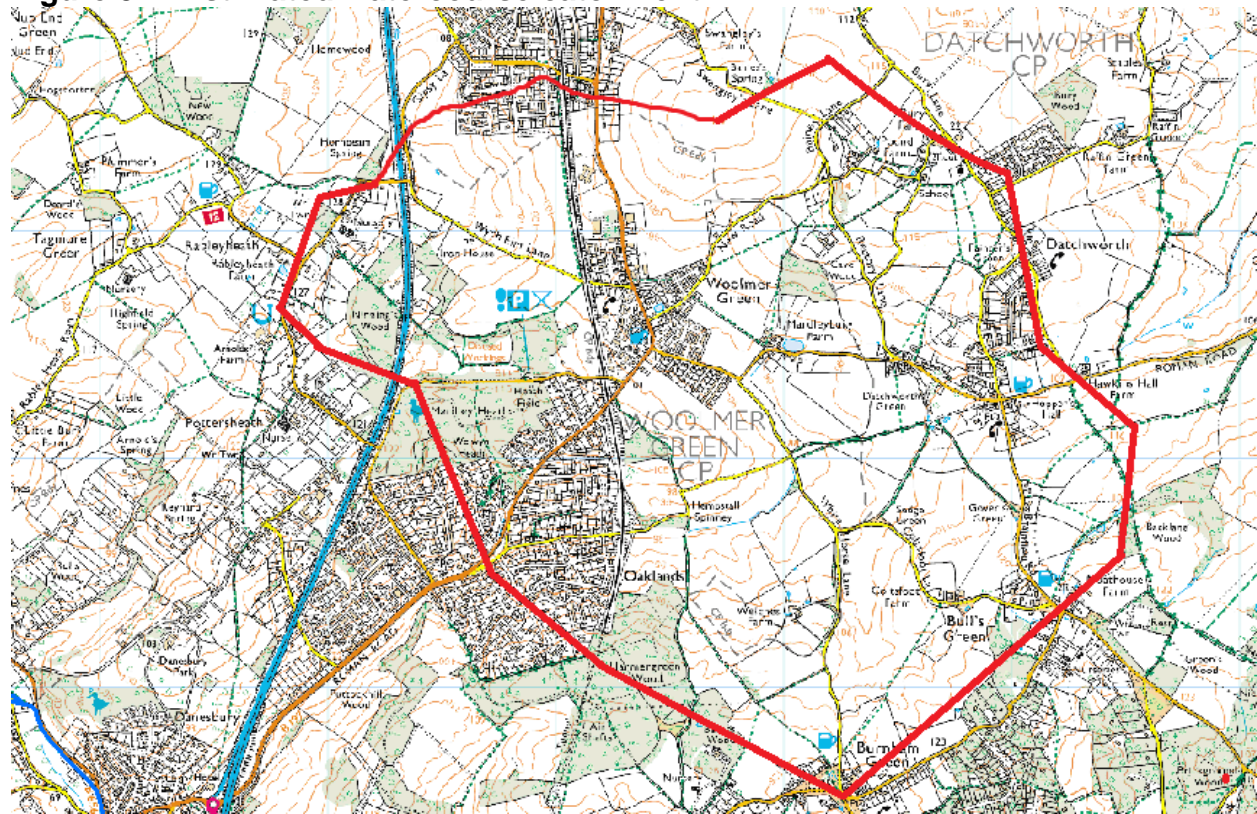
**Figure 3 Estimated watercourse catchment**

Map indicating estimated catchment area at the south west end of Lower Mardley Hill road, approximately 7.25km<sup>2</sup>, area indicated by red line.

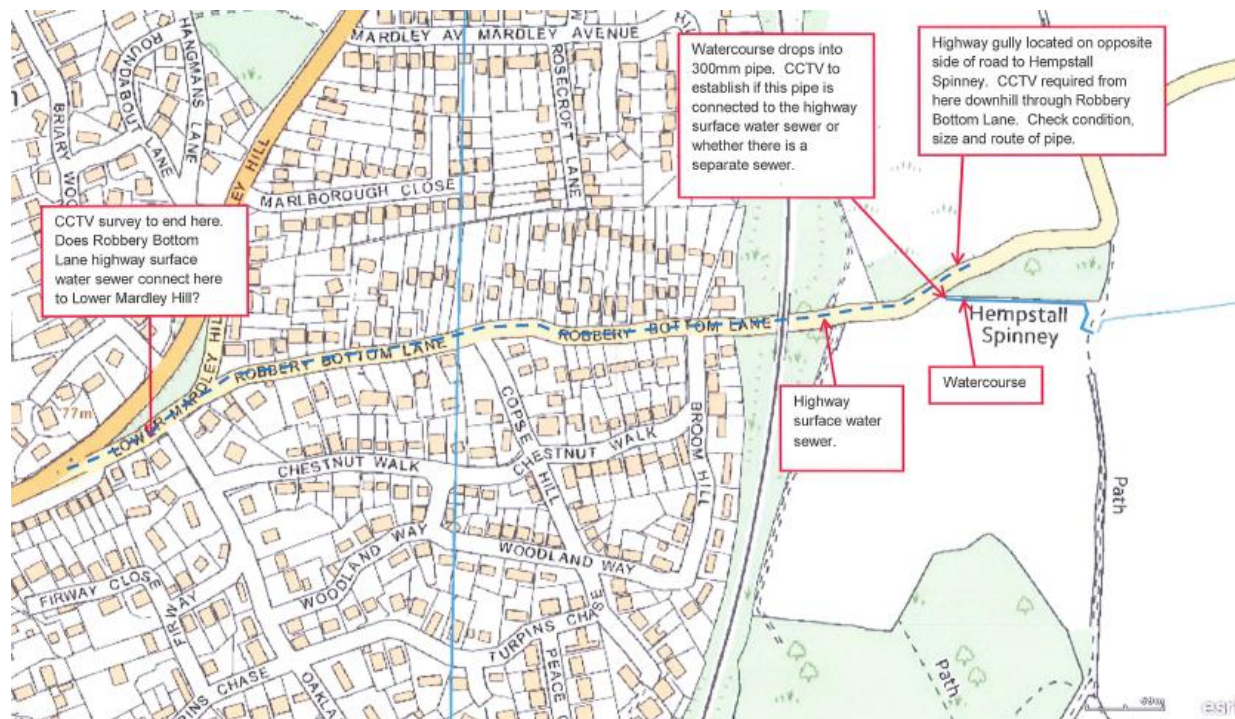
**Figure 4 CCTV Specification, Robbery Bottom Lane**

*CCTV specification, Robbery Bottom Lane.*

From the CCTV footage it was evident that before being cleared the capacity of the

highway drain was reduced by root mass from trees and shrubs which had grown into the drain in five locations. In some of these locations the root mass was large enough to have caused other local debris and silt to collect on its upstream and downstream sides. During times of high flow these blockages would cause water to back up behind them.

A crack in the highway drain was also identified along Robbery Bottom Lane toward the Lower Mardley Hill junction.

- Add Robbery Bottom Lane to the vulnerable gullies list.
- Repair the crack in the highway drain under Robbery Bottom Lane near the junction of Lower Mardley Hill.
- Advise the LLFA in the further assessment of potential flood risk management options.
