**Service Road at High Street Green,
Hemel Hempstead
Hertfordshire, HP2 7AA**

**NDT/Geophysical Investigation
of Surface Cracking to Road**

Final Report - 4644

Hertfordshire County Council

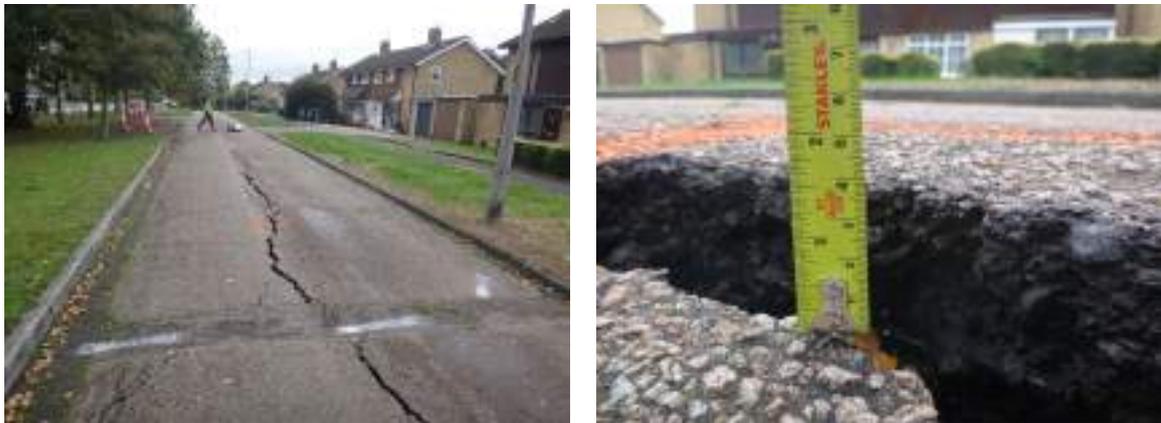
Council, it is understood that the cracking has been present for a number of years; however, the road was closed as of 1st October 2019 due to a sudden increase in the severity of the cracking, principally the longitudinal cracking.

Stake/probing tests by the Client suggest the crack is up to c.500mm deep in places and measurements made by GBG show widths up to 65mm. There is also a c.40mm difference in surface level of the asphalt where the cracking is most severe.

Left: General view looking South of the cracking along service road. Right: View showing the difference in surface level either side of the longitudinal crack.

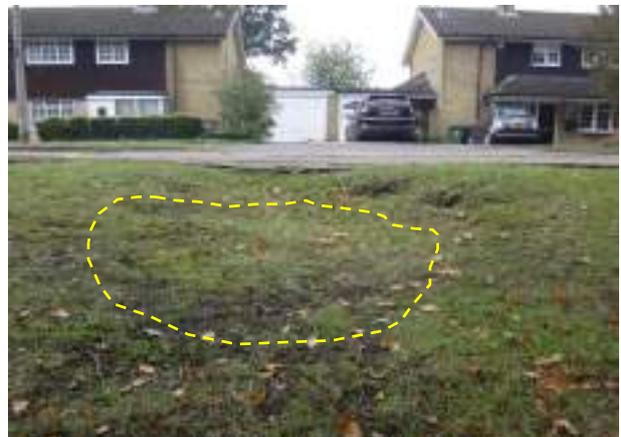
In addition to the cracking, an area of ground subsidence is also present located on the Eastern grass verge immediately adjacent to the service road and c.28m from the northern entrance. This area has a footprint of c.2.5m² and has subsided up to c.300mm compared to the surrounding area. The kerb has also

Area of ground subsidence in grass verge highlighted in yellow.

dropped in this location when compared to the rest of the road.

The Client is unaware as to the origins/development of this ground subsidence, but street images viewed by GBG on the internet show that a slight deformation was present during November 2015, when the most recent street available images were taken. The size of the subsided area now appears to be significantly larger (>50%) when compared to the 2015 images.

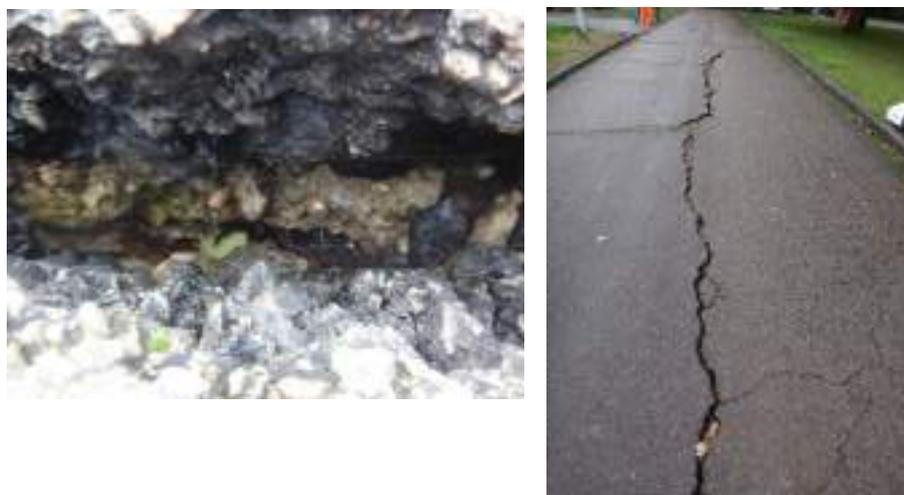
Left: view looking into crack showing asphalt & concrete layer beneath. Right: general view looking North along carriageway showing longitudinal crack along centre of road & regular transverse cracks across road surface.

The continuous longitudinal crack along the centre of the road and the regular transverse surface cracks within the asphalt are most probably reflective of joints in the underlying concrete layer. The cracks/joints have opened up and some differential vertical movement has occurred, notably along the centre line of the road. The road appears to have some light reinforcement or perhaps a thin mesh.

- The crack pattern visible in the asphalt likely mirrors defects in the underlying concrete, possibly original joints or failure points under load.
- An area of ground subsidence, located on the Eastern verge adjacent to the service road carriageway had no associated subsurface voiding or buried/hidden services directly beneath.

Repairs should be conducted on the carriageway to remedy the damage/cracked areas and mitigate against further damage. We recommend that special attention be paid to the underlying concrete layer as we expect this to be of particularly poor condition, as is visible in some locations from the surface. It may be necessary to break-out and replace large sections where damage is irreparable.

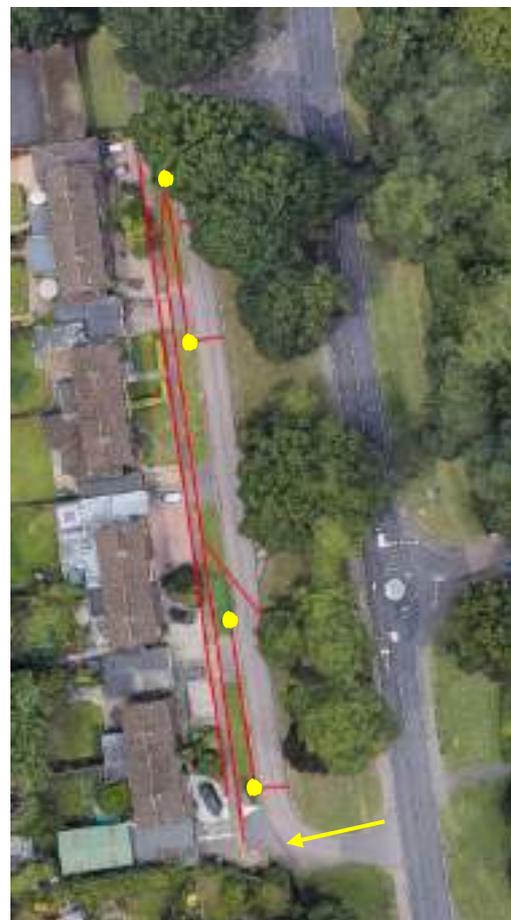
Image showing the position, in red, of services identified by CAT scan. The yellow dots show the position of lampposts.

adjacent image. The position of the 4no. lampposts along the Western grass verge, shown with a yellow dot, indicates the purpose of some of the services identified (power cables).

A service trench is visible in the asphalt at the South-West corner to the service road – yellow arrow on image above. A CAT scan was conducted here but no live/powered services were identified in this position.

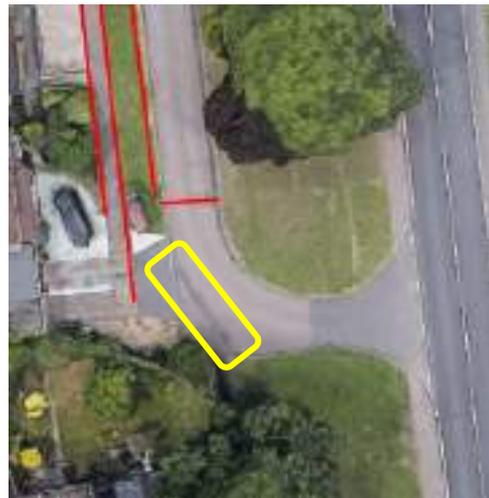
There is another trench visible (shown with yellow outline in image below) in the asphalt running diagonally across the South-West corner of the road, as indicated in Section 3.4 *CAT Scan Service Locations*. Radar identified a linear feature (buried service) corresponding to the position of the trench at a depth of 340mm.

The surface trench seems to correlate to the location of a known drainage channel/path by Thames Water – refer to map in Appendix B. Unfortunately, the route of this feature cannot be traced beyond the Western kerb of the service road. Please note, the drainage system map, provided by the Client from Thames Water, is somewhat vague as it has drawn the service routes as straight lines between points, thus the potential for the actual route to deviate from the map is quite likely.

Satellite view showing location of diagonal trench (yellow rectangle) located at South-West corner of service road.

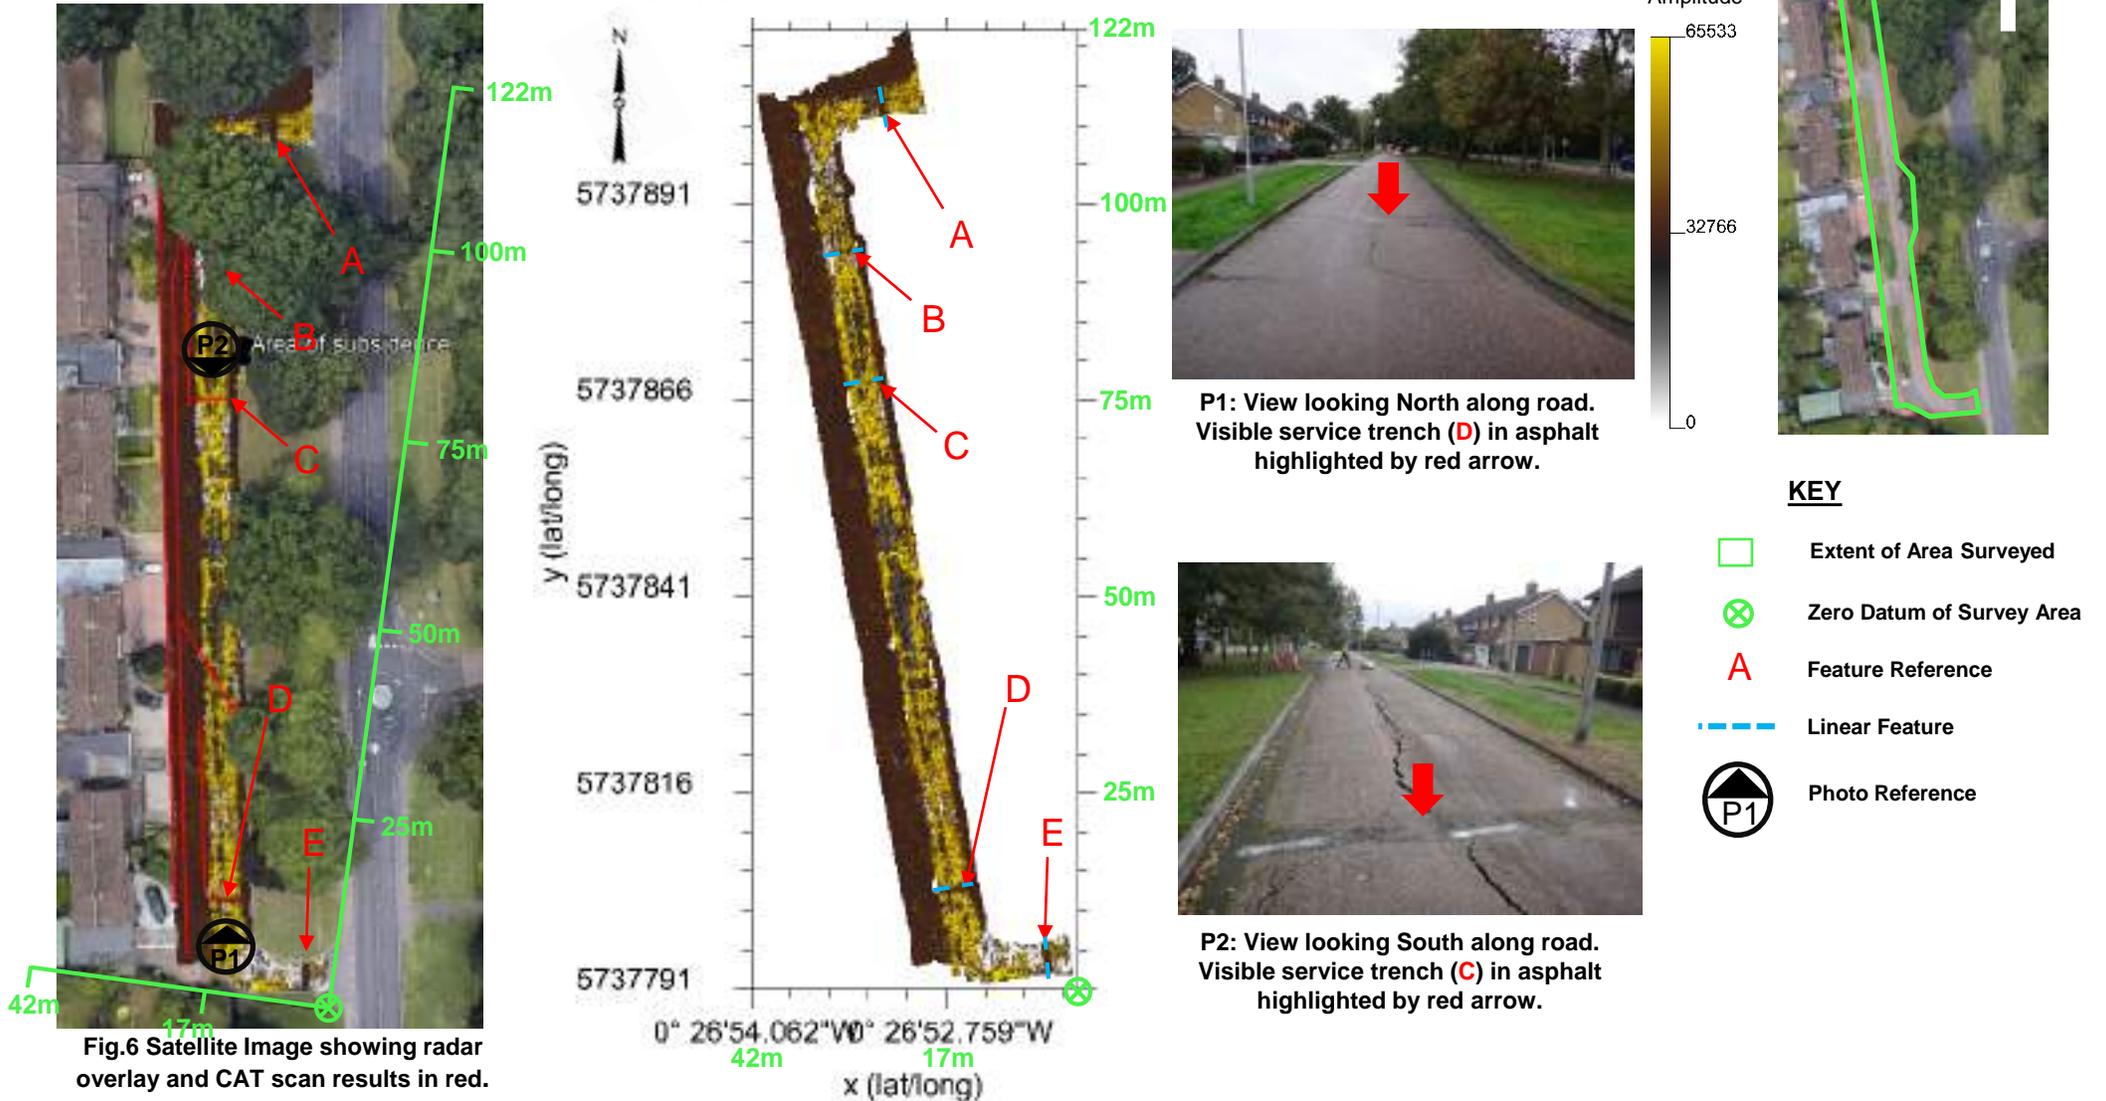
There have been 5no. linear features identified within the radar data each at a depth of c.400-500mm i.e. within the made ground below the concrete slab. These features are coincident with services located via the CAT scan and known water service positions.

Features A and E were not identified during the CAT scan, but are clearly visible within the radar data. These appear to be located in the same positions as those shown on the Affinity Water map (provided by Client) of known water services and shown in Appendix B of this report.

Feature D could also be associated with the path of water services, as one does cross the road at this location. This feature is also visible from the surface in the form of a reinstated trench; a CAT scan revealed that a live/powered service is also located here and connects to a lamppost on the Western grass verge.

Similar to Feature D, both Features B and C were identified during the CAT scan and both appear to extend towards lampposts positioned on the Western grass verge. A reinstated trench is also visible in the location of Feature C.

Figure 6 & 7: Radar data slice at a depth of 410mm; overlay onto a satellite image (left) and shown separately with annotations to features A-E identified at this depth (right).

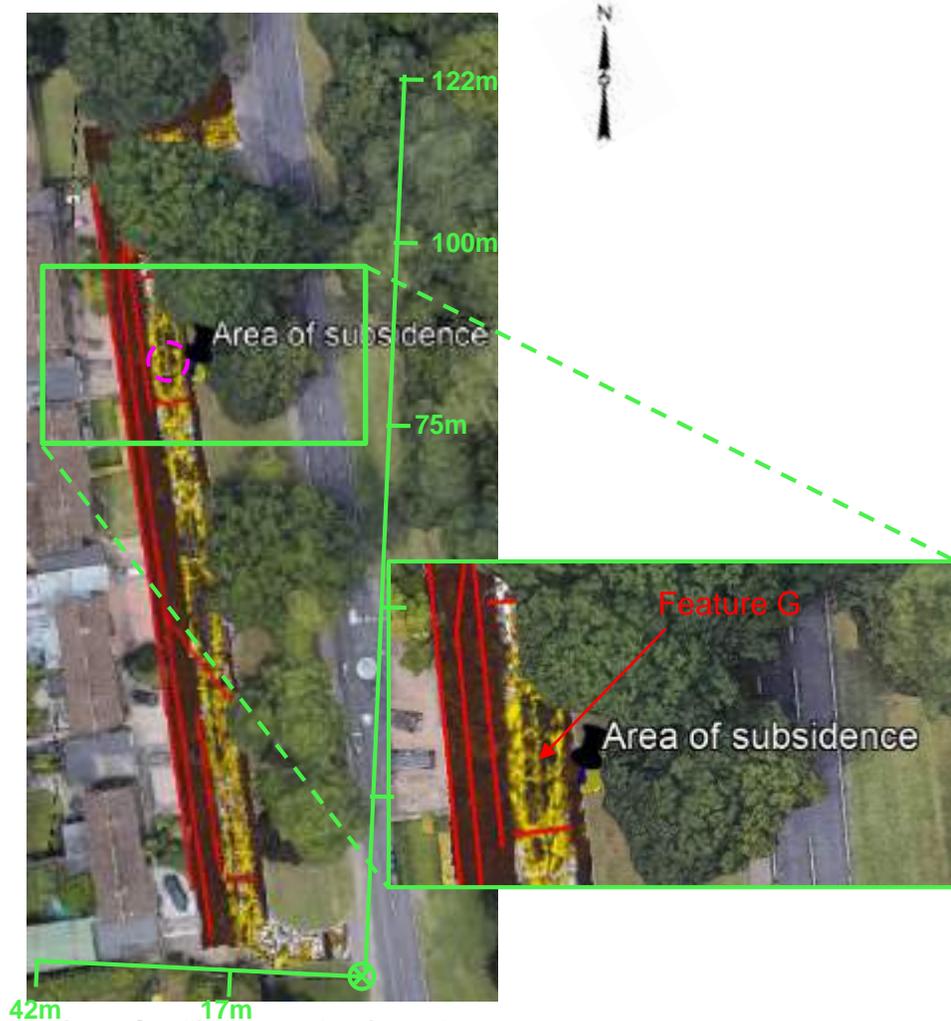
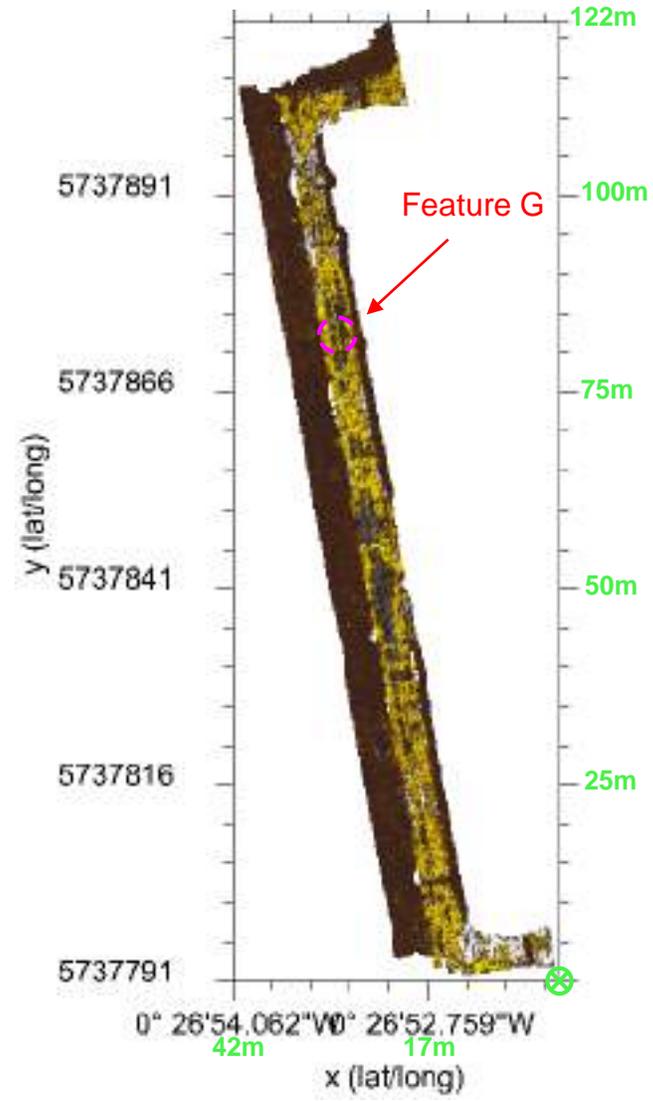
An additional subsurface anomaly (Feature G) has been identified adjacent to the area of subsidence as highlighted at Fig.13 & 14 on drawing 4664-6. Feature G is c.1.8m North-West from the area of ground subsidence.

This roughly ‘circular in plan’ feature spanning c.3.4m North-South and c.3.7m East-West has been identified within the service road from a depth of c.400mm from below the asphalt. The depth of this feature places it within the boundary between the concrete layer and underlying Made Ground/Fill substrate.

The regularity of its shape, being roughly circular, indicates that Feature G is possibly the remains of a buried structure. It is possible that this may be associated with a chamber or area of subsurface voiding.

Figures 13: Satellite image showing location of Feature G adjacent to area of subsidence.
 Figure 14: Plot of radar data slice taken at c.410mm depth; Feature G highlighted.

We recommend that further investigations are conducted within this area to determine/clarify the extent and nature of Feature G.

It is recommended that Feature G is investigated further through intrusive means to determine its nature and structure; non-intrusive tests are unlikely to elicit any more detail than that already provided here.
