# Pix Brook Watercourses Project Update

## PROJECT COMPLETED OCTOBER 2014

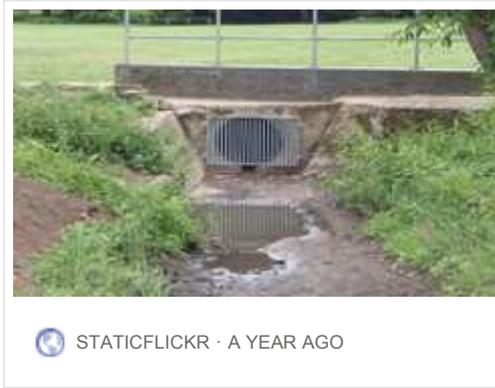
Second trash screen by Project D in the centre of the site

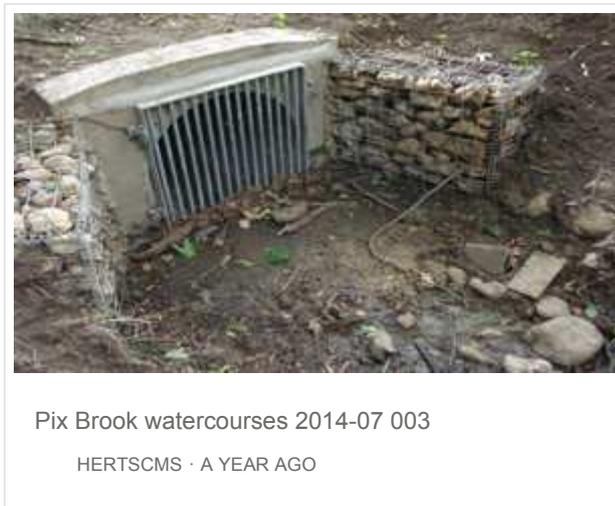
Trash screen to stop rubbish and debris from getting washed into Project D

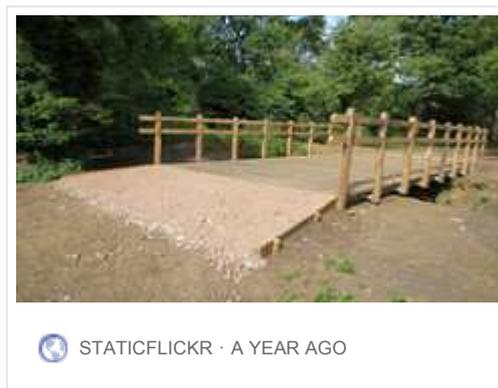
Vehicle bridge with handrails and ramps

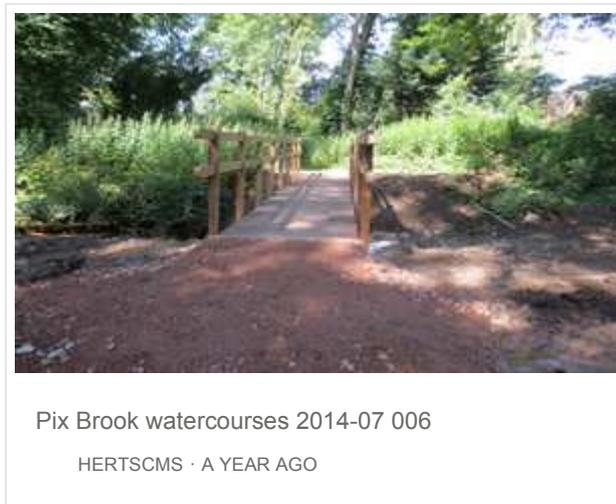
Pedestrian bridge at Project G with ramps

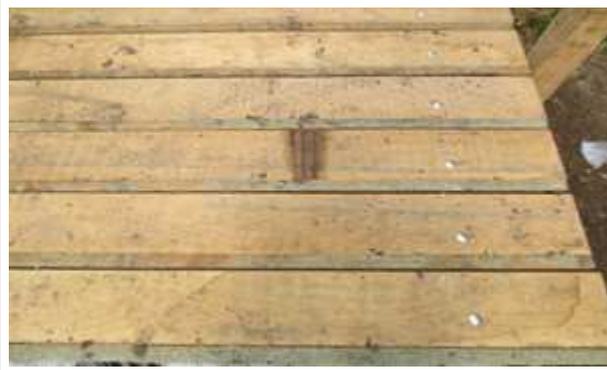
Pix Brook watercourses 2014-06 001  
HERTSCMS · A YEAR AGO

Detail of anti-slip decking on vehicle bridge

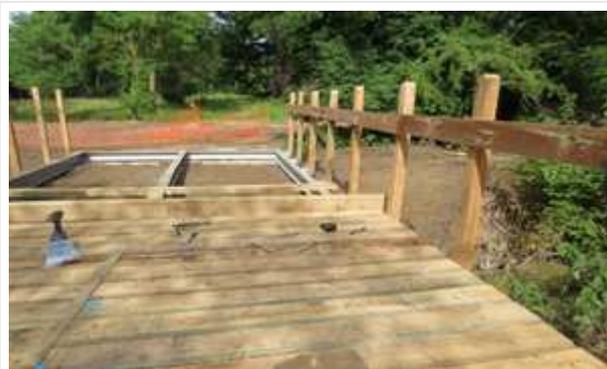
Pix Brook watercourses 2014-06 002  
HERTSCMS · A YEAR AGO

Decking boards being installed

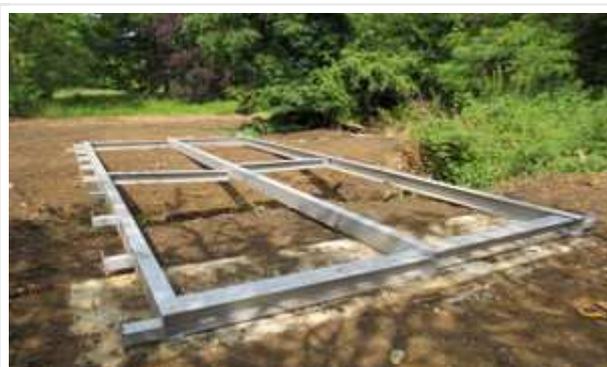
Pix Brook watercourses 2014-06 003  
HERTSCMS · A YEAR AGO

Base of vehicle bridge in position at project H

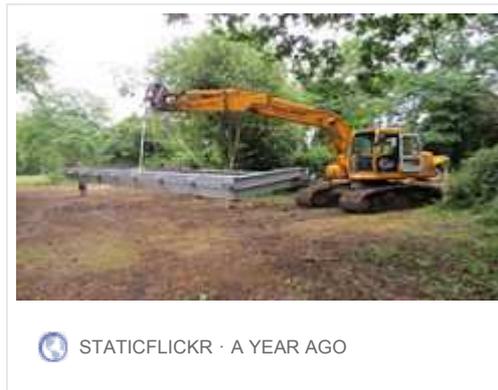
Vehicle bridge base being unloaded

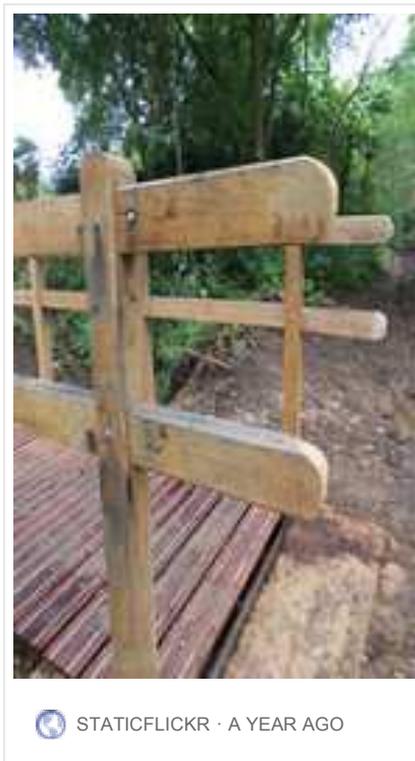
Ends of handrails

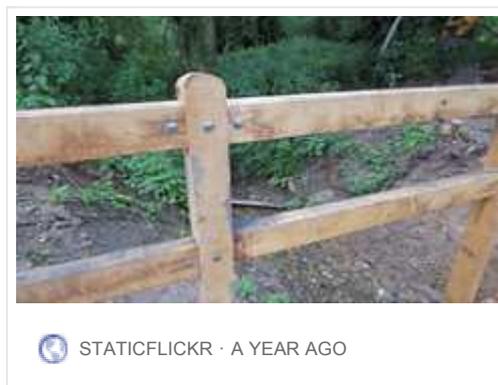
Handrail detail

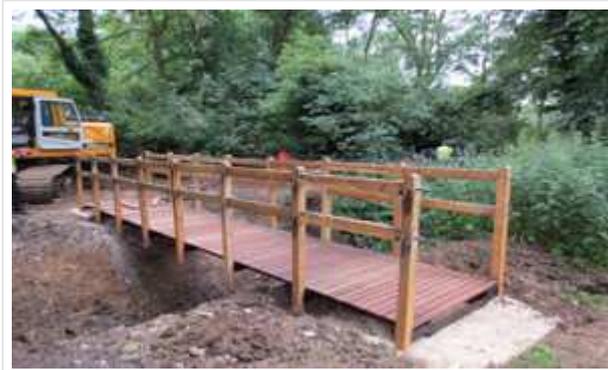
Pix Brook watercourses 2014-06 010

Pedestrian bridge in place at Project G

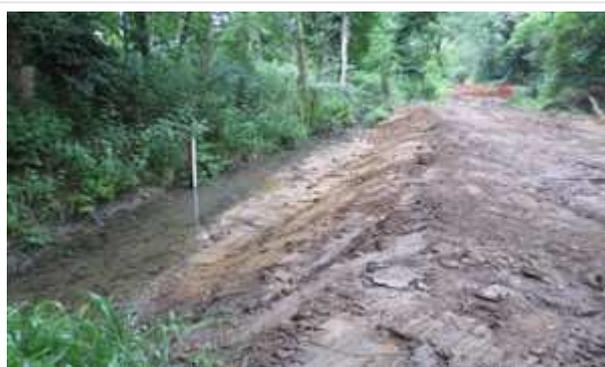
Pix Brook watercourses 2014-06 012

Marginal shelf and bank reprofiling

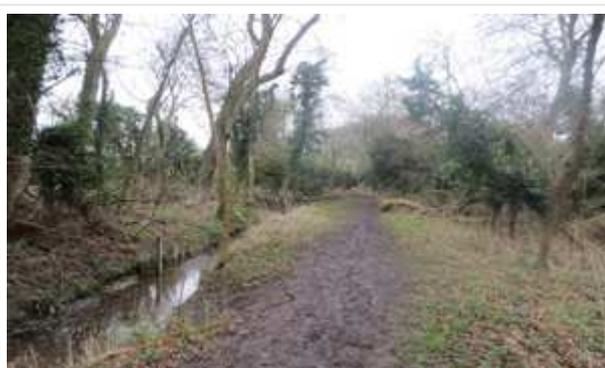
Pix Brook watercourses 2014-06 013

Project G before works

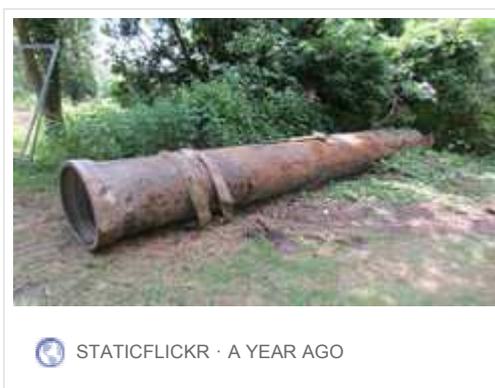
Amazingly for a change it was not a concrete pipe

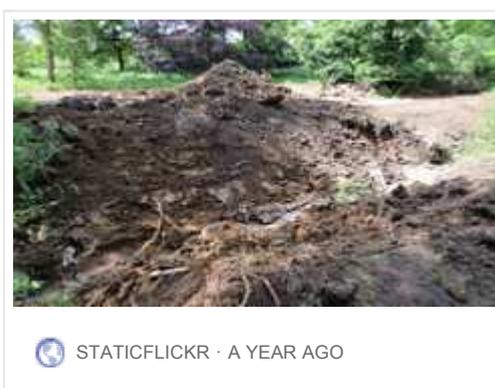
Culvert removed

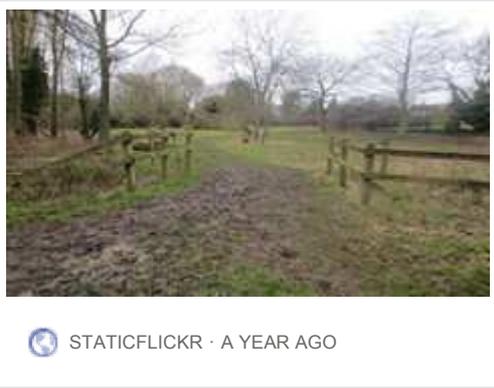
Project H second culvert before works

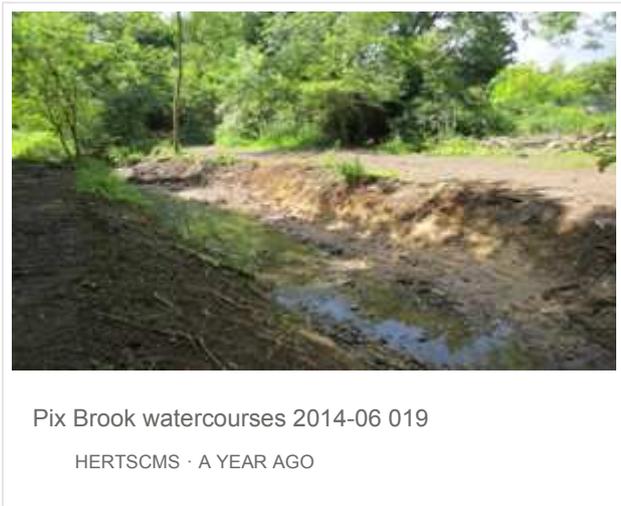
Marginal shelves and reprofiling carried out in areas where there is a lot of light reaching the banks will help the bank side vegetation to colonise

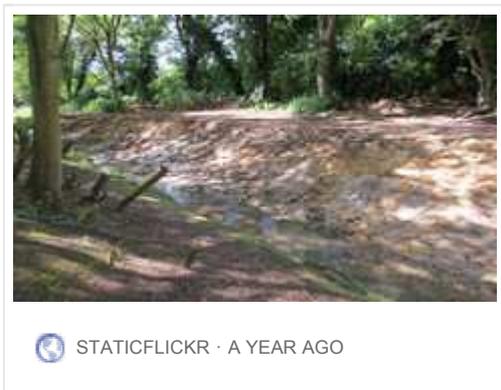
Marginal shelves created

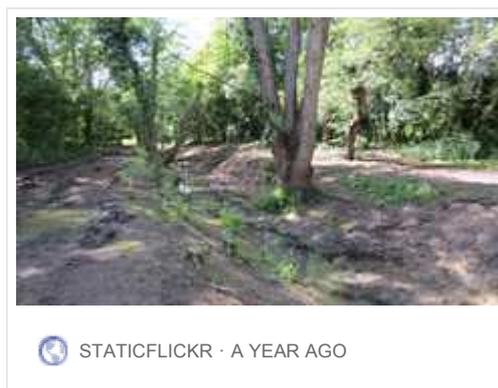
Bank edges being reprofiled

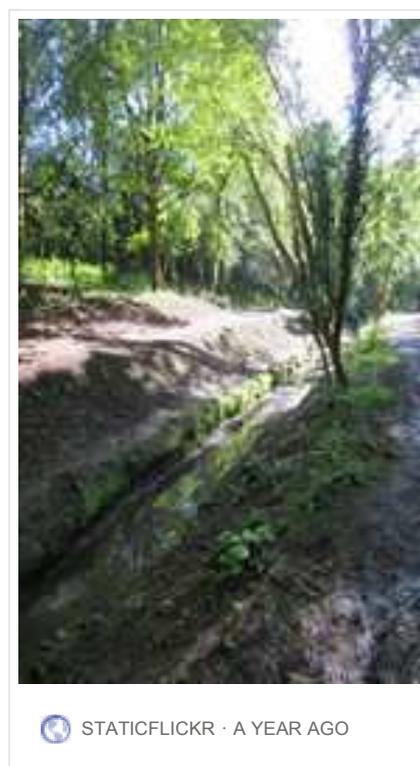
Once a dark straight shady channel

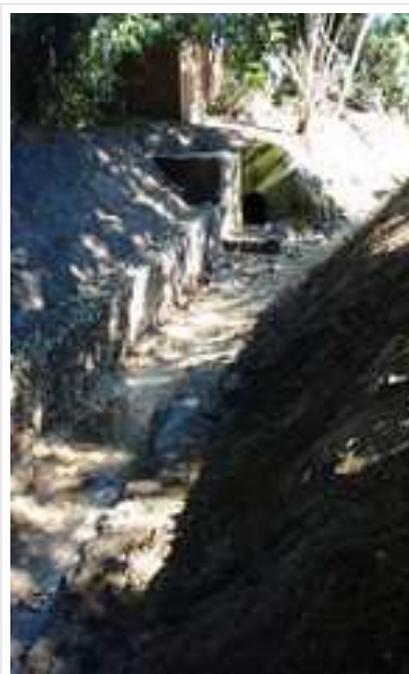
Reprofiled bank edges with marginal shelf

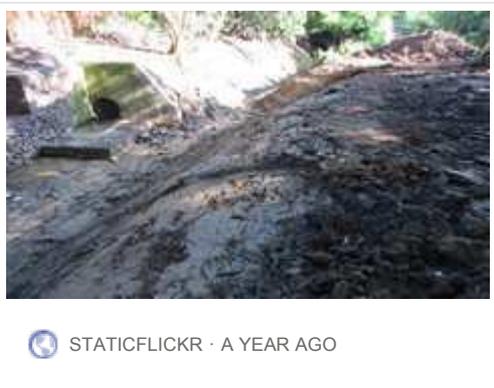
Bank edge reprofiling beginning

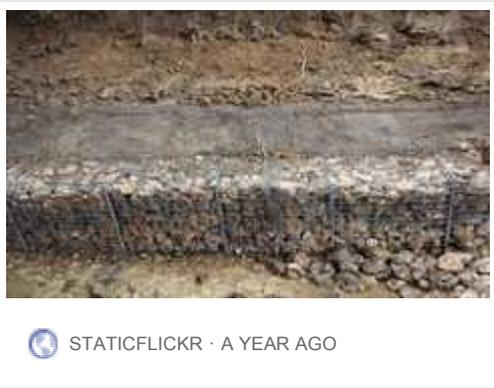
Geogrid being installed to strengthen the bank

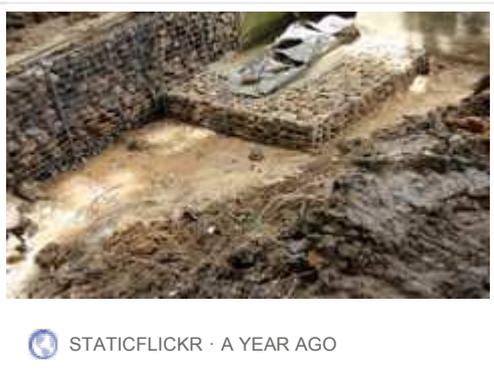
Rock rolls and gabions installed around the inlet to reduce erosion

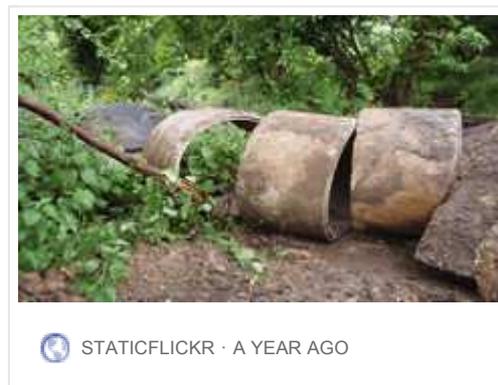
Concrete pipe that came out of the culvert at Project G along with lots more concrete

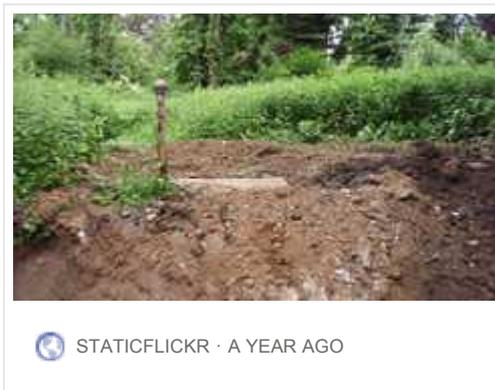
Only an old metal post remaining, waiting for the concrete foundation to dry before it is removed

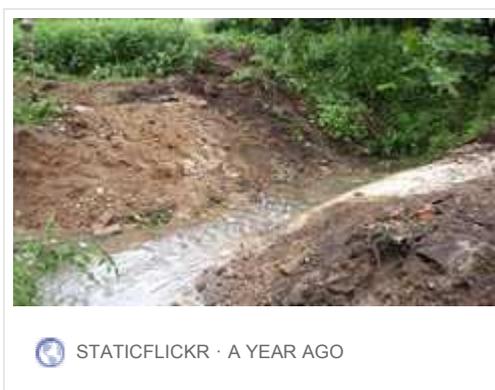
Culvert removed

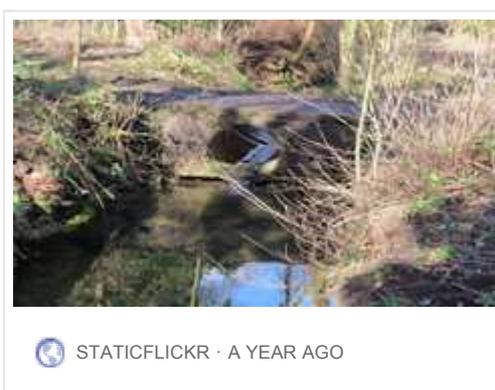
Project G before the culvert is removed

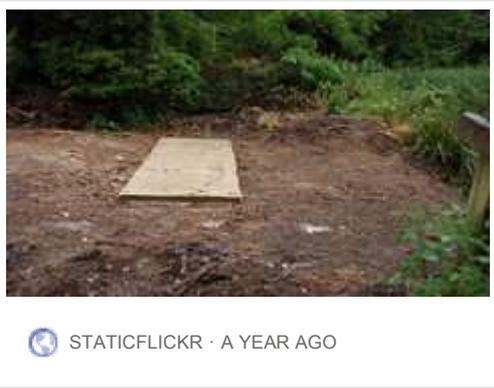
Finished concrete foundation at Project H ready for the new vehicle bridge

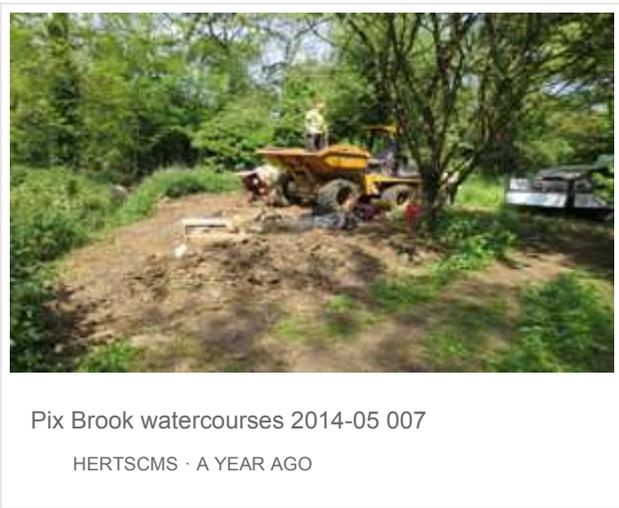
A very slow process filling the foundations with concrete

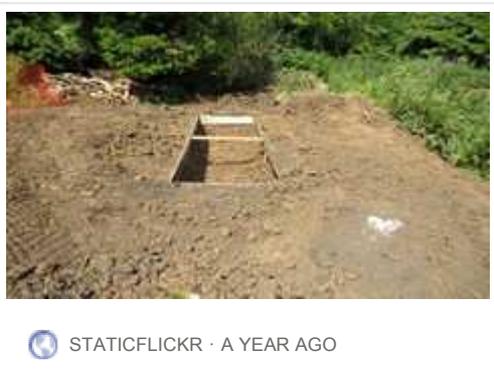
One of the vehicle bridge foundations waiting to be filled with concrete

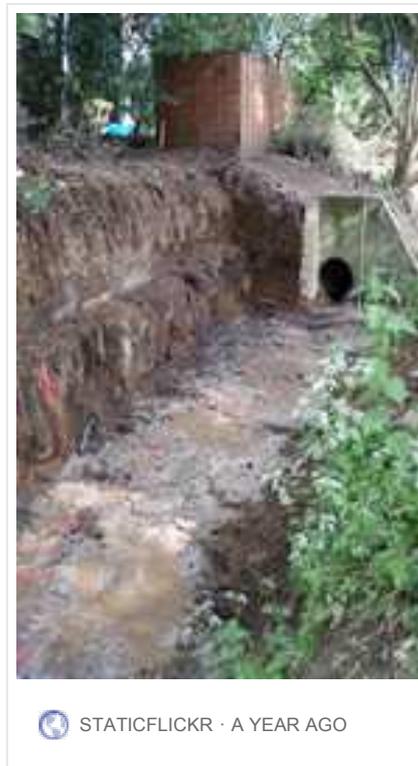
Headwall has been cut back and all concrete removed

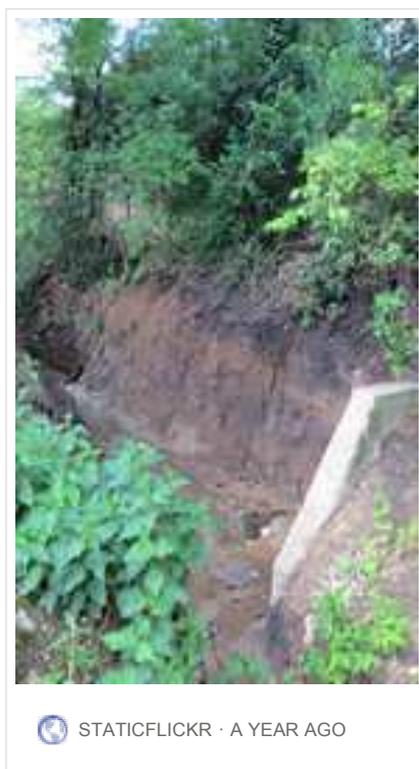
...then the other

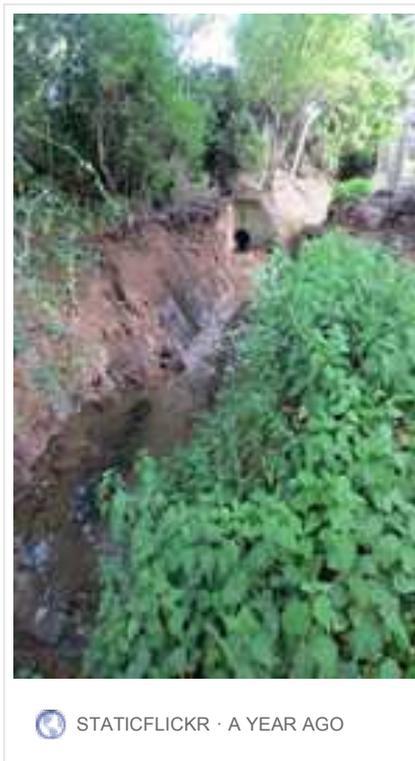
The natural bed is revealed

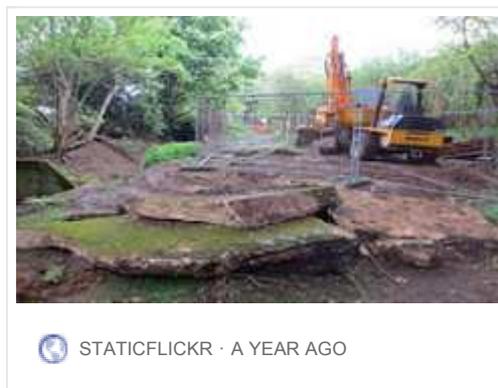
Concrete awaiting removal from site

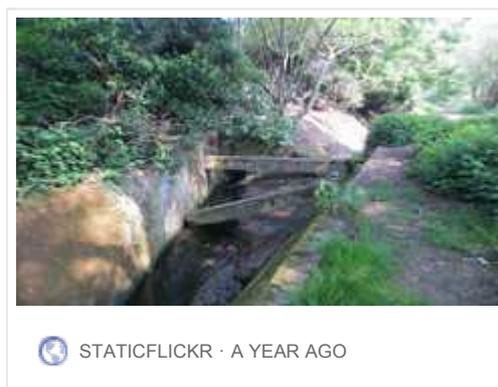
Project F before wetland works started

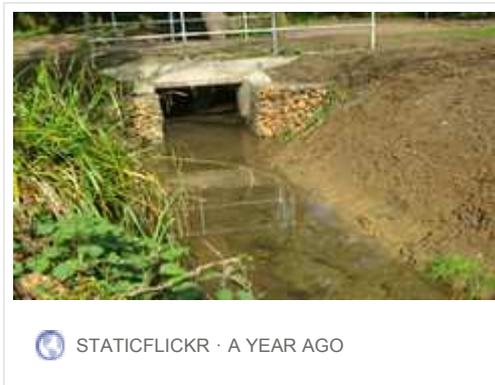
Reprofiled bank edge next to repaired bridge

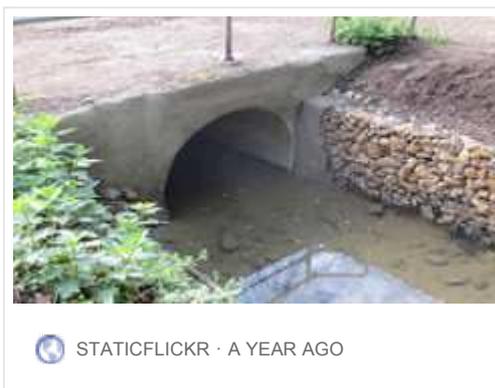
Headwall on downstream side also repaired

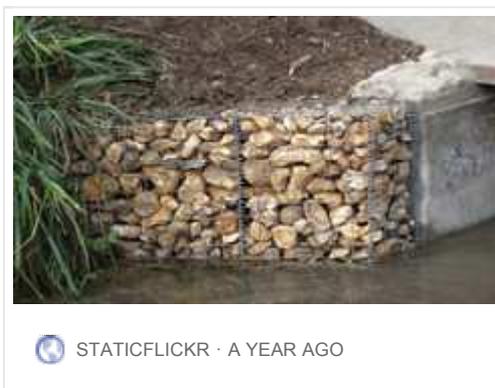
Gabion baskets and stone used to hide the concrete

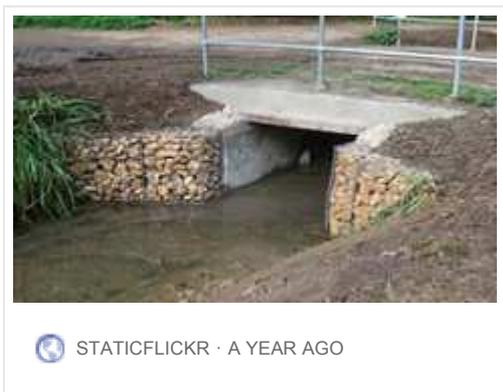
Completed bridge repairs now ready to use

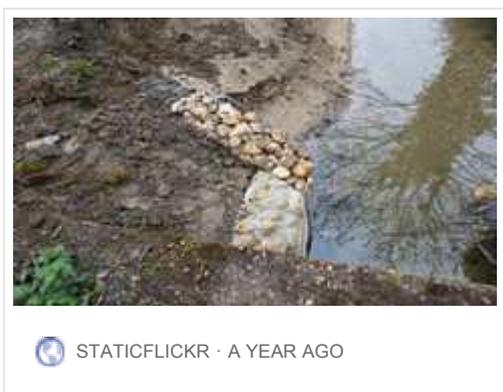
Behind gabion backfilled; stone detail on top of concrete to match gabion

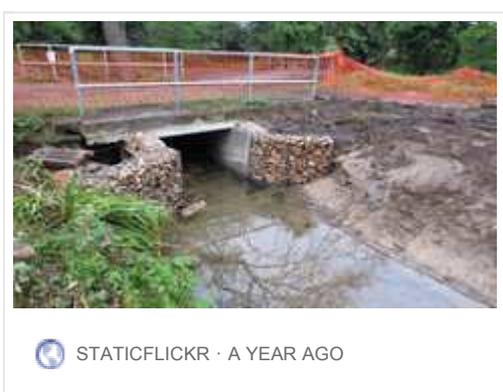
Gabion baskets installed both sides of the bridge to help funnel the water through the pipe

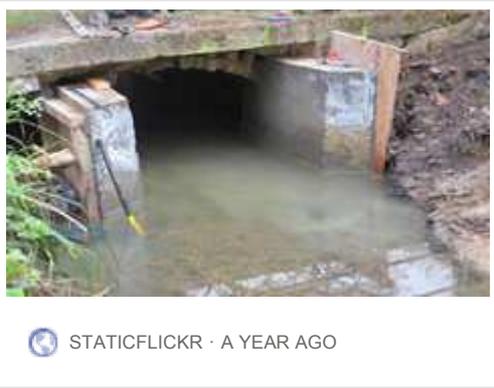
Concrete walls installed, just removing the wooden shuttering

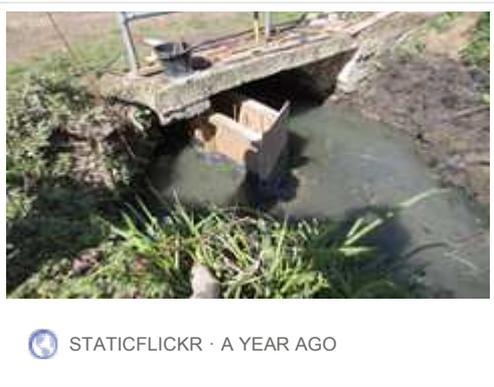
Wooden shuttering being installed to cast the concrete bridge support

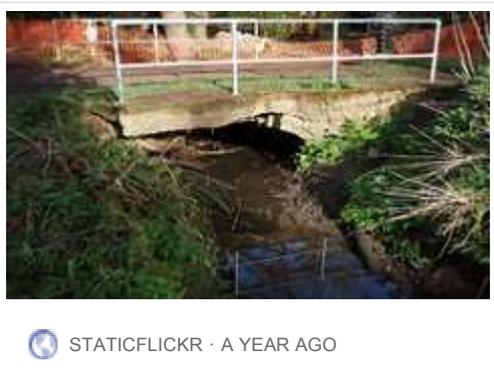
Bridge before repair works, lots of the bricks have become dislodged due to a large tree root

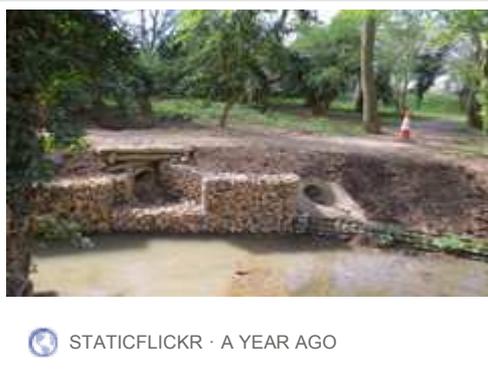
Improvements to the pipe headwall

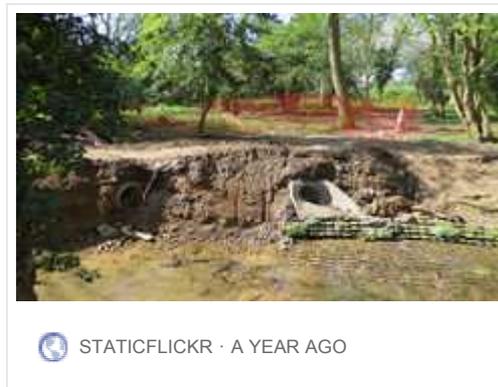
Old headwall removed

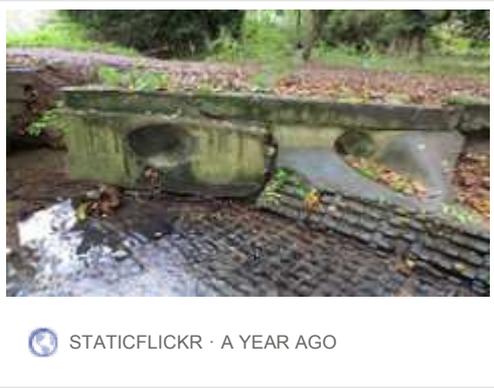
Old pipe headwall

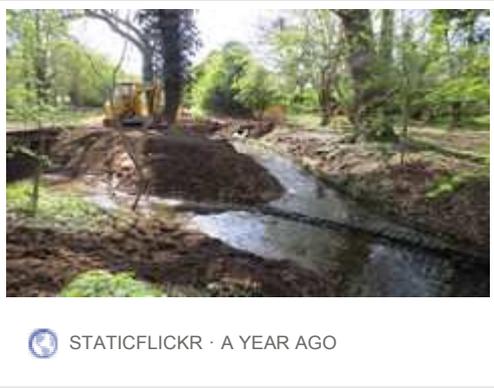
Removed concrete blocks, reprofiled bank edges and marginal shelf

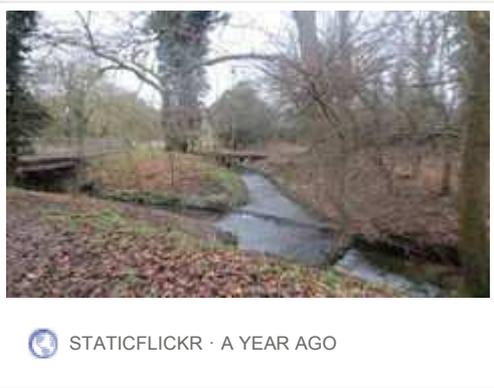
Bank edge before works with concrete armour blocks up the banks

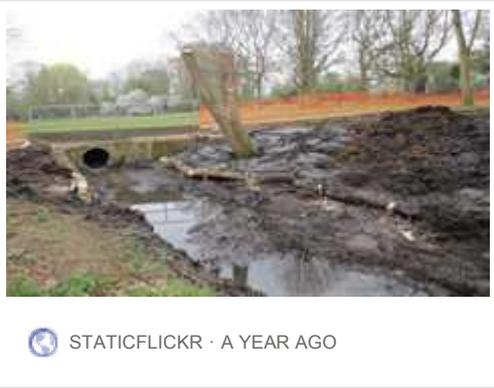
Logs from tree works being used to hold back material removed from channel

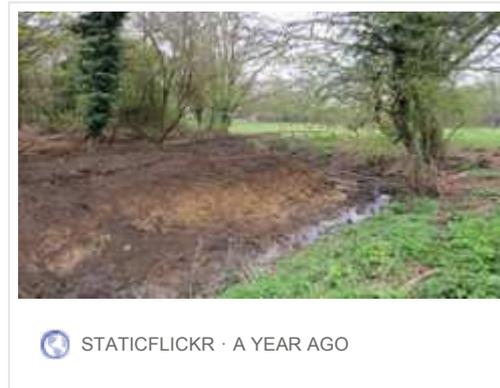
The additional bay on Project B having a marginal shelf added along with gently reprofiled bank

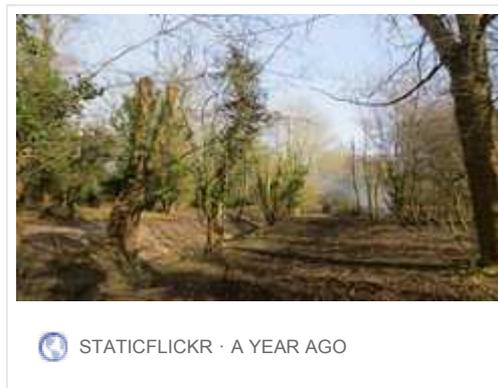
Large willows high pollarded along the watercourse

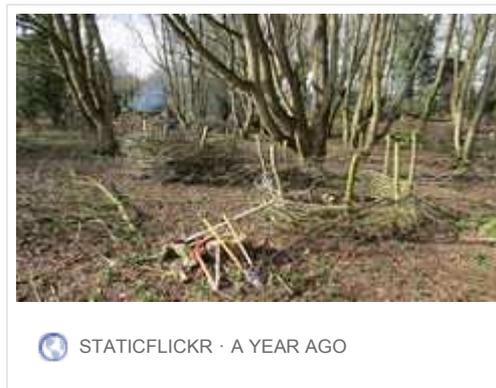
Cut material was used to make deer baskets around some hazel coppice stools to protect them from grazing deer

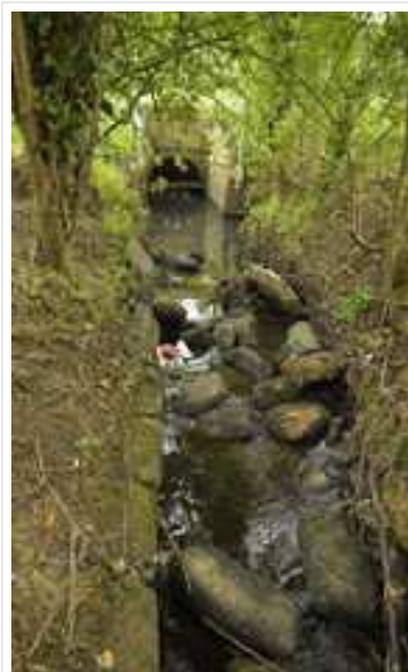
Concrete in channel near inlet
