# **Hertfordshire County Council Flood Investigation Report**

**Acorn Street, Hunsdon  
Hertfordshire**

## Hertfordshire County Council Acorn Street, Hunsdon Flood Investigation Report

January 2017  
Revision 5 FINAL

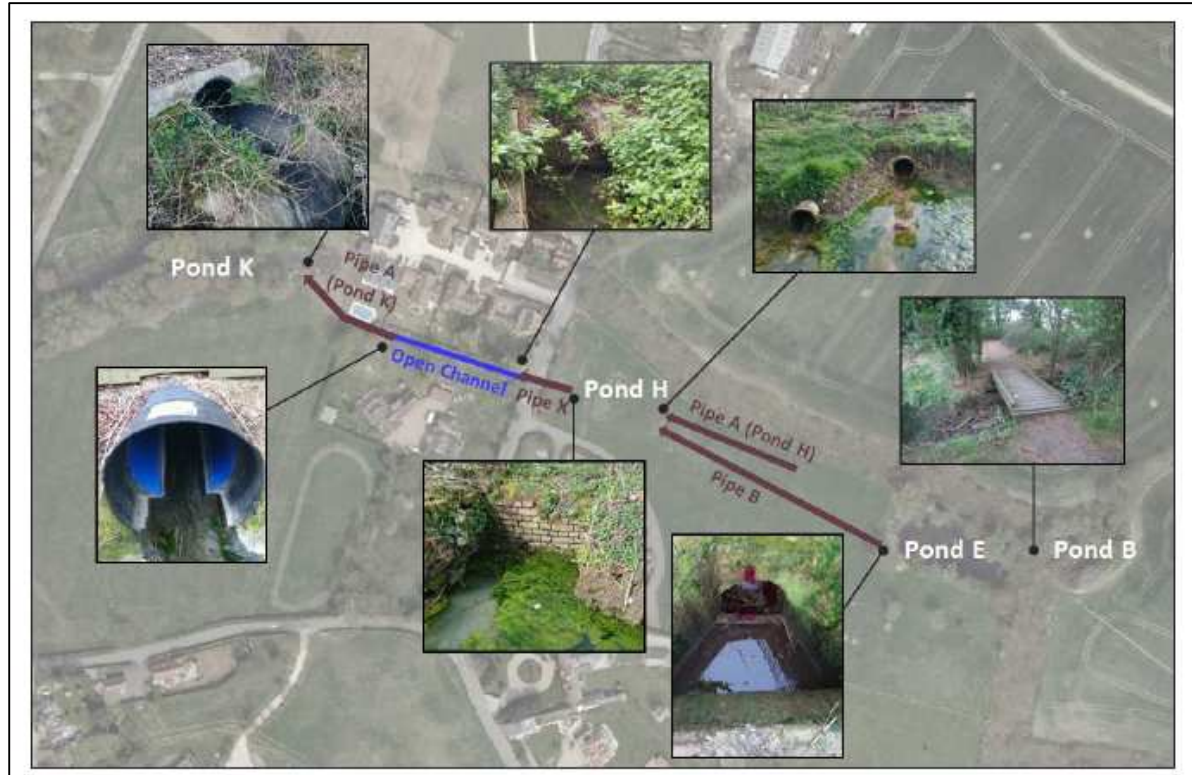
**Figure 7 Map of key structures and the Ordinary watercourse**

There is a topographical low point in Acorn Street where surface water pools from both sides of the carriageway and from overland flow from the Nine Ashes site. Figure 7 shows the key structures in the site of study. In close proximity to houses, there is an Ordinary watercourse that has been culverted through the Nine Ashes site (Pipe B) that is fed by a pond used for fishing (Pond E). The watercourse opens

out for 10 metres (Pond H) before it goes back into culvert (Pipe X) that flows under the road. The outlet of this culvert is within a neighbouring residential property's garden. Water spills out of the culvert (due to the culvert's poor condition) throughout the Nine Ashes site.

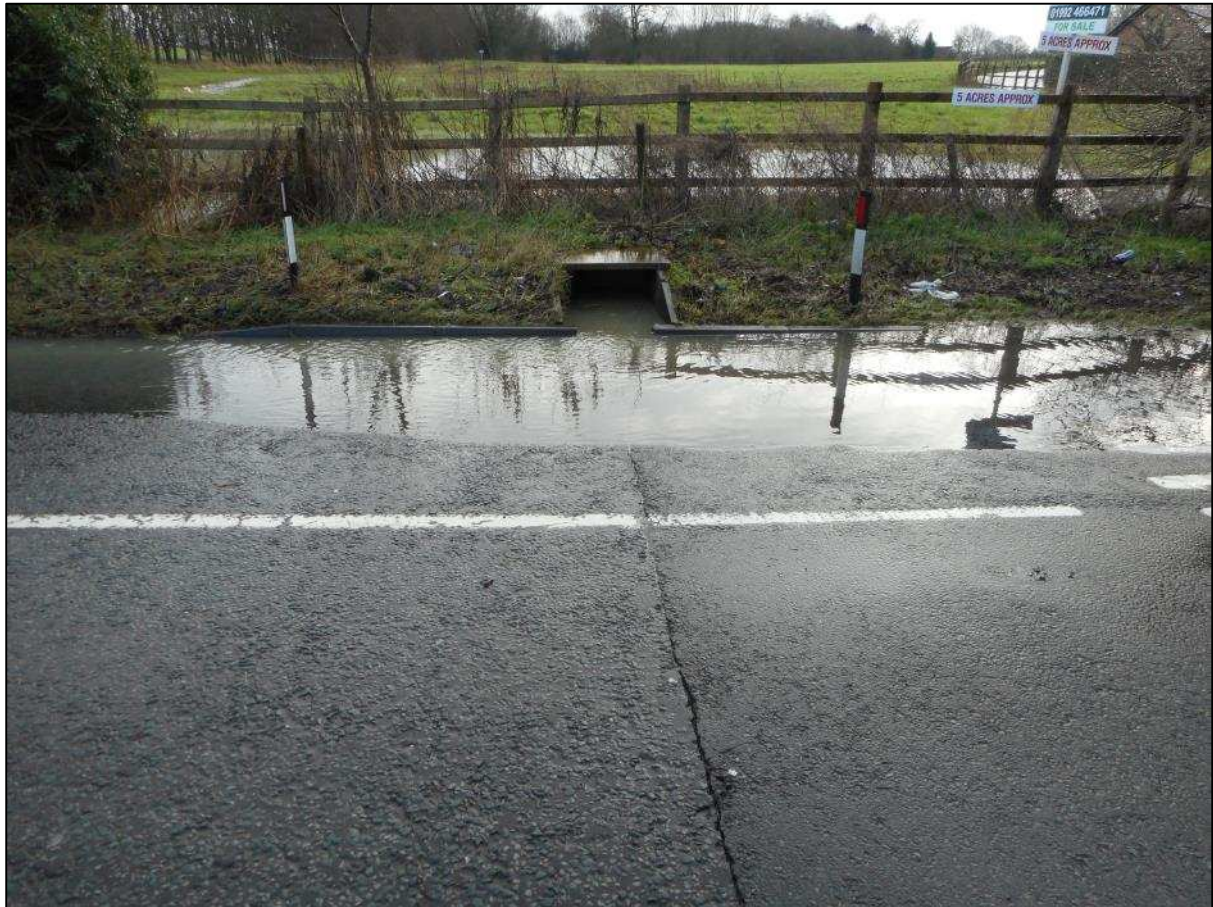
Figure 8 shows water pooling on the highway. The highway drainage at this point of Acorn Street is connected to the Ordinary watercourse. The pooled water was unable to drain away from the road due to the culverted watercourse being at 100% capacity, so there was no room for the additional flood water to enter the culvert, arising from the highway. Furthermore, due to the surrounding area being used for agriculture, the highway drains and gullies are susceptible to high levels of debris. This increased debris reduces the capacity of the gullies, as well as slowing down the time it takes for the water to drain away from the road.

**Figure 8** Water pooling on the highway, unable to discharge in the culverted watercourse, due to the culvert being at full capacity

2.	Upgrade the culvert under Acorn Street.	The detailed model suggests that the current culvert cannot withstand flows during a 3.3% AEP flood event. Upgrading the culvert would increase drainage through the Nine Ashes site, as well as being able to drain the pooling water in the Highway quicker.	Riparian owners of the culvert.

3.	Maintain highway drainage.	<ol style="list-style-type: none"> <li>1 It is recommended that Hertfordshire County Council as Highway Authority add Acorn Street to the vulnerable gullies list.</li> <li>2 It is recommended that the mainline connecting pipe from the gullies is investigated to ascertain who is responsible for its maintenance. Currently both Thames Water and the Highway Authority do not have this recorded as their asset.</li> </ol>	Hertfordshire County Council as Highway Authority.

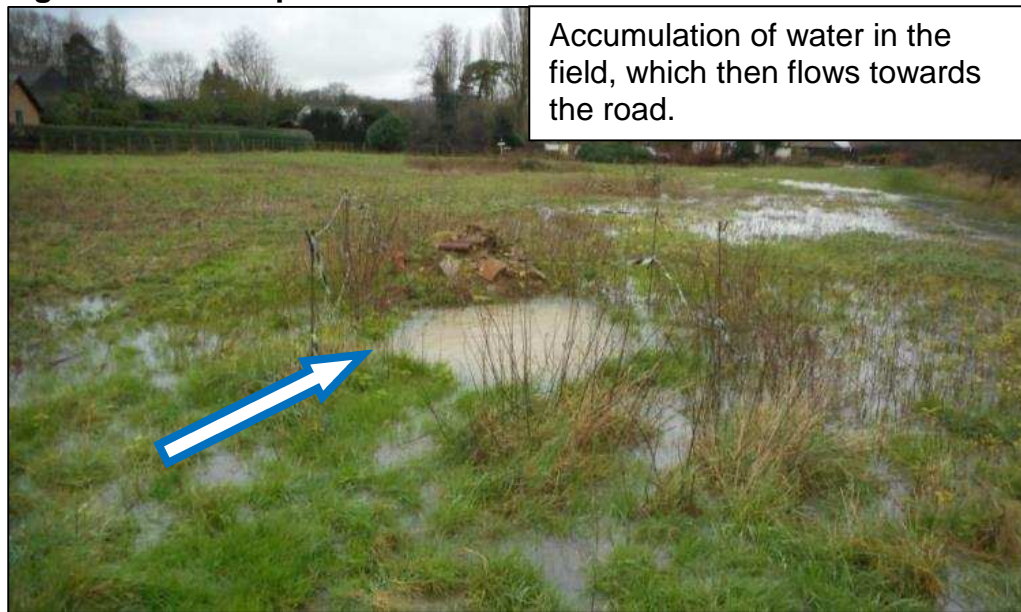
Pipe A and B are in poor condition, with the culvert collapsed in places within the Nine Ashes site. This causes water to spill out of the culvert and contributes to the overland flow from the Nine Ashes site towards Acorn Street. On the Nine Ashes site water flows overland, perpendicular to Acorn Street (please see Figure 9).

**Figure 9 Collapsed section of watercourse in the Nine Ashes site (arrowed)**

<b>No.</b>	<b>Recommendations</b>	<b>Comments</b>	<b>RMAs and other parties to be involved</b>
1.	Repairs conducted to the culverted sections through the Nine Ashes site.	This would need to be conducted by the riparian owner of the culverts. Putting the culverts back into their original state would contain water within the drainage network and stop it contributing to the overland flow of Acorn Street.	Hertfordshire County Council as Lead Local Flood Authority, Riparian Owner.

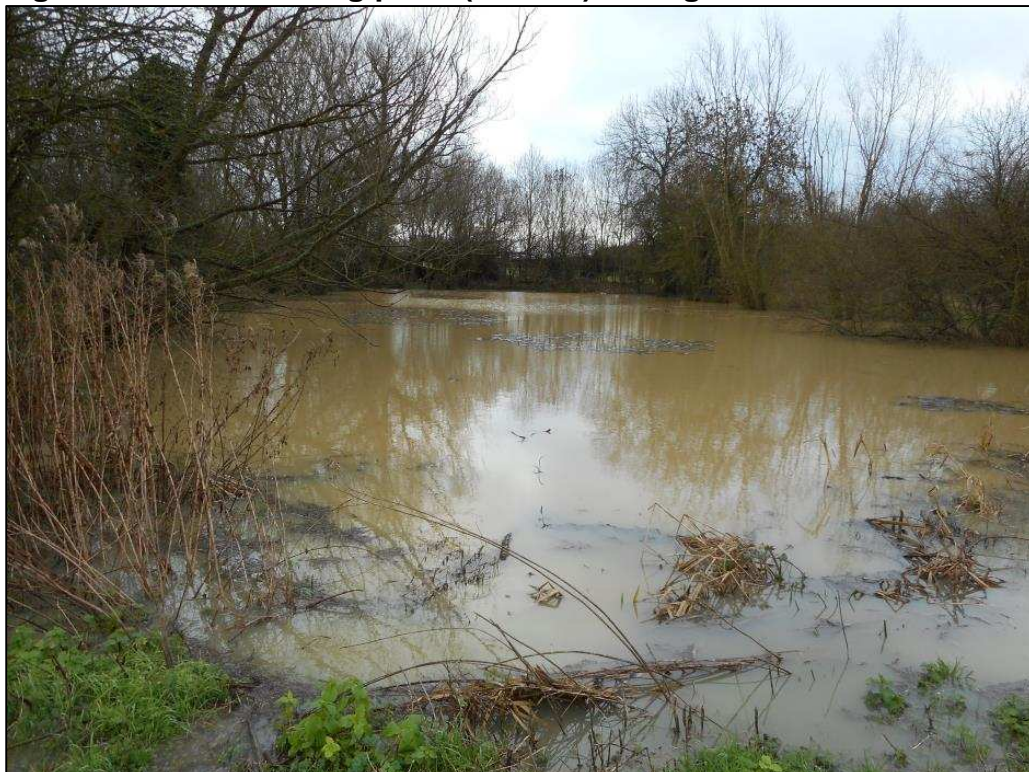
When the culvert is at 100% capacity, the fishing pond (Pond E) was unable to discharge into the culverted Ordinary watercourse. This causes water to exceed the banks of the pond and flow across the Nine Ashes site towards Acorn Street; following a similar line to Pipes A and B, however flowing as overland flow rather than culverted (please see Figure 10).

**Figure 10 The fishing pond (Pond E) during flood**

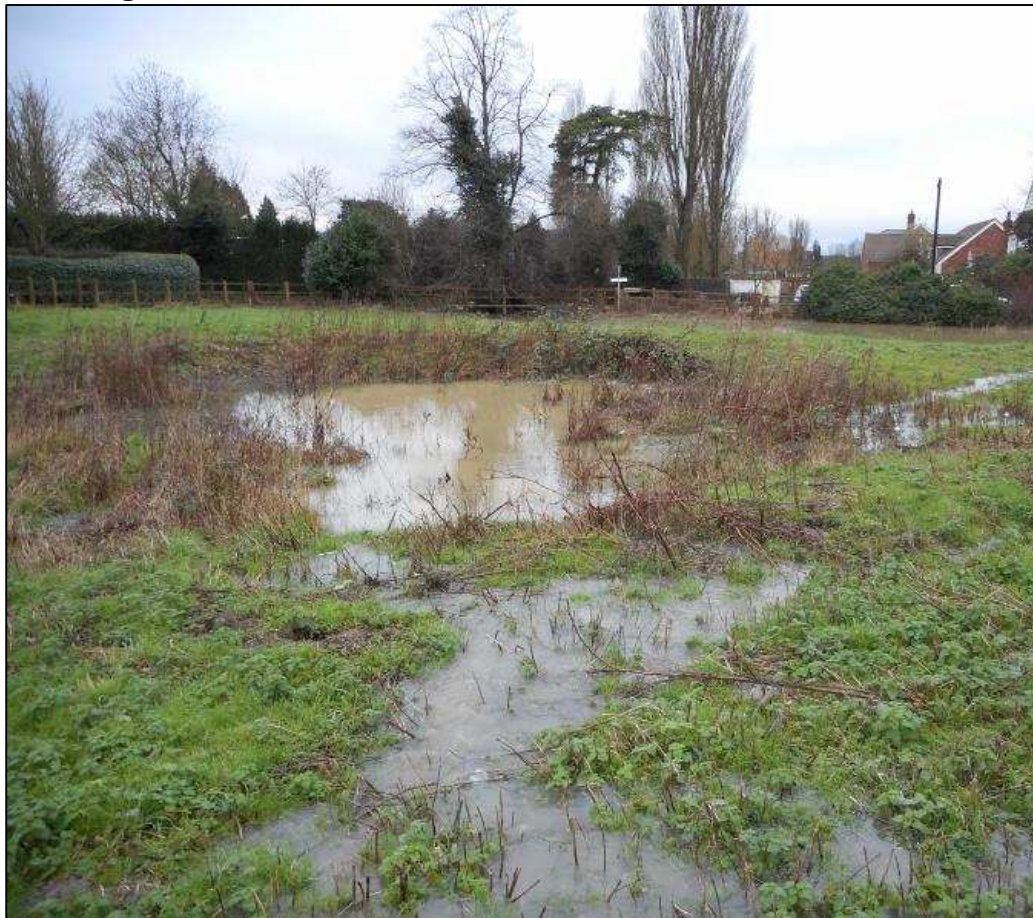
The overland flow from both the collapsed culverts and the fishing pond flows towards Pond H. Pond H also receives additional water from other incoming connections. From Pond H, water tries to enter the culvert under the road; however the amount of water during flood events far exceeds the capacity that it can cope with (see Figure 11), and therefore spills over the edge of the pond, and towards the road. Figure 12 shows this ponding of water in the Nine Ashes field, and Figure 13 shows the other side of this pond, with water spilling onto the highway.

**Figure 11 Pond H during flood, the outgoing culvert is completely submerged**

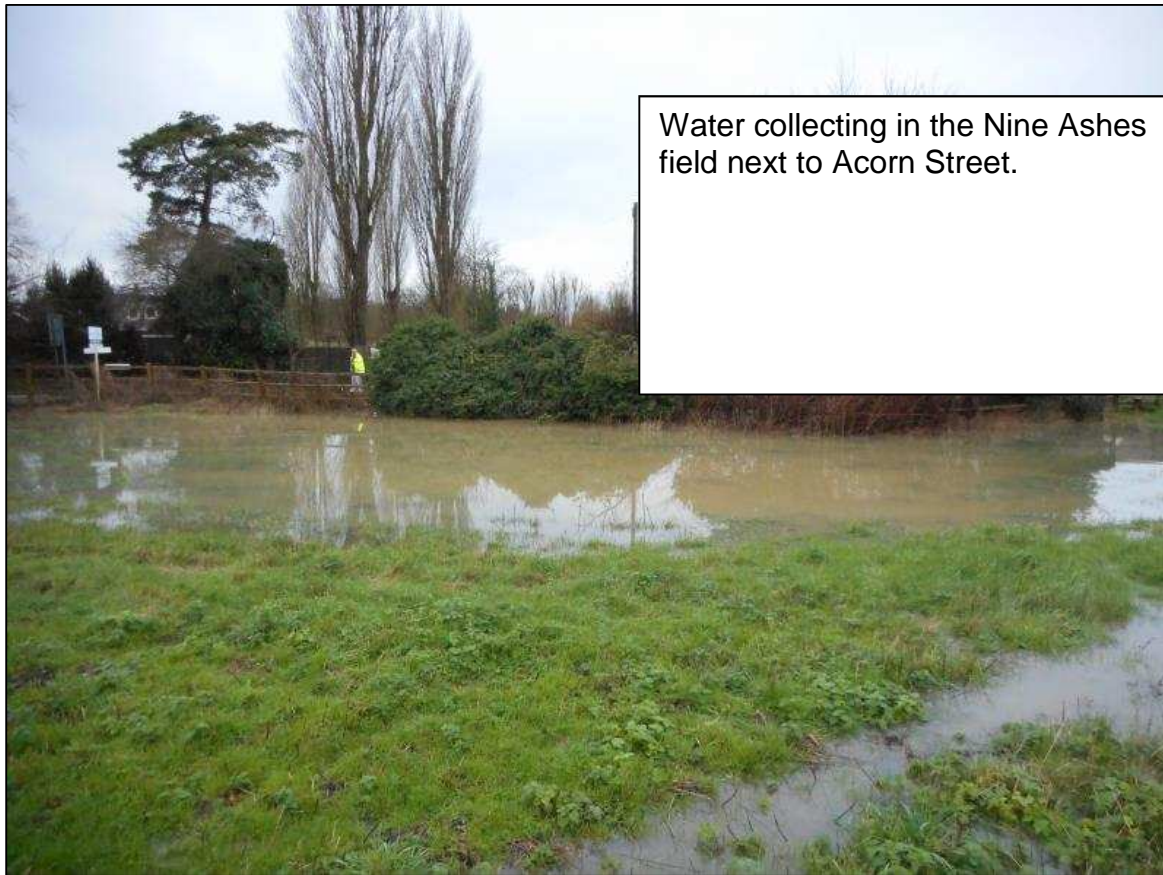
**Figure 12 Flood flow from Pond H creating a pool of water beside Acorn Street**

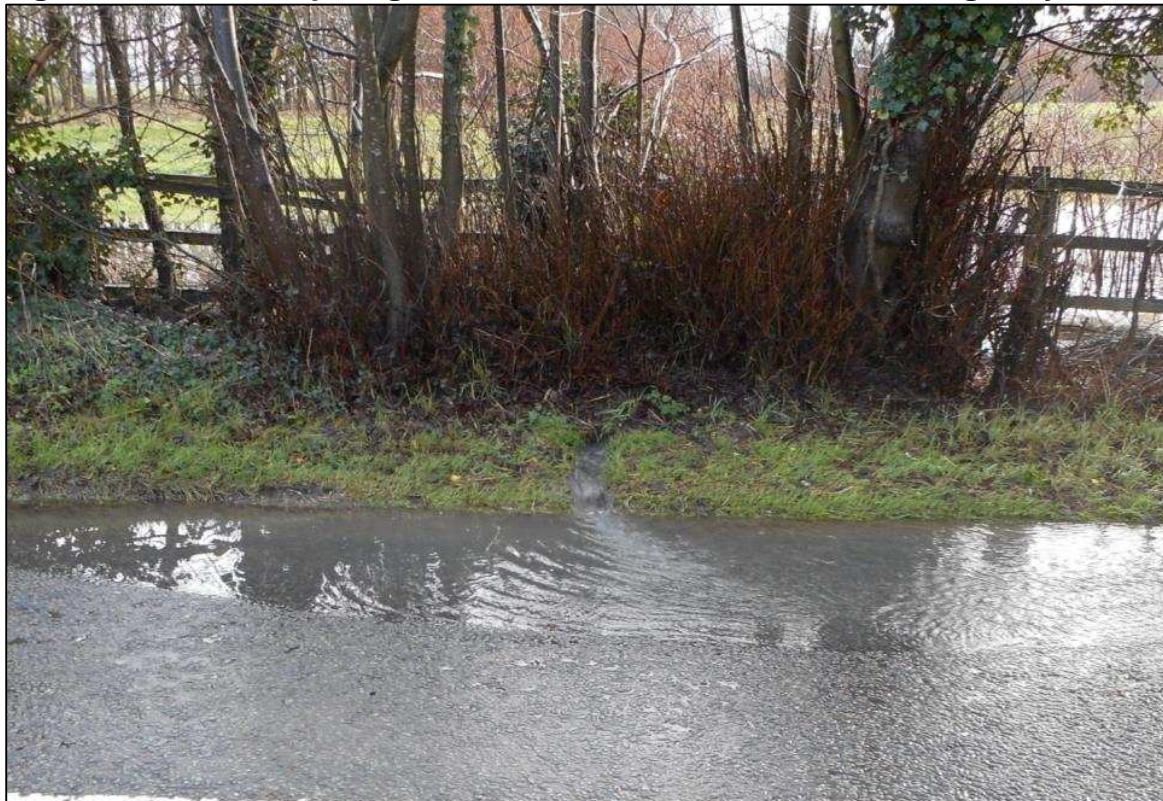
**Figure 13 Water spilling from the Nine Ashes site onto the highway**

This failure of the drainage network is adding to the volume of overland surface water flow that discharges onto the highway from the field. Due to the culvert under the road being at full capacity and the highway network being inundated with additional flows, water pools on the road and quickly flows towards the houses. This is further exacerbated by traffic causing a bow movement of water as they drive through the water on the highway.
