Hertfordshire County Council Flood Investigation Report

Bragbury End, Hertfordshire

Hertfordshire County Council Bragbury End Flood Investigation Report

Revision 5 - Final

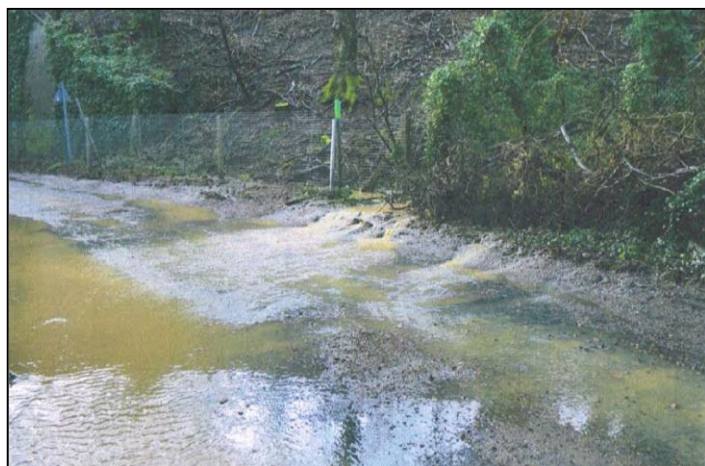
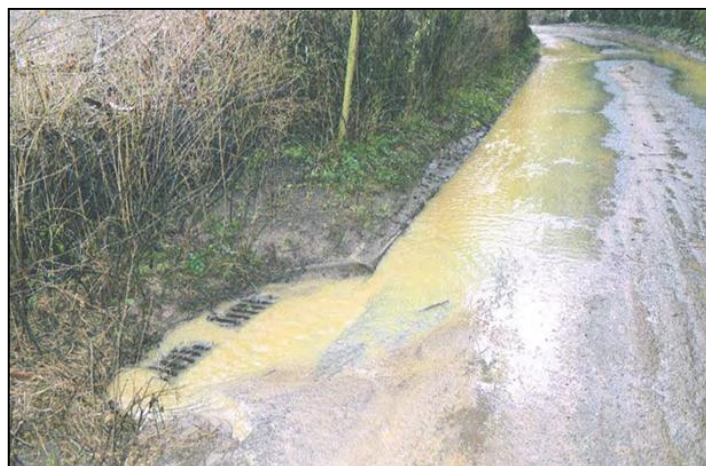
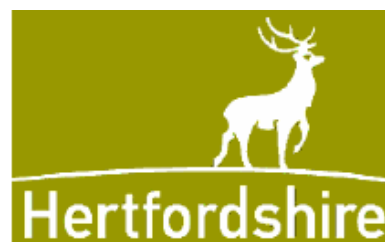
Photos courtesy of local residents

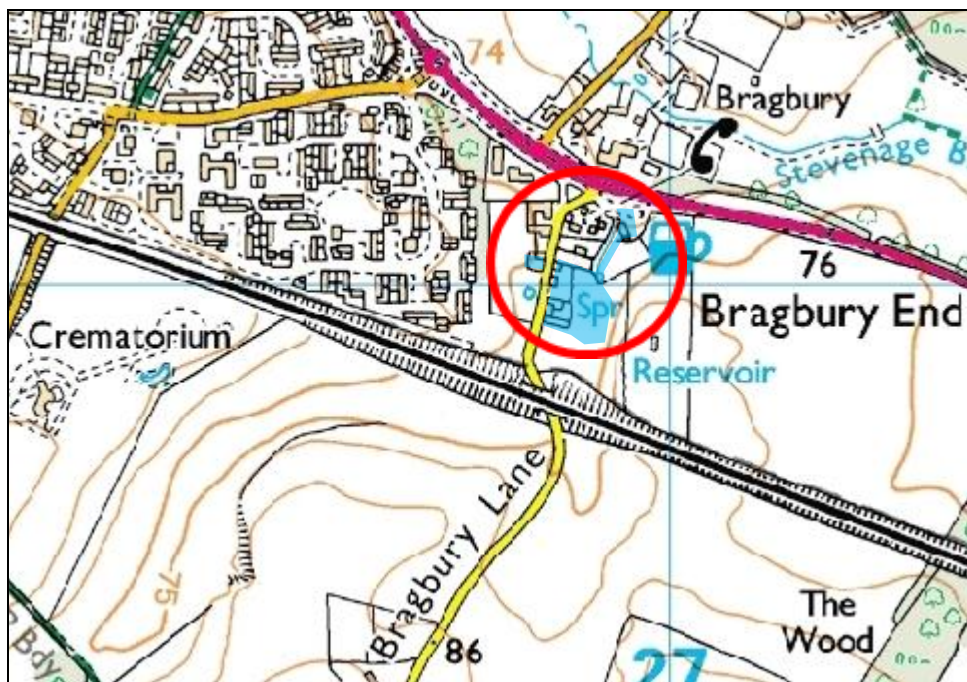
Figure 1.2 Area affected by flooding in Bragbury End

Bragbury End is situated in the south east of Stevenage, as illustrated in Figure 1.1. The site affected by flooding is located in the south east of Bragbury End, as shown in Figure 1.2.
