# ORCHARD WAY / BROOM GROVE

## Knebworth

Technical Assessment Report to support  
Section 19 Flood Investigation

**Project No:** 0469  
**Date:** October 2014

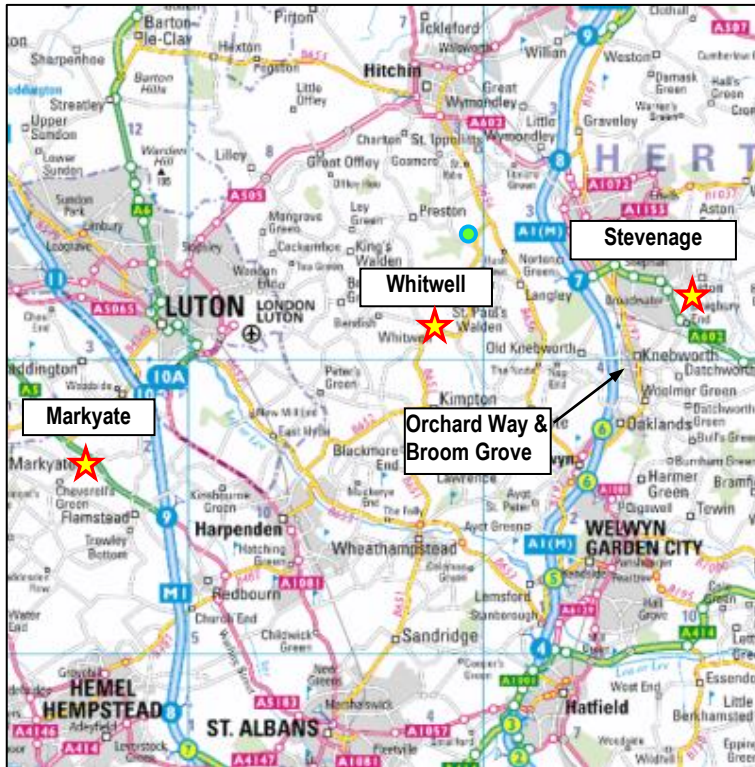
**Figure 8: Rain gauge locations**

Details of rainfall recorded at three permanent rain gauge sites, maintained by the Environment Agency, were obtained by the Lead Local Flood Authority for this investigation. The gauges were located at the following sites shown geographically in Figure 8 below:

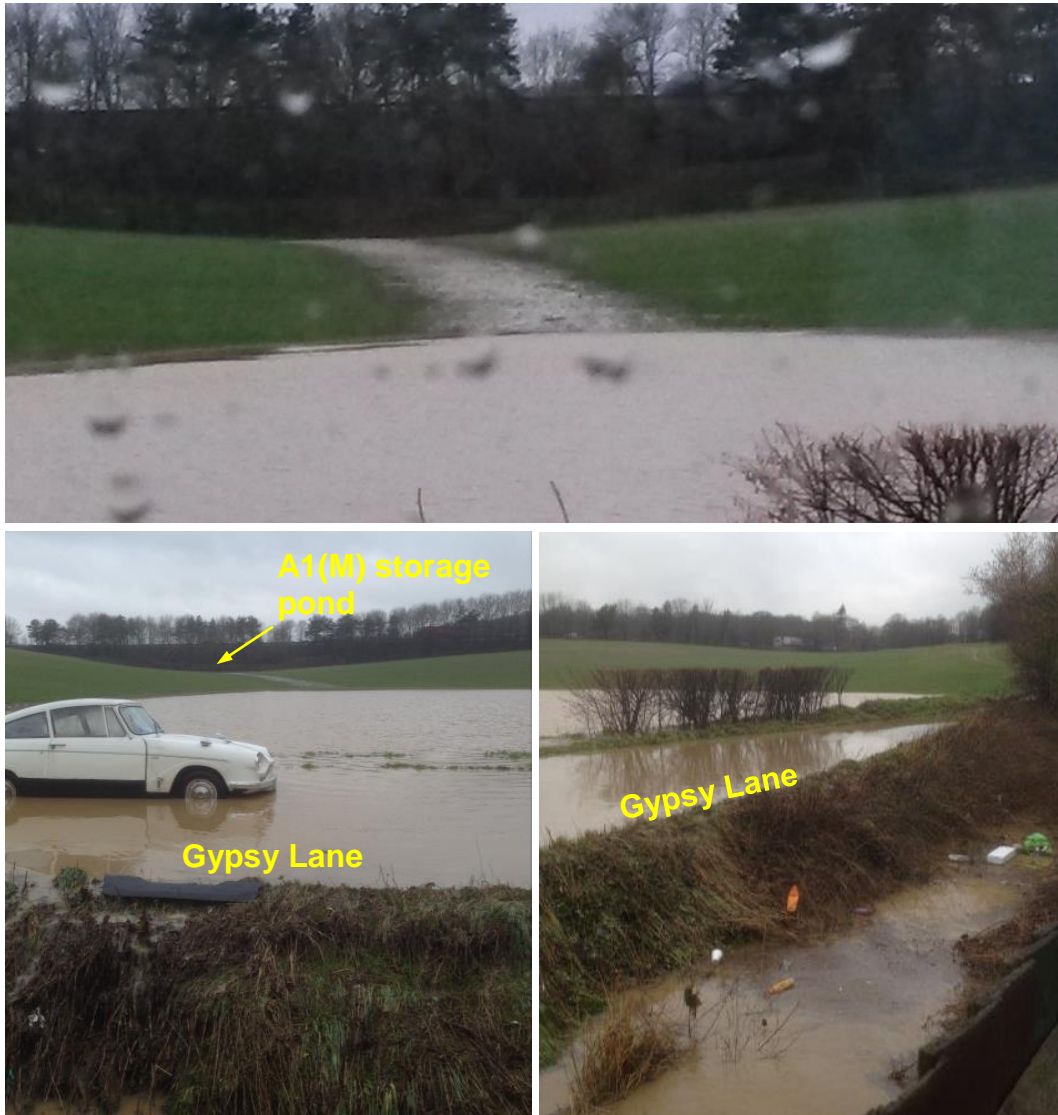
**Figure 10: Images of runoff from field adjacent to Gypsy Lane during storm of 7 February 2014**
