Hertfordshire County Council Flood Investigation Report

**Leyton Road, Harpenden
Hertfordshire**

Hertfordshire County Council Leyton Road Flood Investigation Report

July 2016
Revision 4

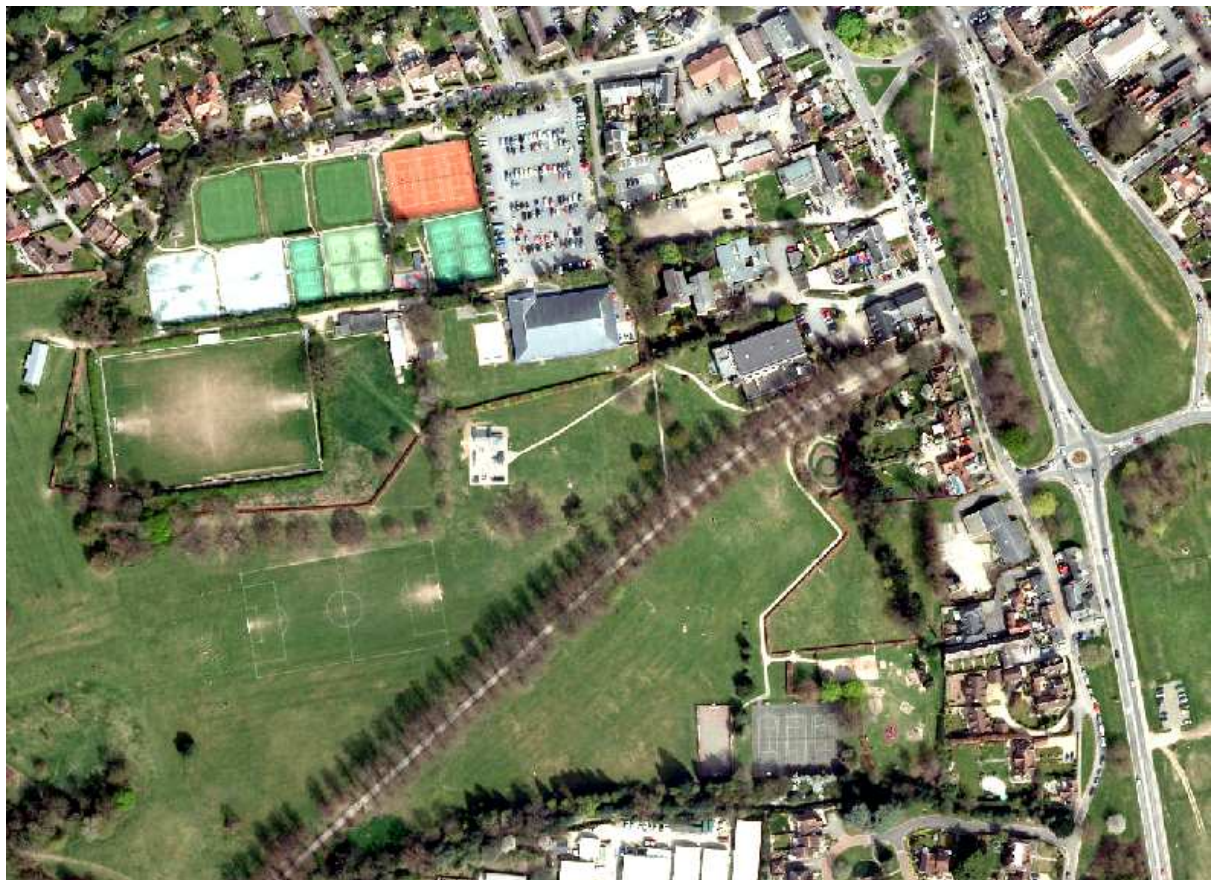
**Leyton Road and Rothamsted Park in 2010
Aerial Photography © GeoPerspectives.co.uk**

The flood waters affecting Leyton Road resulted from large volumes of surface runoff generated due to exceptional rainfall and antecedent conditions. The likely flow paths are shown on the cover illustration which show predicted flooding from rainfall modelling for an event with a 1% annual probability and at figure 3.1 which shows flows which have been observed. The differences in predicted and observed flow routes will stem from the resolution of the modelling which may not always pick up the subtle features and drainage networks which influence surface water flow paths.

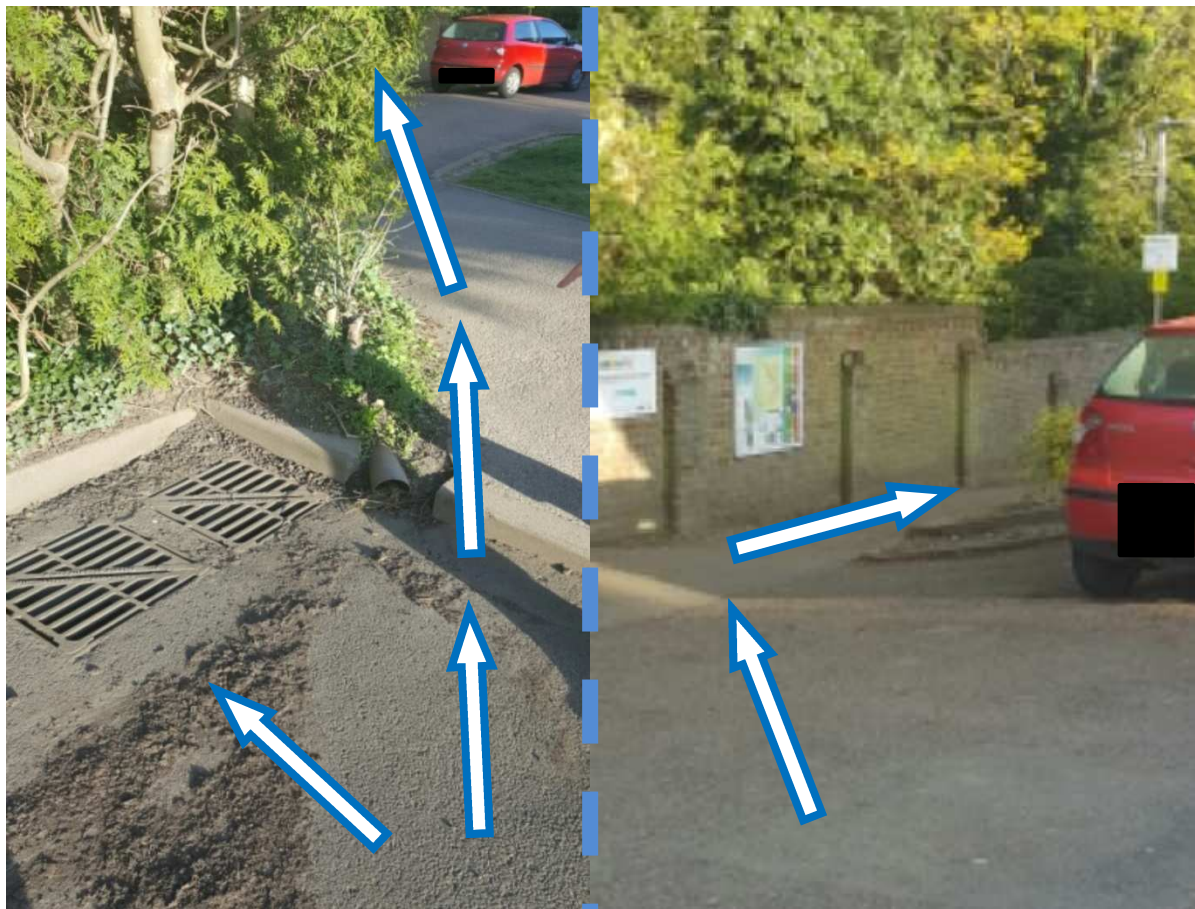
Figure 3.3 Flood flow path through Amenbury Lane car park

The contribution made to the flooding by the runoff from the Amenbury Lane car park is uncertain. A surface water flood has been observed and a video is available. The fall of the car park will cause water to flow across the surface towards the south east corner where there are two drainage grids which are understood to feed a soakaway.

There is also an overflow set into the kerb by the grids which suggest an ongoing problem with drainage due to capacity issues with the soakaways see fig 3.3. This picture was taken on 4 May 2016.

Include in Recommendations? Yes with qualification. Any contribution from the car park to the flood flows is uncertain. If the car park is reconfigured or resurfaced in the future it would present an opportunity for the cost effective incorporation of techniques to manage surface water flow.

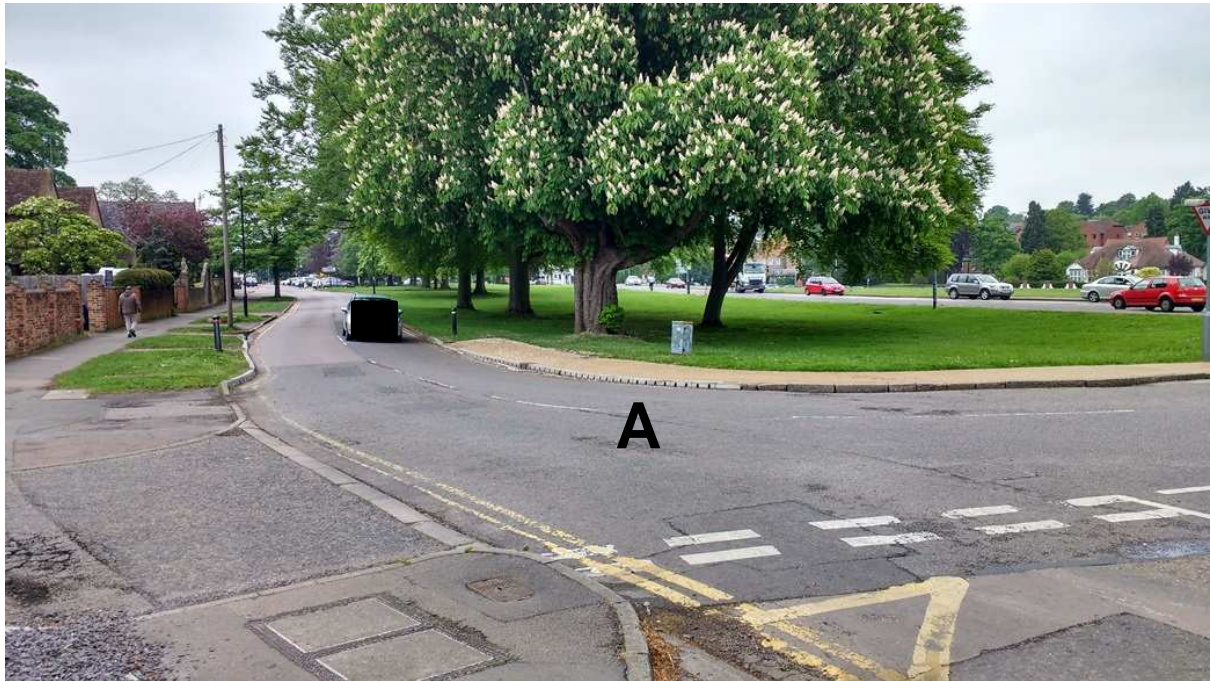
Figure 5.1 Leyton Road and A1081 looking north

There is a line of kerb inlet drainage on the corner of Leyton Road opposite the Fire Station (see fig 5.1 point A) which has been installed since June 2011. At the time of writing this report the onward connection from this area has not been established but is likely to be to a connection to the surface water sewer or high capacity soakaway.

1. Use swales or a combination of swales and bunds to capture flood flows and direct them around the properties onto Leyton Road and the two areas of common beyond (see figures 5.1 and 5.2).
