Hertfordshire County Council Flood Investigation Report

Flooding location - Eastern end of Hitchwood Lane near Preston,
Hertfordshire – TL 196 238

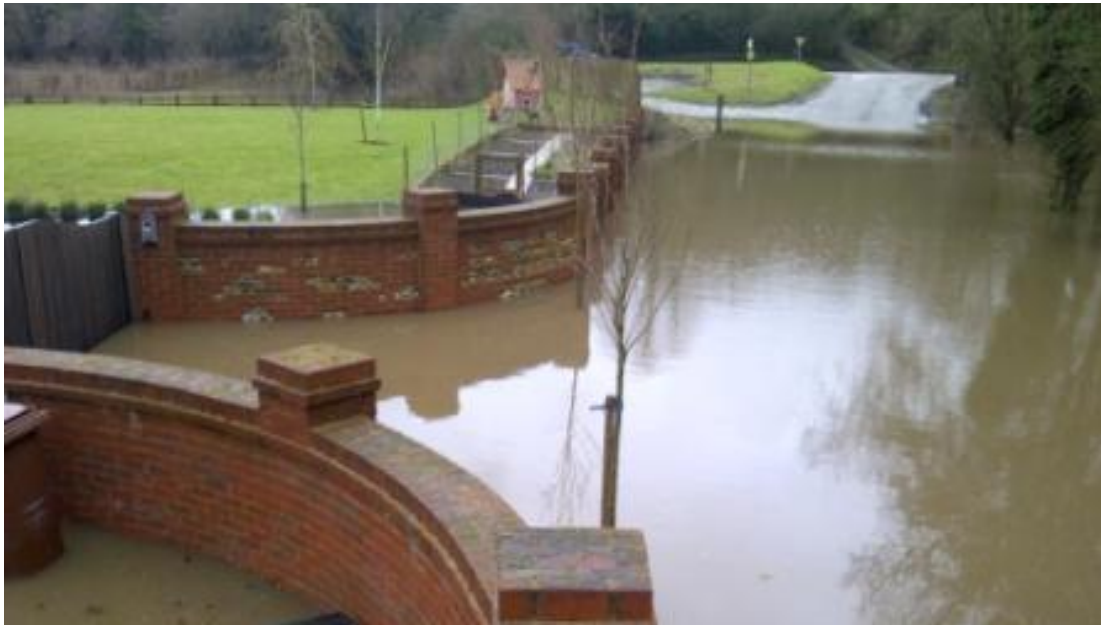
Photograph 1: flooding extent 27 January 2013

Water ponding adjacent to Hitch Wood near Preston Hertfordshire affecting road and encroaching into gateway and curtilage of dwelling. Water reaches a depth (300mm plus for a significant area and a max depth of 1100mm has been measured) and extent (60m plus) that prevents use by the majority of vehicles affecting access from the south to properties on Hitchwood Lane and the village of Preston.

Referring to figure 1 below, flooding to extent A was observed during site visit on 30 January 13. There are photographs of flooding to the extent B (see photographs 1 and 3). Photograph 2 taken on the day of the site visit gives an indication of the lowest area on the site. At this extent the flooding is 250mm deep at some points along the road.

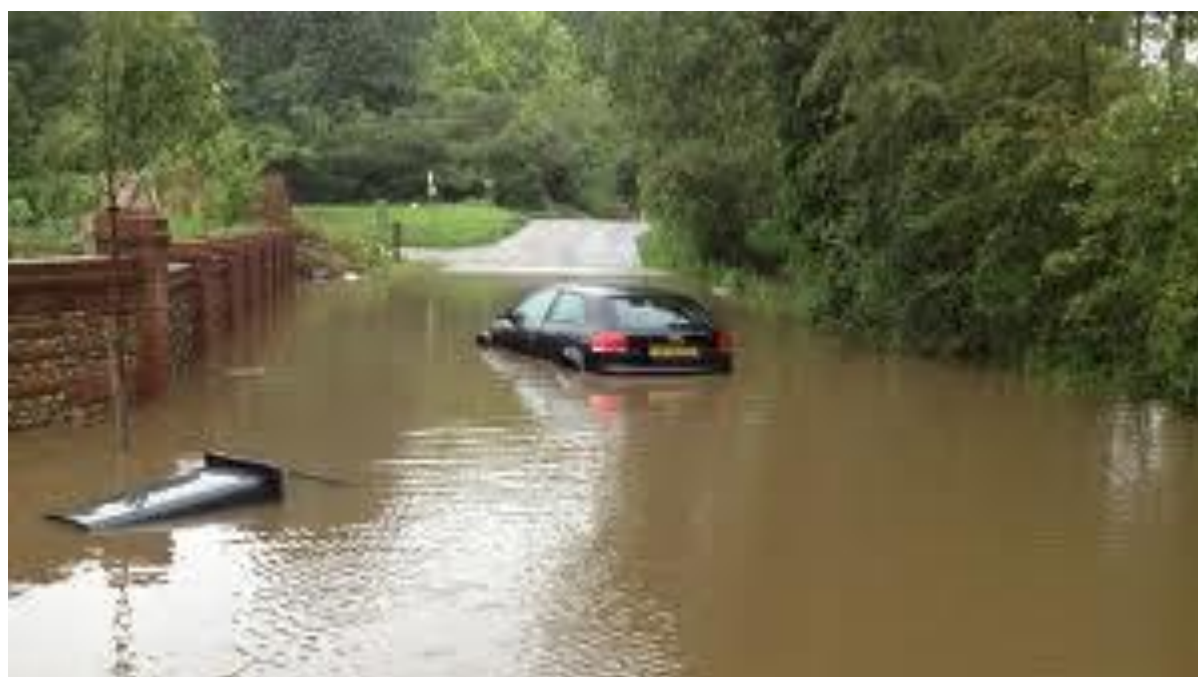
Photograph 3 Hitchwood Lane flooding 10 /11 June 2012

Similar event reported in June 2012 (emails and photos from resident and newspaper article about stranded car).

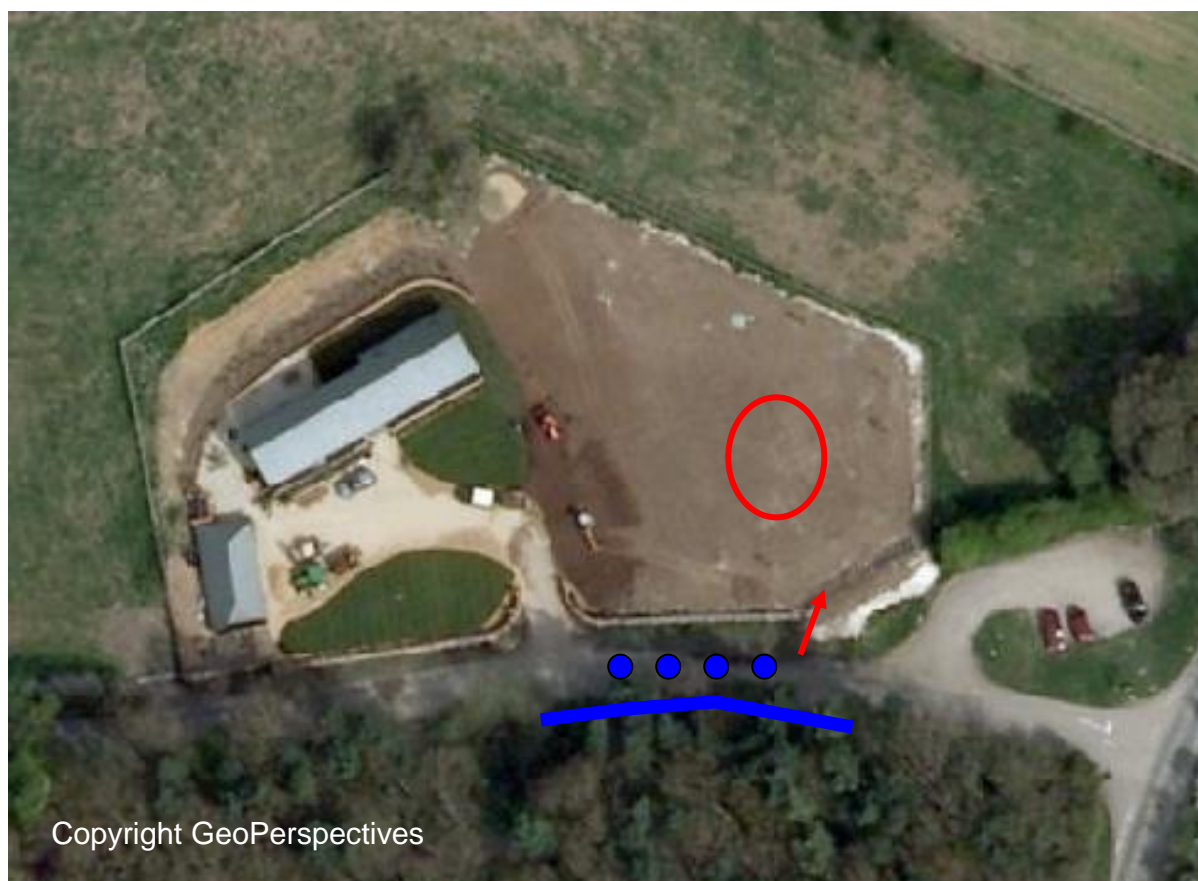
Figure 2 annotated extract from 2010 aerial photography

Following the conversion to a dwelling, a pond was constructed within the curtilage (solid red circle gives approximate location). Water was able to drain from the highway into the grounds along a grip in the highway verge which was directed between the boundary wall and adjacent bund (solid red arrow in figure 2 below). No levelled plans are available and it is assumed that some water would have flowed away from the area of flooding along the grip into the garden where it would disperse, including some infiltration into the pond. However the current owner never observed that happening which suggests it would only happen under extreme conditions. At the time this report was drafted there were some images on Google “Streetview” showing the grip and pond but copyright restrictions do not allow them to be used in this report.

There was further landscaping of the garden area in January 2010 including infill of the pond, alteration of levels and re-profiling of the bund in the north–east corner of the property to make it contiguous with the property's boundary wall.

Soakaways under road fed by ditches in the adjacent verge to the south were installed by Herts Highways during 2010 and are indicated in blue in figure 2 above. (There was evidence of fresh excavation of the ditches seen on site visit 29 January 2013).

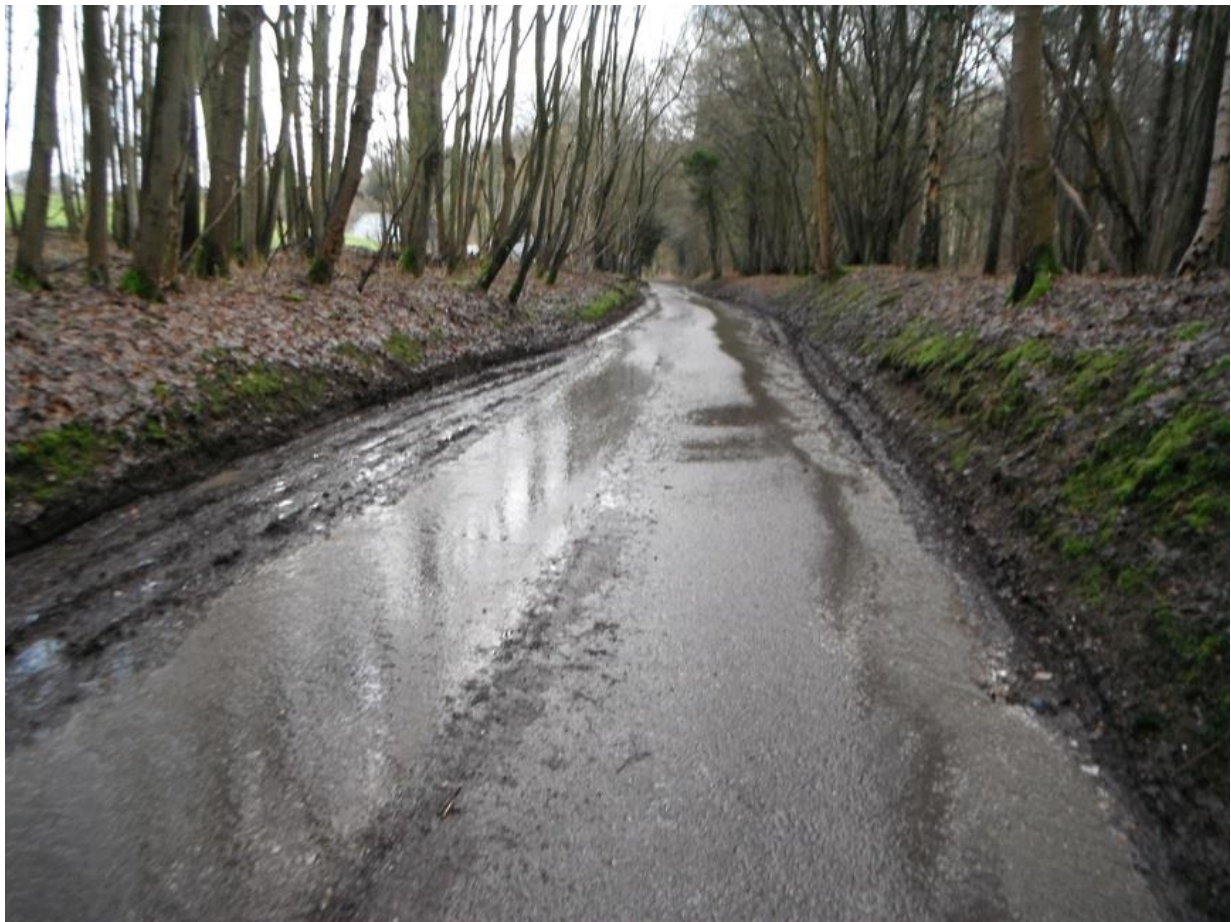
Photograph 4 view looking down Hitchwood Lane toward flooding site showing roadside banks

To the north and west of the area affected, water flows off adjacent farmland and woodland into Hitchwood Lane (for a distance of c 1 km) and follows the line of the road, until it reaches a point circa 30m from its junction with the B651 (White Lane/ Hitchin Road); this is a natural low point and it ponds here. On the day of the site visit it was up to 250mm deep. There is potential for additional flow from the south overland through Hitch Wood and possibly some flow from the east over the B651 and then down the short section of Hitchwood Lane to the area of ponding. The catchment contributing the flows to the flooding area is in the order of 2 to 3km² (figure 3 below). Land use is mostly woodland with some pasture and dwellings. Hitchwood Lane acts as a natural flood route. The fields / woodland either side are up to, and in cases, more than 1 metre higher.

Given the generally saturated ground conditions it is likely that any soakaways in this area are full. The water level in ditch-like structures in the woodland was contiguous with the water level in the road.
