# Hertfordshire County Council Flood Investigation Report

## Redbourn, Hertfordshire

## Hertfordshire County Council Redbourn Flood Investigation Report

Wednesday 17 December 2014  
Revision 5 - Final

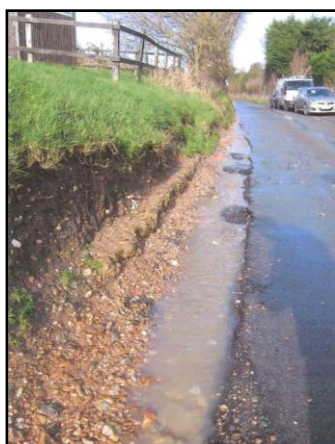
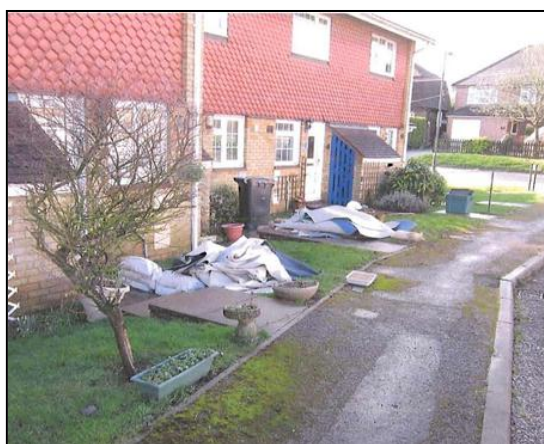
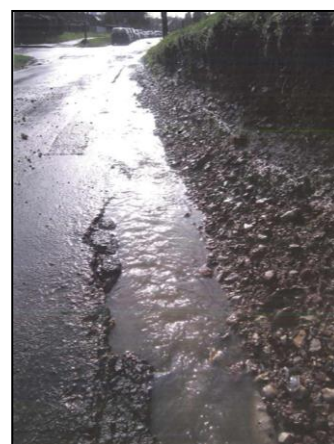
*Photos courtesy of local residents*

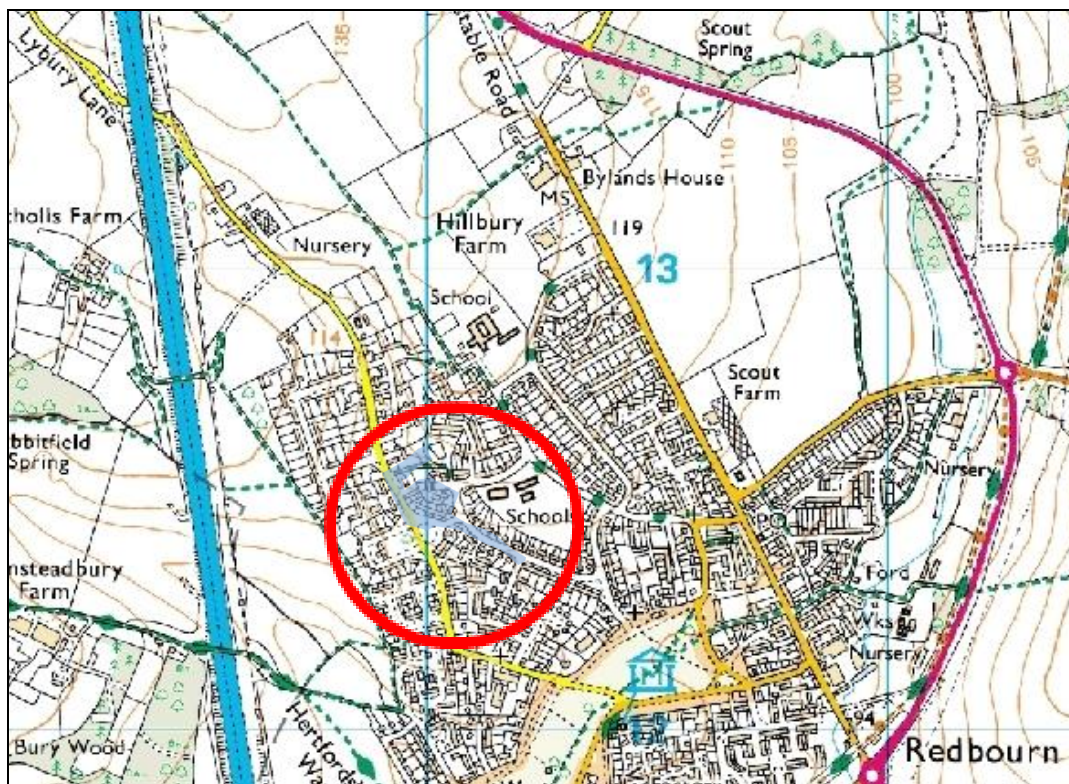
**Figure 1.2 Areas affected by flooding in Redbourn**

The village of Redbourn is situated to the north west of St Albans as shown in Figure 1.1. The site affected by flooding is located in the west of Redbourn, east of the M1, as shown in Figure 1.2.
