**ROSE ACRE, RIDGEDOWN &
SNATCHUP
Redbourn**

**Technical Assessment Report to support
Section 19 Flood Investigation**

Project No: 0469
Date: October 2014

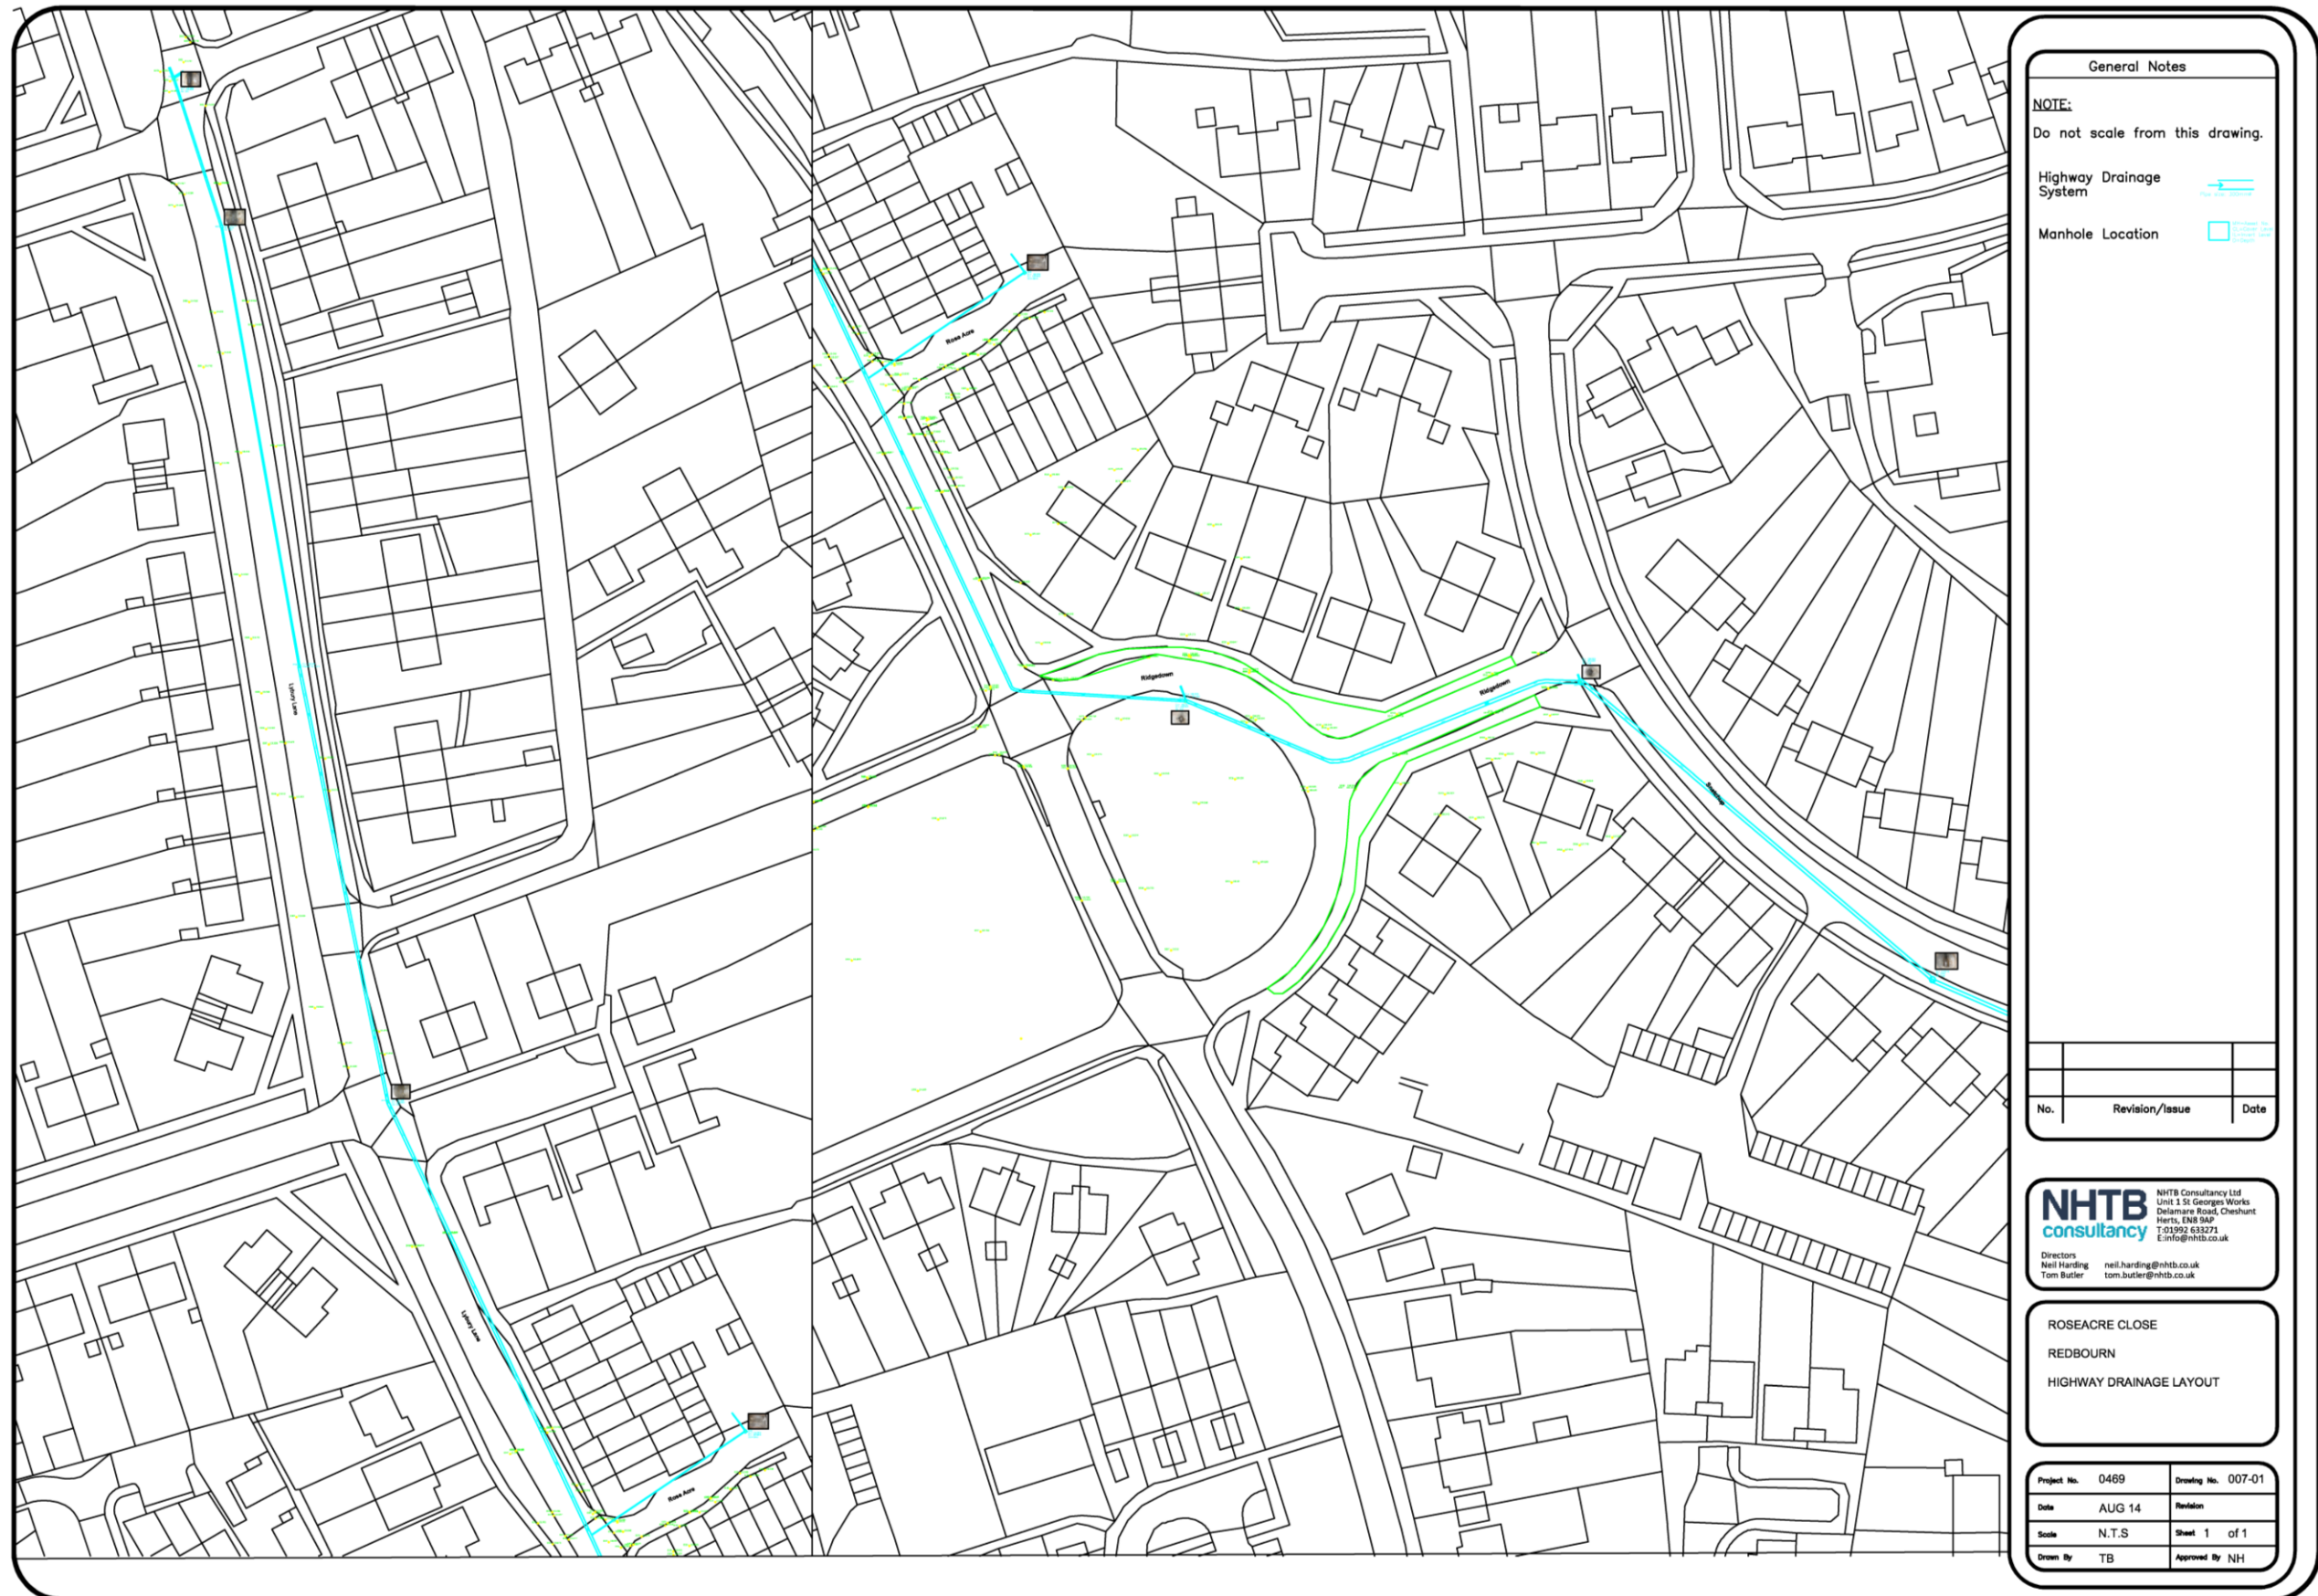
Figure 6.2: Highway Drainage System

During the survey of the highway drainage all road gullies in Lybury Lane were clear and appeared to be operational. There are manhole chambers along the line of the highway drain and these were also inspected and found to be clear with the exception of the manhole chamber in Rose Acre, at the entrance to the garages, which was partially blocked with silt.

Photographic evidence taken during the time of the storm shows this is not always the case and become easily blocked when runoff flows wash fine silt and debris off the fields into the carriageway. Residents from Rose Acre carefully monitor the condition of the gullies and regularly keep the surfaces clear to help keep in maximum operating performance. The highway drain is believed to follow the topography of the land along Ridgedown, Snatchup and beyond, eventually discharging into a main river on the opposite side to 'The Common'.

Normally highway drainage is designed for storm conditions that are less severe than the exceptional weather that occurred over the winter of 2013-14. The highway drainage system would not have been able to accommodate all of the surface water runoff from the extreme conditions experienced, even if each component part was operating to its optimum performance. As an illustration, the theoretical capacity of the highway drainage system, based on the different pipes sizes and gradients along Lybury Lane, Ridgedown and Snatchup (as indicated in Figure 6.2) are summarised in Table 6 below.

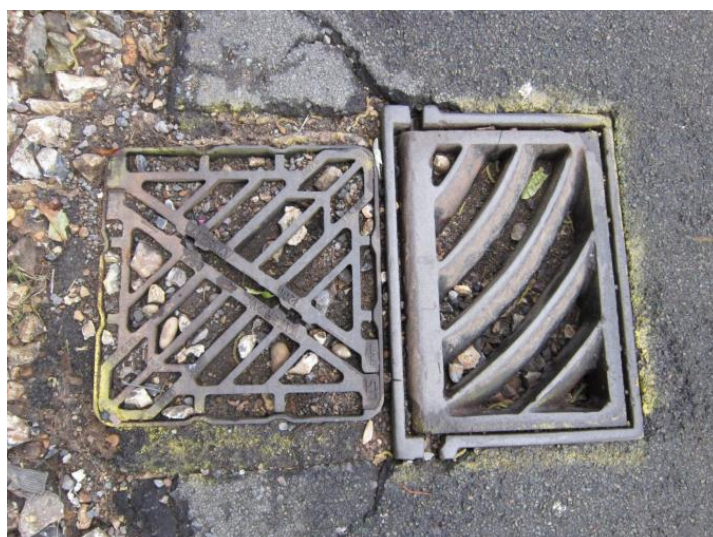
Figure 9: Blocked Gullies in Lybury Lane
(Image taken following the storm event in February 2014)

Evidence from pictures taken by residents during the storm (see Appendix A) show the gullies were full with silt and debris and non-operational at the time of the storm in February 2014. The silt and debris is a result of the field runoff during the storm. The gullies and all manholes that form part of the highway drainage system in Lybury Lane, Ridgedown and Snatchup were clear and operational during the time of the survey conducted in October 2014 as part of this investigation.

The existing highway drainage system could be very effective and offer considerable protection against flooding if existing gullies and pipework are kept clear of silt and other debris that restricts the removal of water from the road surface. The current arrangement of gullies is not, however, sufficient to prevent flooding because there are too few gullies. It is recommended that the entire system is cleaned using high pressure jetting and a CCTV survey conducted to establish any structural defects and restrictions that are inhibiting optimum hydraulic performance. The programme of routine inspection and reactive maintenance of gullies should be examined and where necessary more regular action taken. These actions should be implemented by Hertfordshire County Council Highways Department.

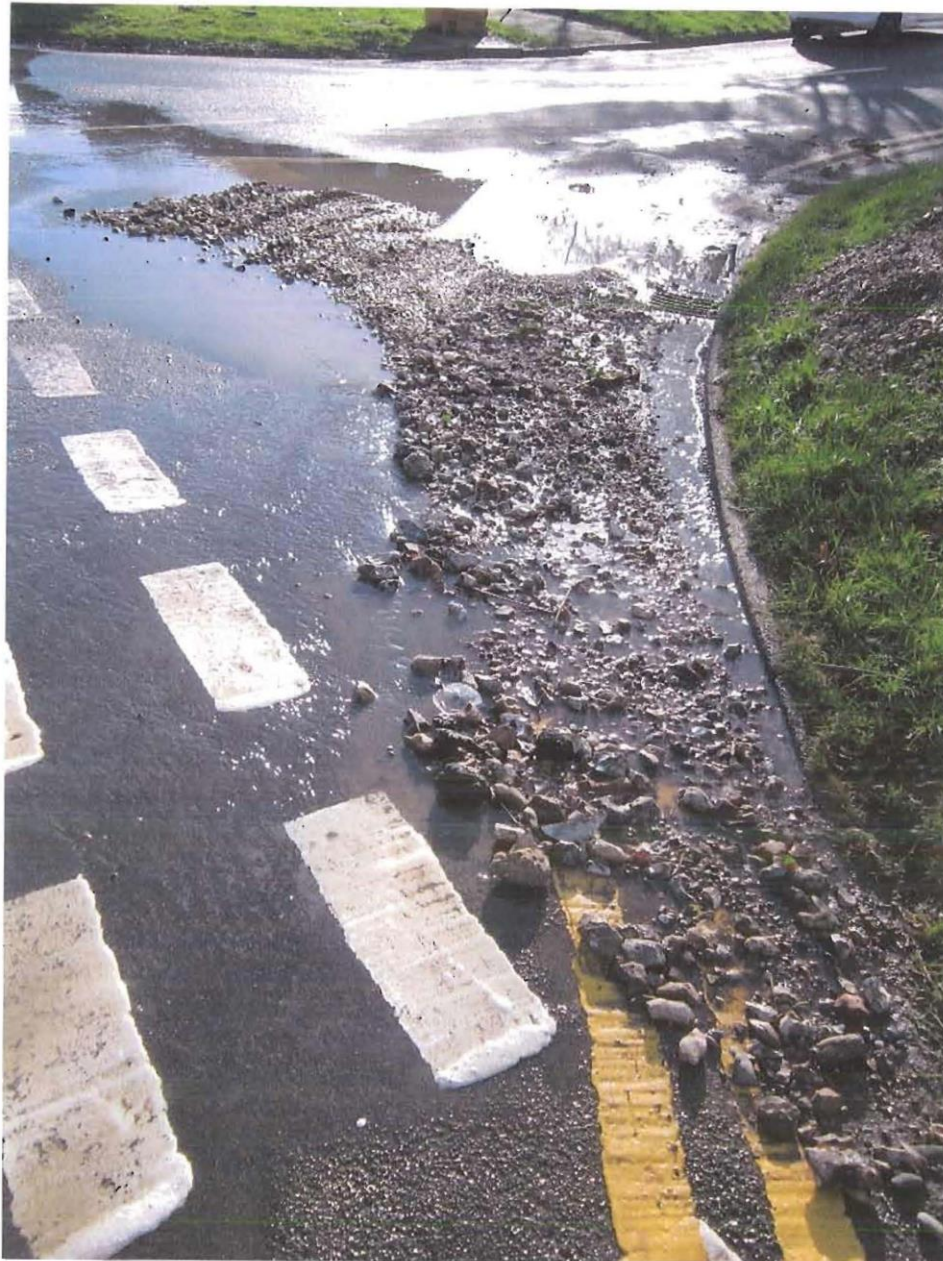
Top of Lybury lane – showing debris blocking drains.

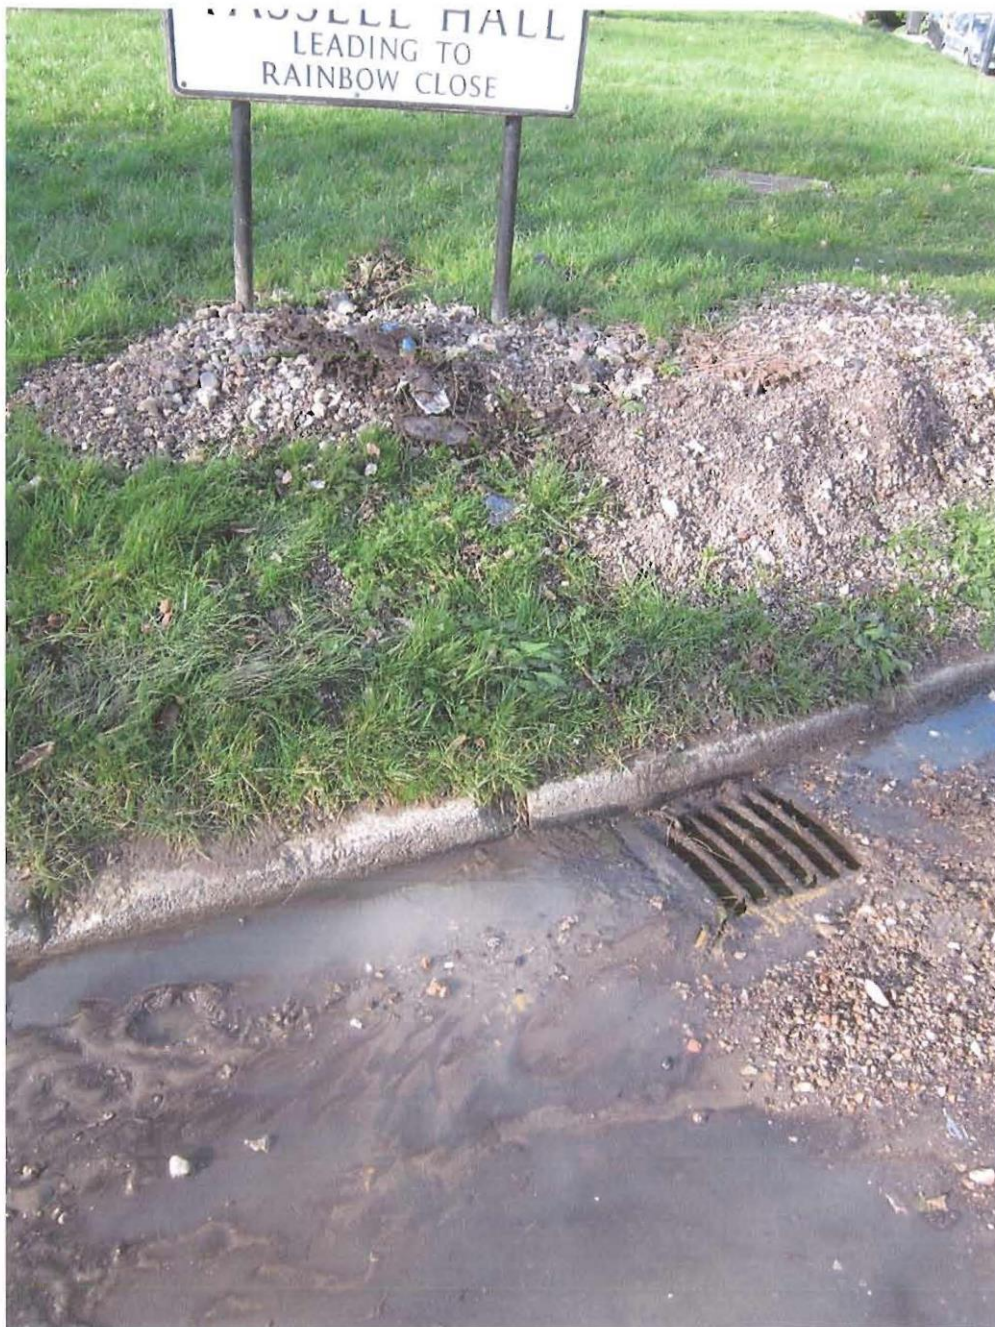
Top of Lybury Lane – Debris blocking drains – Note the amount of debris on the grassed area that has already been hand cleared from the tops of the drains by local residents.

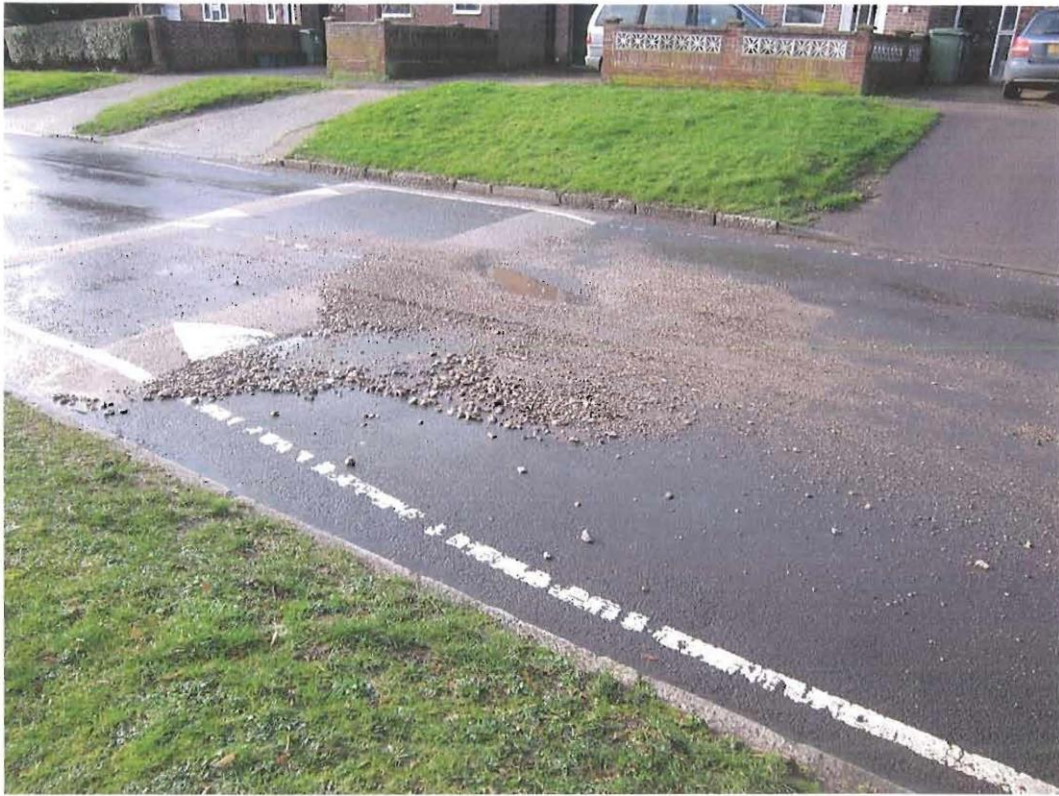
Midway down Lybury Lane – Debris swept by flood across whole road.

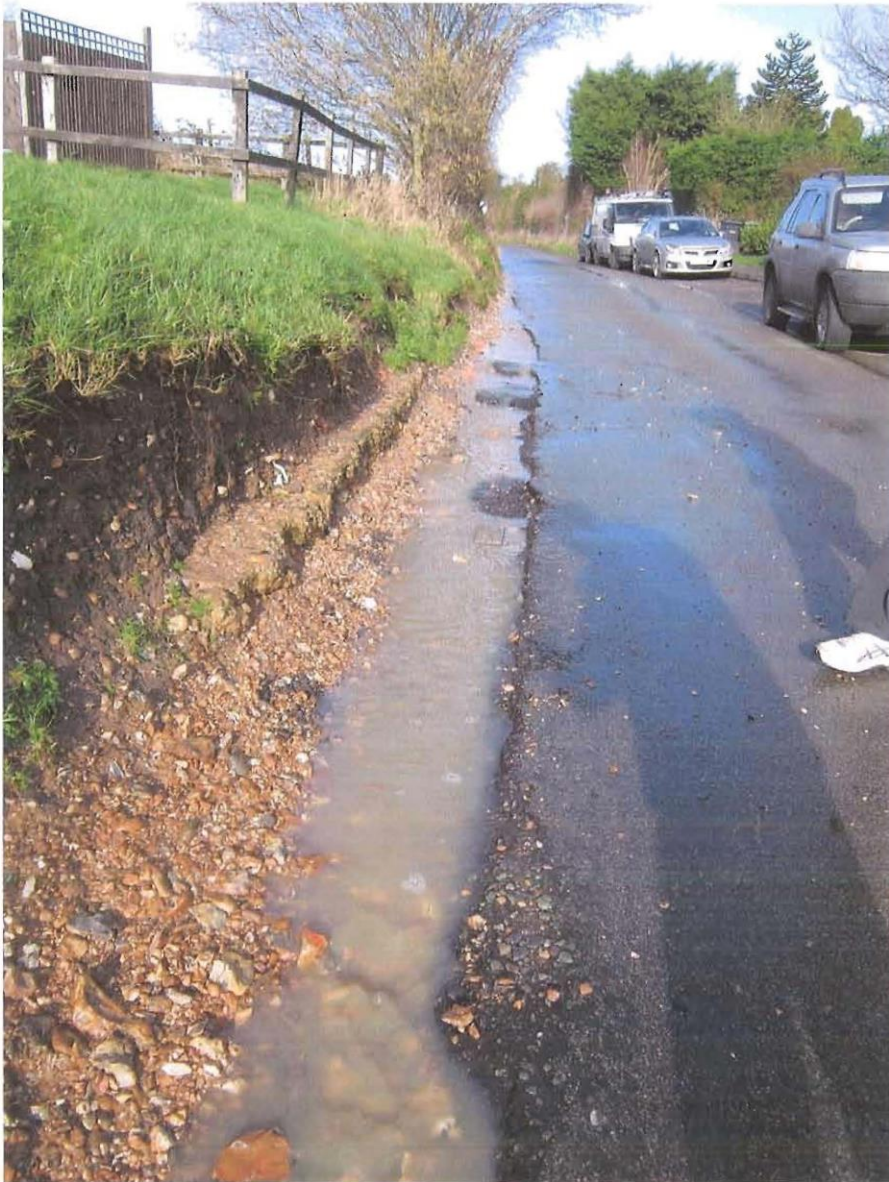
Top of Lybury Lane – Stream of water due to blocked drains further up the road. Note the erosion of the road. The drains have been blocked for several months which has caused this.

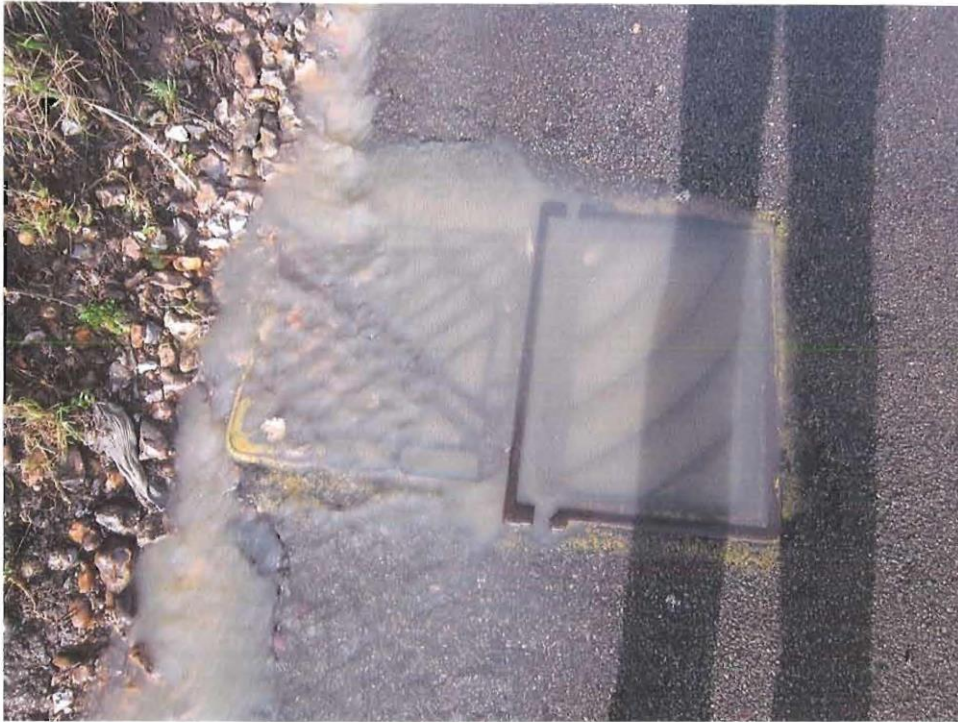
Top of Lybury Lane – Two blocked drains, completely full to the top with debris.

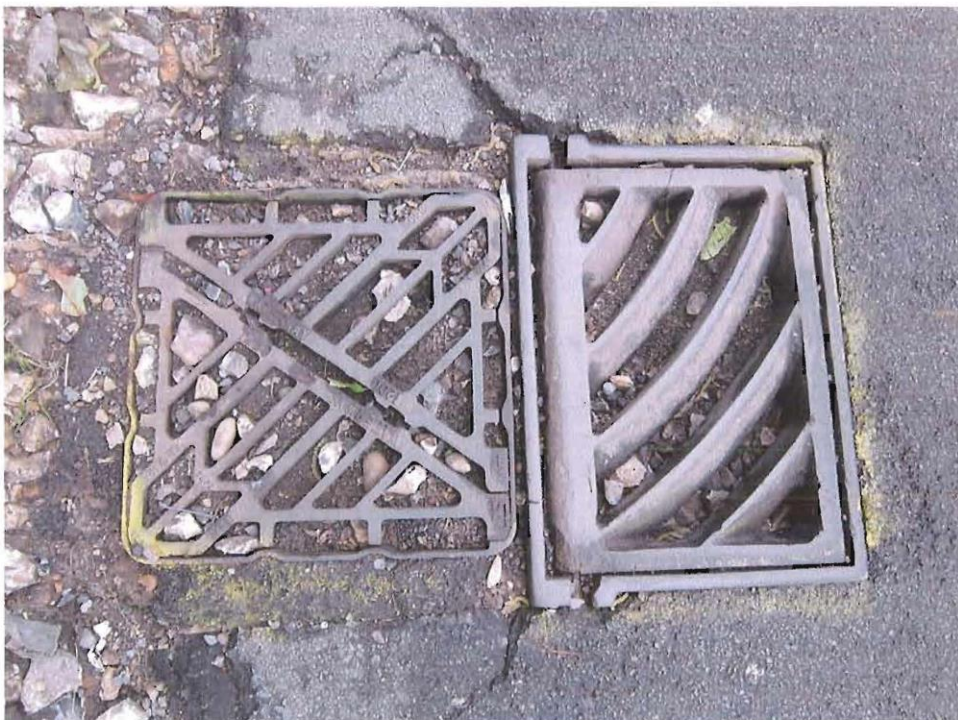
Top of Lybury Lane – Two blocked drains (photo taken 10/02/14).
