Hertfordshire County Council Flood Investigation Report Report Travellers Lane, Hatfield Hertfordshire

Hertfordshire County Council Travellers Lane Flood Investigation Report

August 2017
Revision 5

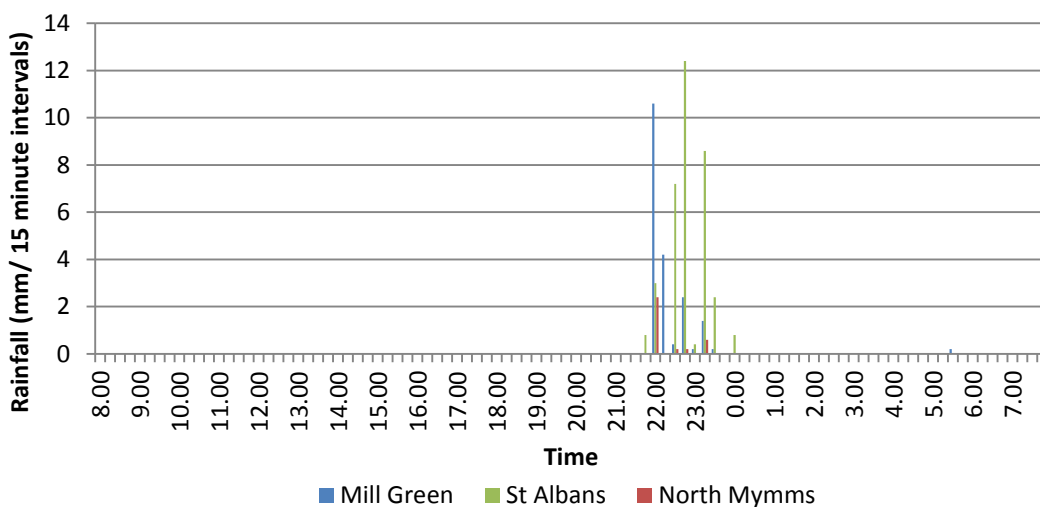
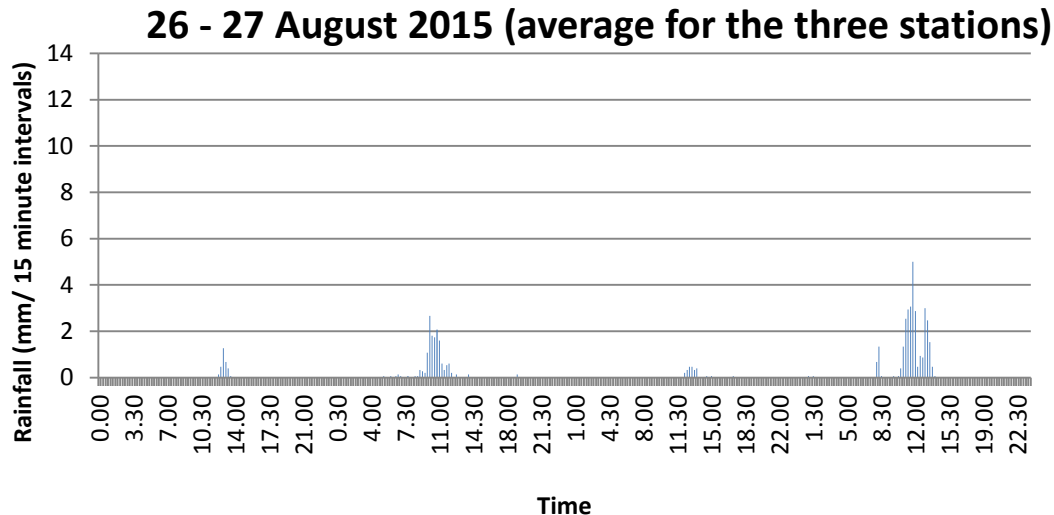
Figure 5: Rainfall preceding flood events

- 7 February 2014 – Heavy rain (50% probability of occurring in any given year) after three days of rain.
- 16 July 2015 – Heavy rain including a high intensity peak (1.7% probability of occurring in any given year)
- 26 August 2015 – Heavy rain (20% probability of occurring in any given year) following three days when rainfall occurred.

6 - 7 February 2014 (average for the three stations)

16 - 17 July 2015 (plotted for each station)

Rainfall at the Travellers Lane catchment was assumed to be an average of what was recorded at these stations given that they are each a similar distance from the catchment. The measured rainfall is shown graphically in figure 5.

The rainfall on 16 July 2015 (see figure 5 (b)) as recorded at the local weather stations has been plotted for each station and not as an average to reflect the local variability of rainfall. Because of this variability, quantifying the amount of rain at Travellers Lane catchment cannot be determined exactly.

Surface water flooding occurred because of two distinct combinations of rainfall and antecedent conditions. The February 2014 and August 2015 floods were caused by heavy rainfall conditions preceded by wet weather which had caused the ground to become saturated. In contrast, the July 2015 flood was caused by intense rainfall, with a large volume of water falling in a short space of time.

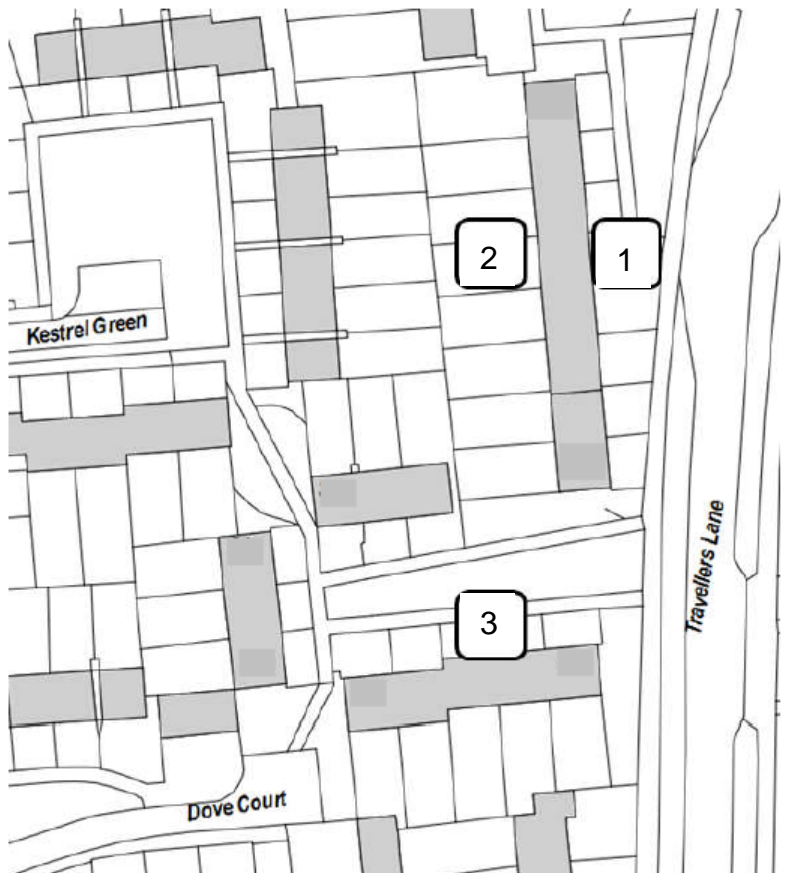
Figure 7: Flood mechanisms for Travellers Lane

Location 1	<p>In all events, surface water flow contributes to the flood extent at this location. A flow path is predicted originating from Briars Lane to the North.</p> <p>Surveyed pipe network along front of properties is shown to have capacity in the February 2014 event, while surcharge occurs at manholes in both the July and August 2015 event.</p> <p>Flood extent and depth at this location is greatest for the July 2015 event, this correlates with the highest surcharge levels in the pipe network for all events.</p> <p>Reports from latest flood event in August note flooding from manholes in front of the property, which correlate with the outputs of the model.</p>
	Location 2	<p>Surface water flow contributes to flood extent at this location, with areas draining to a low point from the area to the east and north of the properties. A large flow path is predicted within the model from Briars Lane to the north, overtopping the kerb on Woods Avenue and flowing towards the rear of properties.</p> <p>Pipe network is surcharged in February 2014 event, without flooding of the manholes being represented by the model.</p> <p>In both 2015 events the hydraulic model represents flooding manholes to the rear of the properties, contributing to flood depths and extents at this location.</p> <p>Flood extent and depth at this location is again greatest for the July 2015 event, with surcharge levels in the sewer network highest for this event.</p>

Location 3	<p>Surface water flow contributes to flood levels at this point, with notable surface water flow paths from Dove Court and Kestrel Grange.</p> <p>In all cases, the pipe network to the front of the properties appears to have sufficient capacity within the immediate sewer network. In the 2015 events, capacity within the receiving network is close to capacity, in the main sewer line running parallel to Travellers Lane.</p> <p>Flood depths and extents are greatest for the July 2015 event.</p>

The model results indicate that the three separate rows of houses in Travellers Lane flood from different flow paths and drainage networks. A detailed summary is listed next to the row of houses, see Figure 8. Overland flow occurs at both Kestrel Grange and Dove Court and from the north of the affected properties (from Woods Avenue).

The model also evaluated the surface water sewer network, as well as the highway gully network. The model found that both networks were close to full capacity; however the surface water sewer had sufficient capacity to accommodate surface run off collected by the highway gully network. The model predicts that not all surface runoff was collected by the highway gully network for the rainfall events considered, in particular the July 2015 rainfall event. Gully inlets have a finite capacity and where this is exceeded surface runoff will not enter the surface water sewer that will cause surface water flooding.

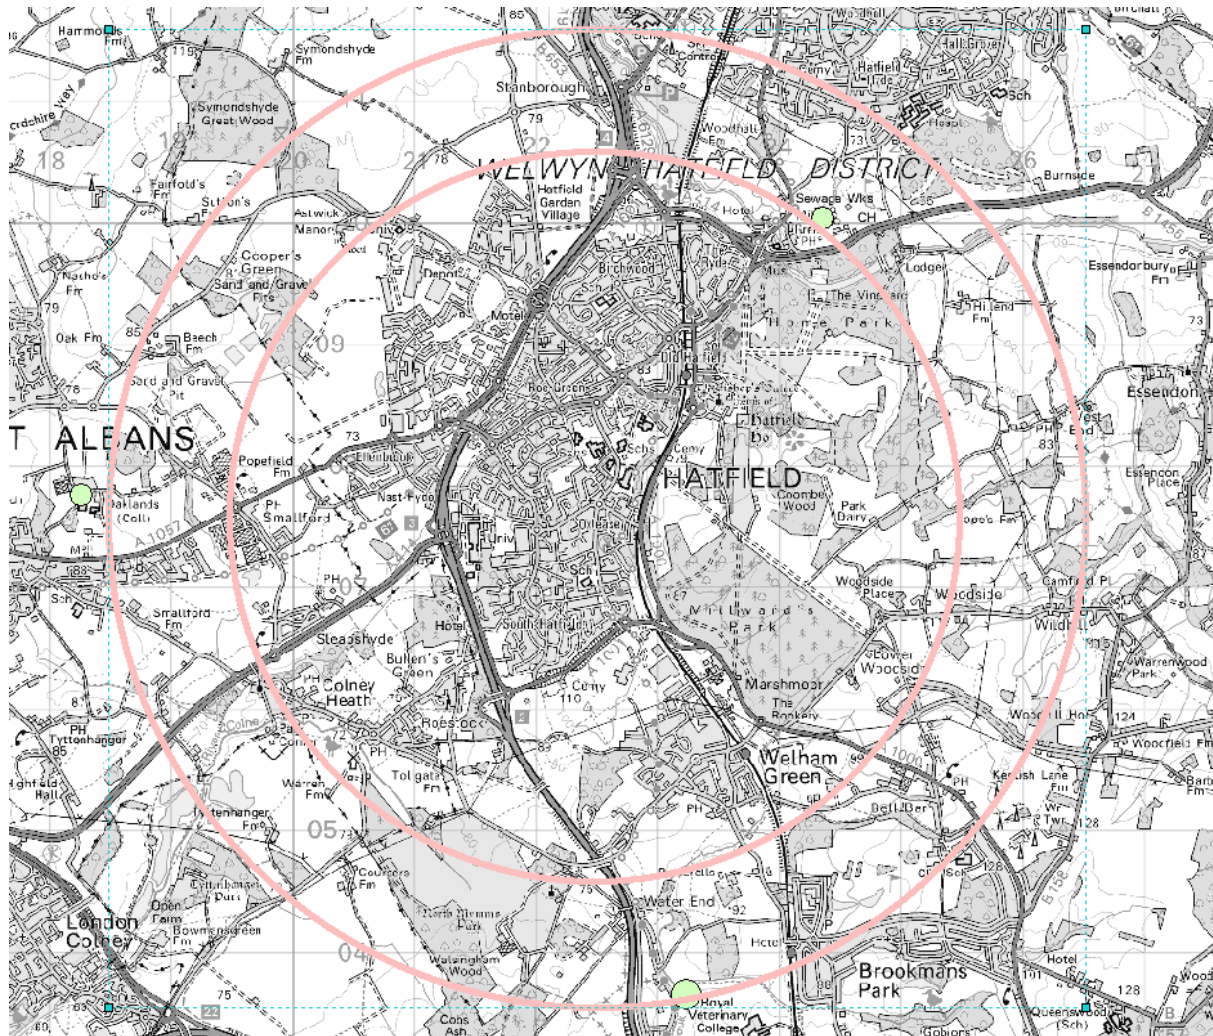
Figure 10: Rain gauges as used to predict rainfall identified by the green dot.

Rainfall data provided by the Environment Agency from climate stations at St Albans, Mill Green and North Myrms.

The levels of rainfall related to the flood events were estimated using data from weather stations in North Myms, Mill Green and St Albans. For the location of these weather stations, see figure 8 in appendix 1.

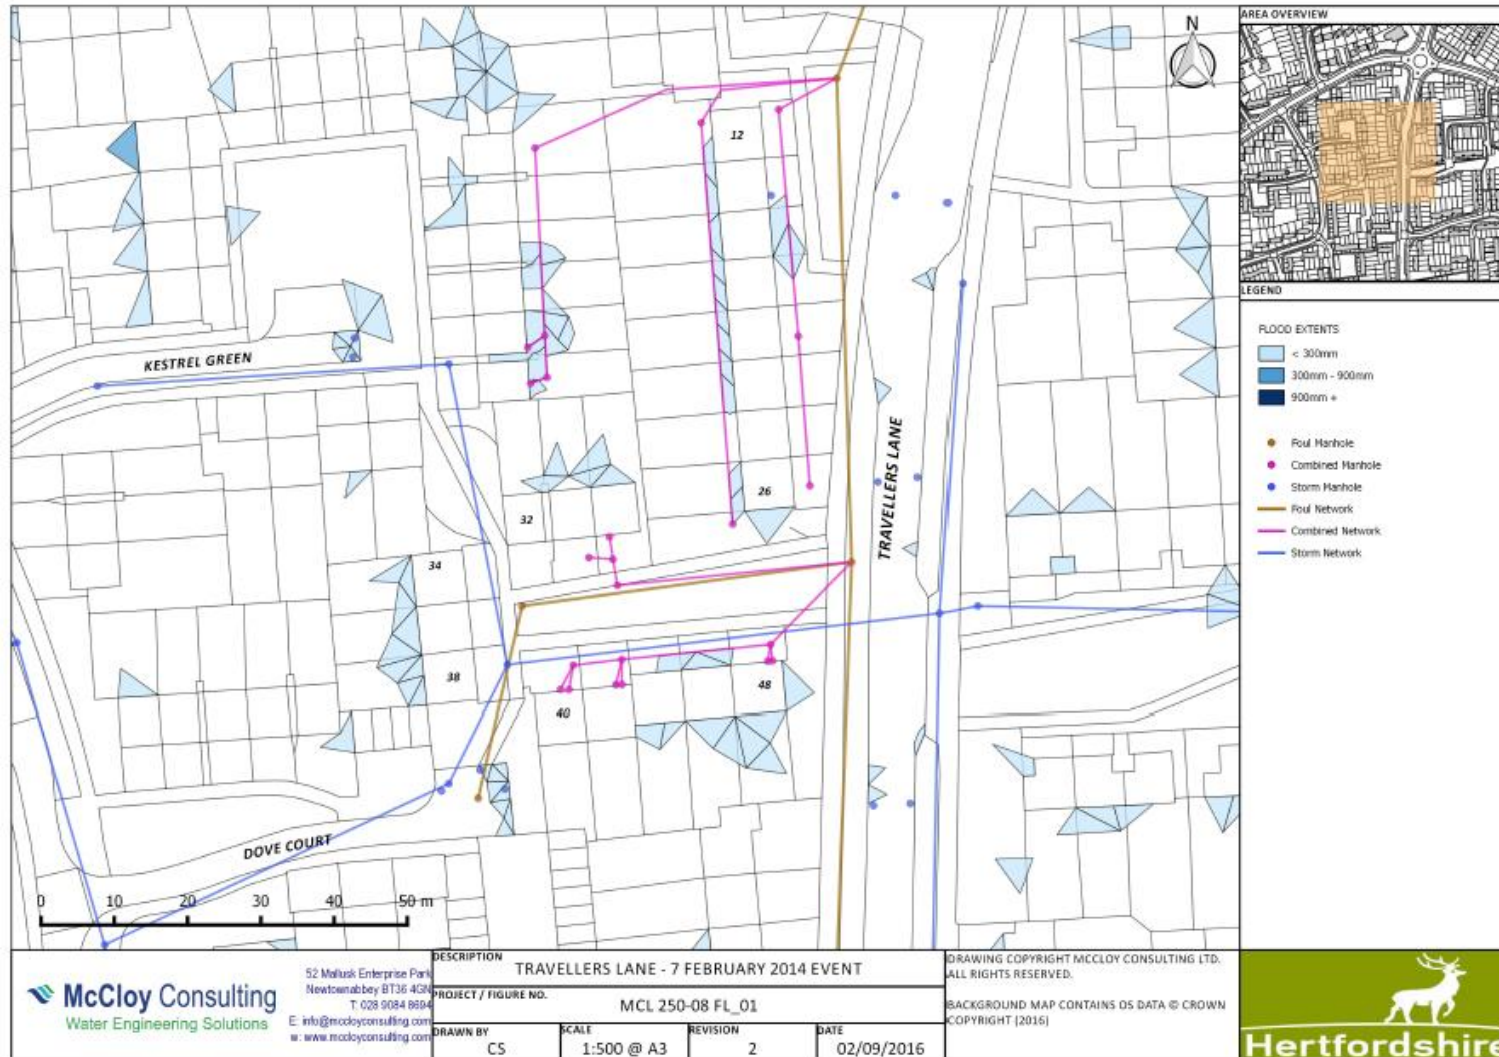
Travelers Lane modelled outputs for the 7 February flood event

The model has produced flood extent maps with likely flood depths depending on differing rainfall events and saturated levels. An example of the model results (the run for the flooding on 7 February 2014) is included within Appendix 3. The model helps in understanding the probability and severity of flood risk which will be used to assess the feasibility of any mitigation work.
