Hertfordshire County Council Flood Investigation Report Whitwell, Hertfordshire

Hertfordshire County Council Whitwell Flood Investigation Report

Friday 23 January 2015
Revision 5 - Final

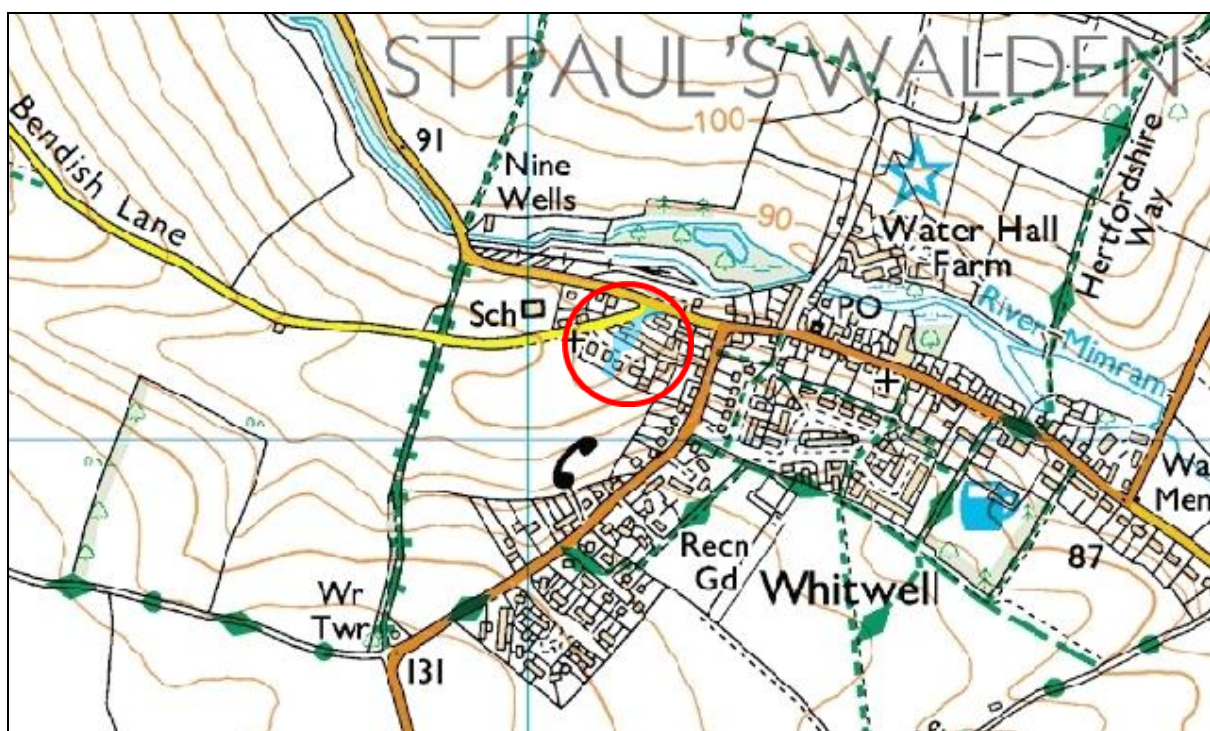
Figure 1.2 Area affected by flooding in Whitwell

The village of Whitwell is situated six miles south of Hitchin, illustrated in Figure 1.1. The site affected by flooding is located in the north west of Whitwell, as shown in Figure 1.2.

Flood flows then found their way round both sides of the property, onto Cresswick and towards the rear gardens of Mimram Close. Water built up in the gardens of properties in Mimram Close, finding its way into one property via an old dryer vent and the rear conservatory. The adjacent property in Bendish Lane suffered flooding to their garage.
