CRESSWICK / MIMRAM CLOSE

Whitwell

Technical Assessment Report to support
Section 19 Flood Investigation

Project No: 0469
Date: October 2014

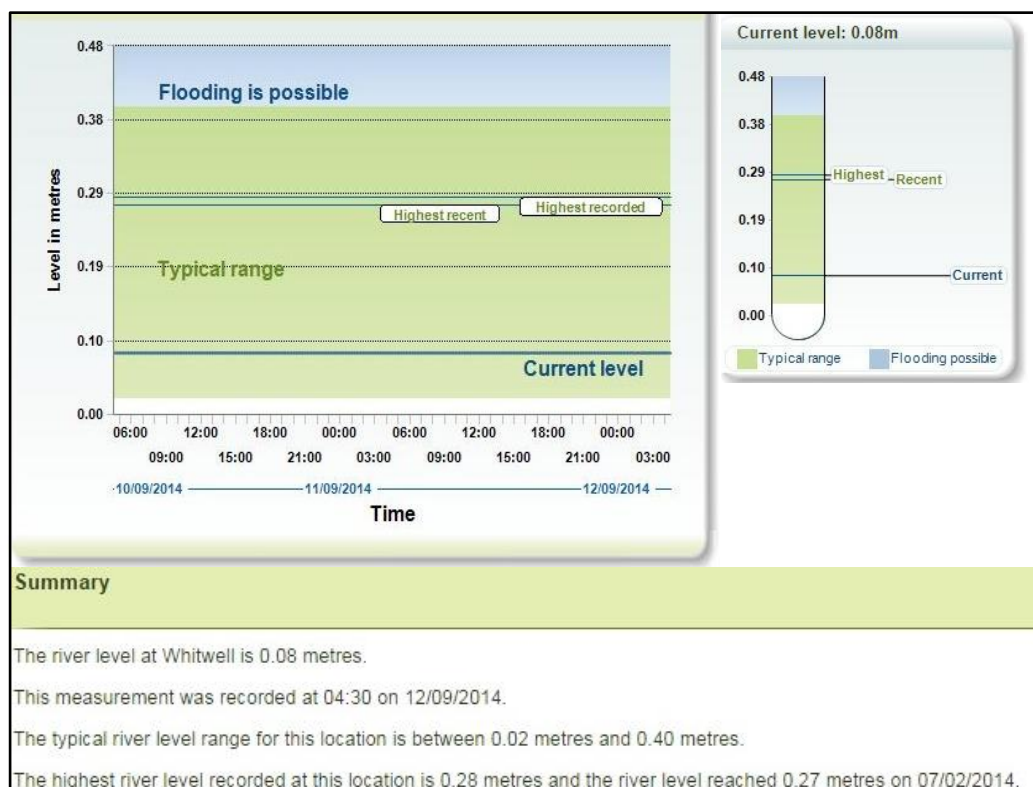
Figure 3a: Main River Levels

According to the Environment Agency website, and the river flow data for the gauging station in Whitwell shows the historic high level. This was incidentally recorded on 7 February 2014, at a level of 0.27m. The height at which flooding from the river is possible is set at approximately 0.40m. It is clear that the river had sufficient capacity so as not to impact on any surface runoff into the river; see Figure 3a below for extract from the website:
