# Hertfordshire County Council

## Flood Investigation Report

### Admirals Walk, Hoddesdon

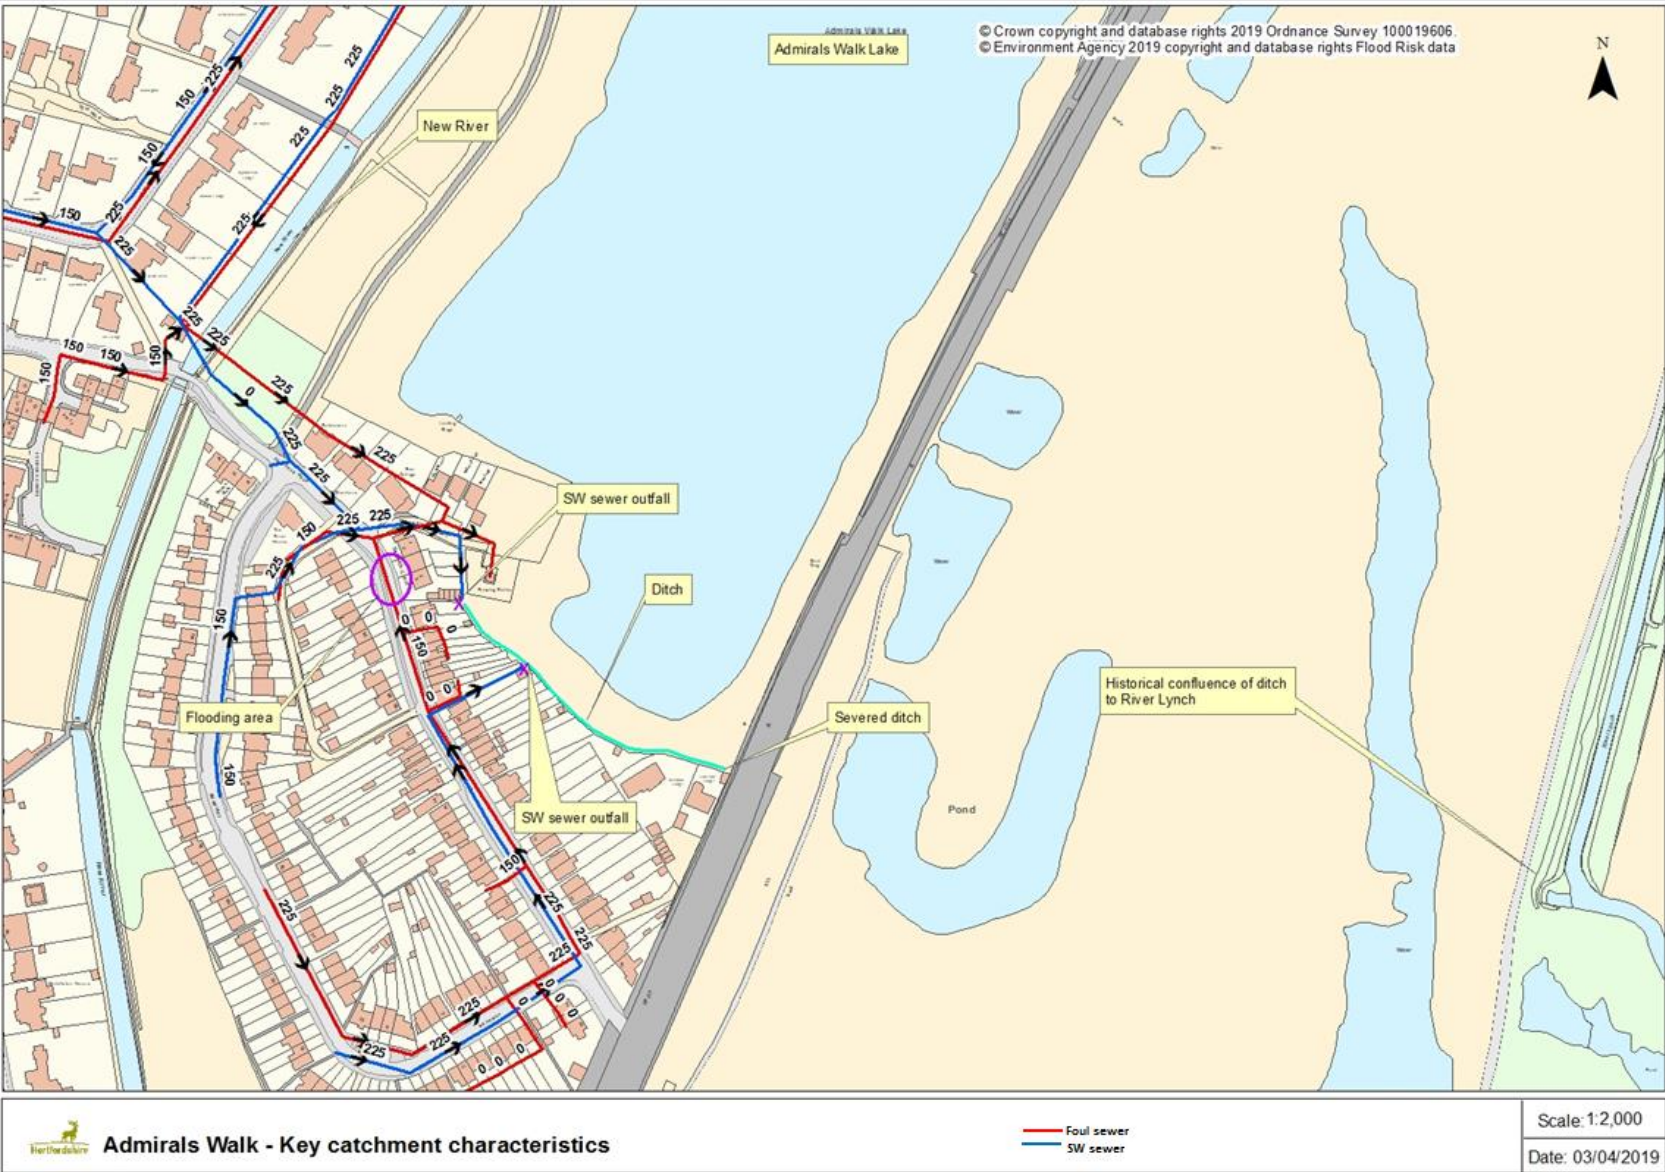
Figure 2: Significant catchment characteristics and details

Figure 2 maps the TWUL drainage network system within the investigation area. There are two discharge locations, one off Pallett Close and the other between properties off Admirals Walk (highway).

The majority of the surface water from the northern area of the catchment is draining to a 225 mm diameter pipe that discharges to the ditch that is adjacent to Admirals Walk Lake (see Figure 2 for outfall location).

The second surface water sewer outfall, located towards the middle of the ditch, drains the southern area of Admirals Walk (see Figure 2). Due to the high silt and water levels in the ditch, this outfall could not be seen and is presumed to be completely submerged (see Figure 13).

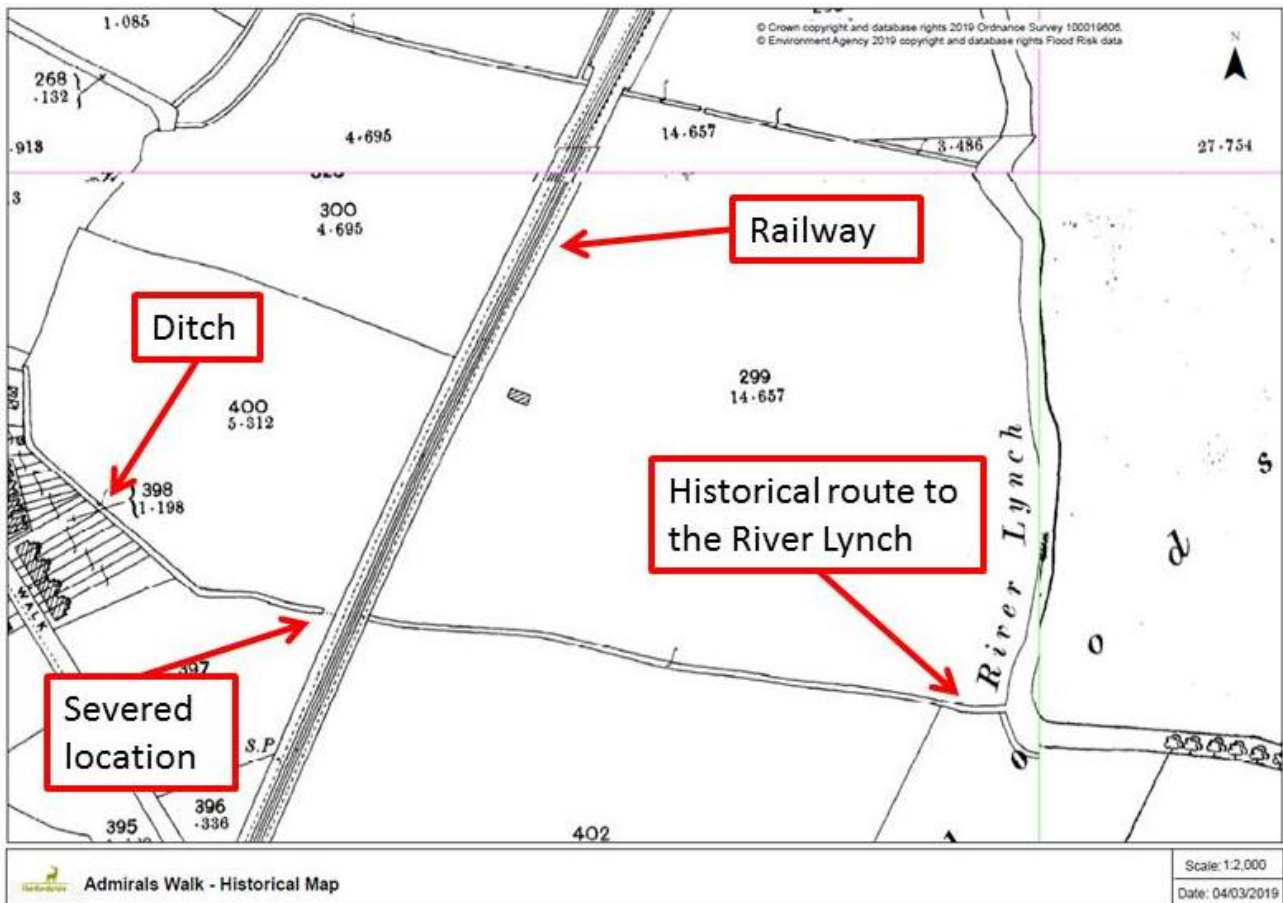
**Figure 4: Historical map of Admirals Walk site**

This investigation included studying historical maps that indicated that there may have been a connection to the River Lynch (see Figure 4), but this could not be found on site and there was no records on the Network Rail Asset Database.

There have been significant changes to the land either side of the railway since the production of the map at Figure 4, with extensive quarrying and subsequent restoration taking place in the catchment, which is likely to explain why the watercourse was severed at some point historically.

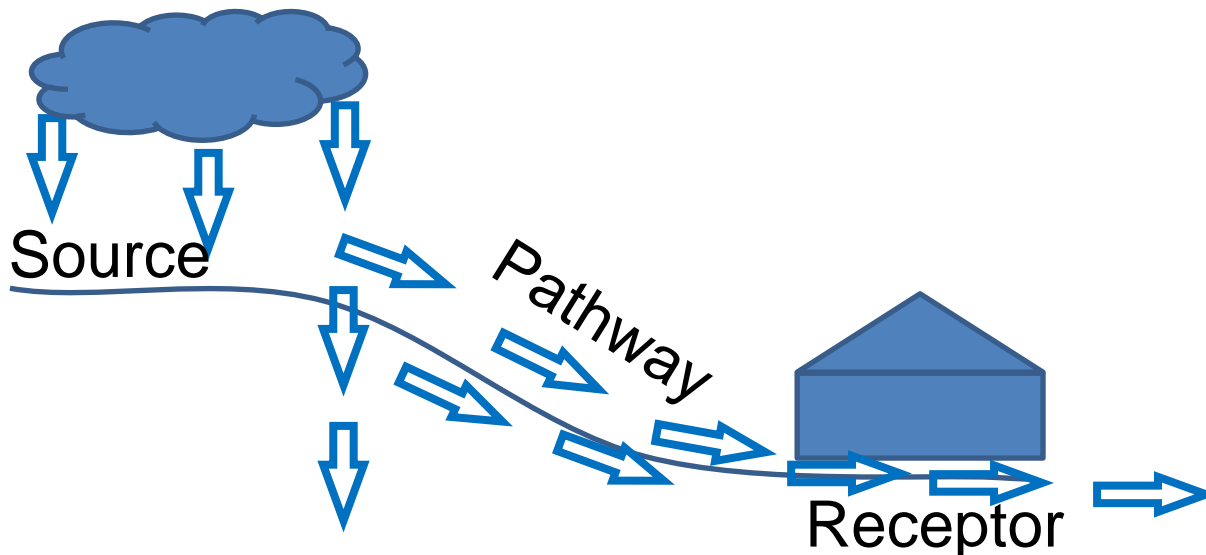
**Figure 5: Overall flooding system showing Sources Pathways and Receptors**

The investigation approach is based on the source pathway receptor conceptual model (represented in Figure 5) in order to better understand the flood risk and the flooding mechanism. The main purpose is to analyse and investigate all parts of the model (source, pathway and receptor), and identify which ones most contribute or are likely to cause flooding in Admirals Walk.

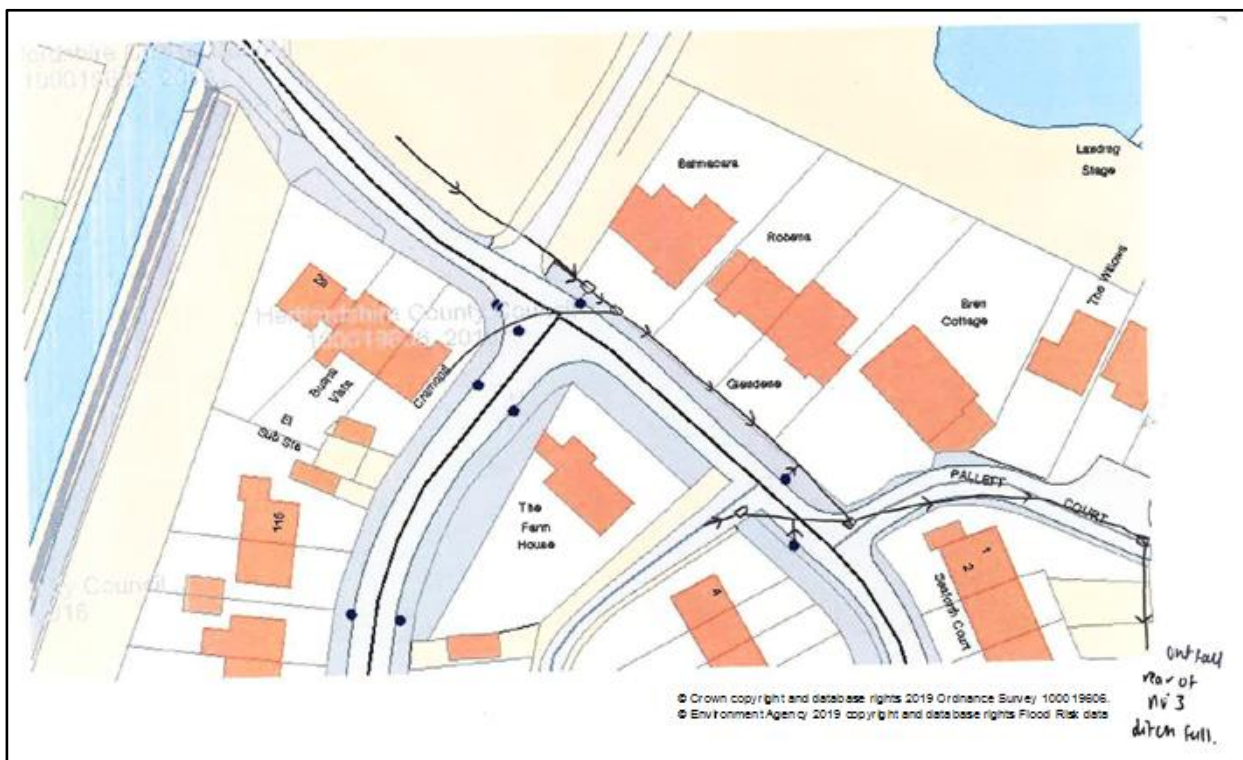
**Figure 6: Ringway highway drainage sketch**

A CCTV survey of the highway gully network was conducted by Ringway in 2016 to check the condition of the highway drainage network and ascertain if there were any blockages that were contributing to the flood experienced in the highway. The survey confirmed that all gullies in the vicinity had individual connections to the TWUL surface water sewer network and that the highway drainage network was free flowing with no obstructions or defects within the network. Figure 6 shows a connectivity sketch of the highway drainage network in the catchment.

It is noted that the existence of drop driveways to facilitate off street parking in Admirals Walk reduces the storage capacity available in the highway. In the same way it facilitates the surface water to flow towards the front of the properties.

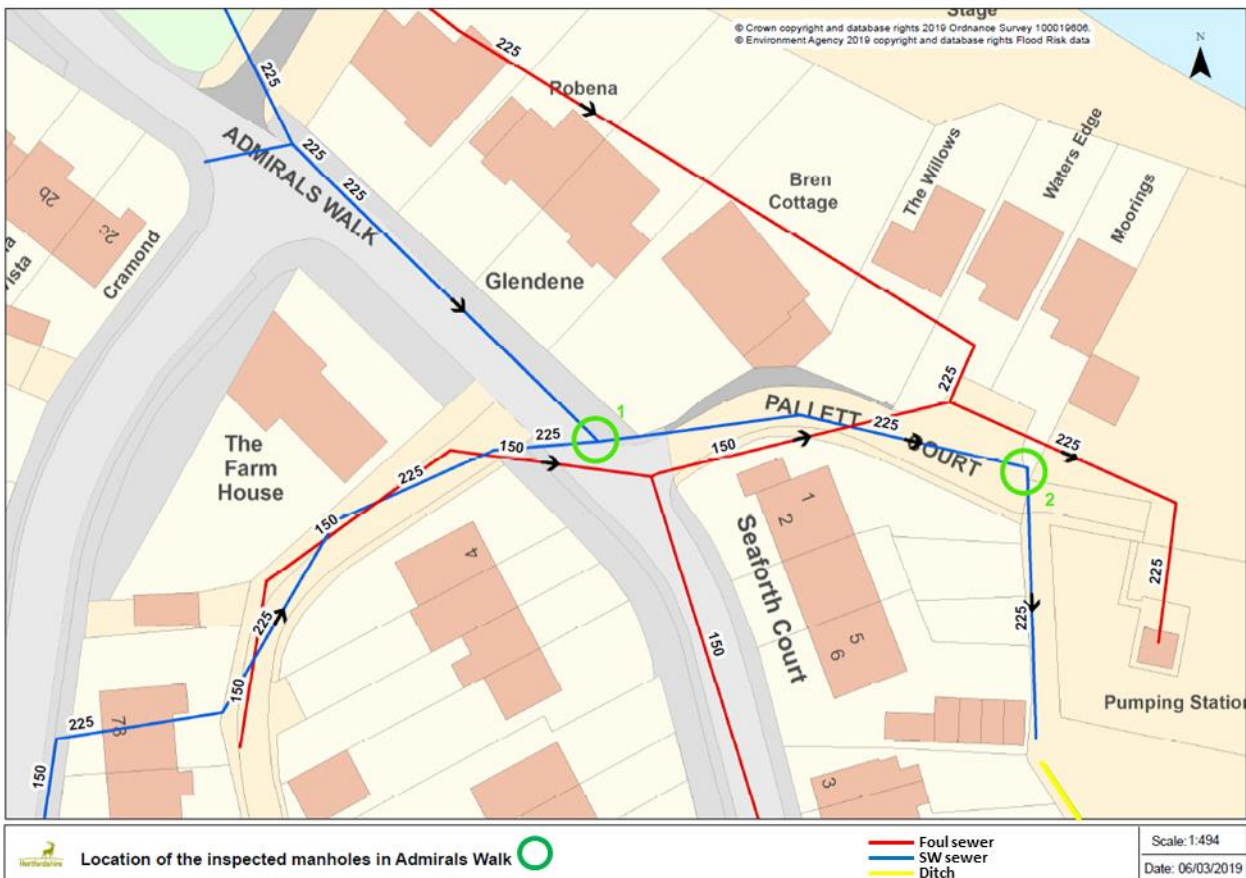
**Figure 7: Location of the inspected manholes in Admirals Walk**

Manhole covers on the surface water sewer network were lifted within Admirals Walk and Pallett Close to identify sources of water entering the network and to confirm connectivity (marked in Figure 7).

There is a manhole chamber at the junction of Admirals Walk and Pallett Court, which was not plotted on TWUL asset maps (marked as 1 on the map of Figure 7). It was found that there are two incoming pipes (identified as A and B in Figure 8) and one outgoing pipe (signalled as X) and the incoming pipes sizes are larger than the outgoing pipe.

In the second manhole chamber (marked as 2 on the map of Figure 7), an incoming pipe was found (identified as A in Figure 9) which is larger than the outgoing pipe (identified as X). The outfall pipe was also found to be much higher than the incoming, suggesting that this was done to allow the chamber to store water and/or sediment.

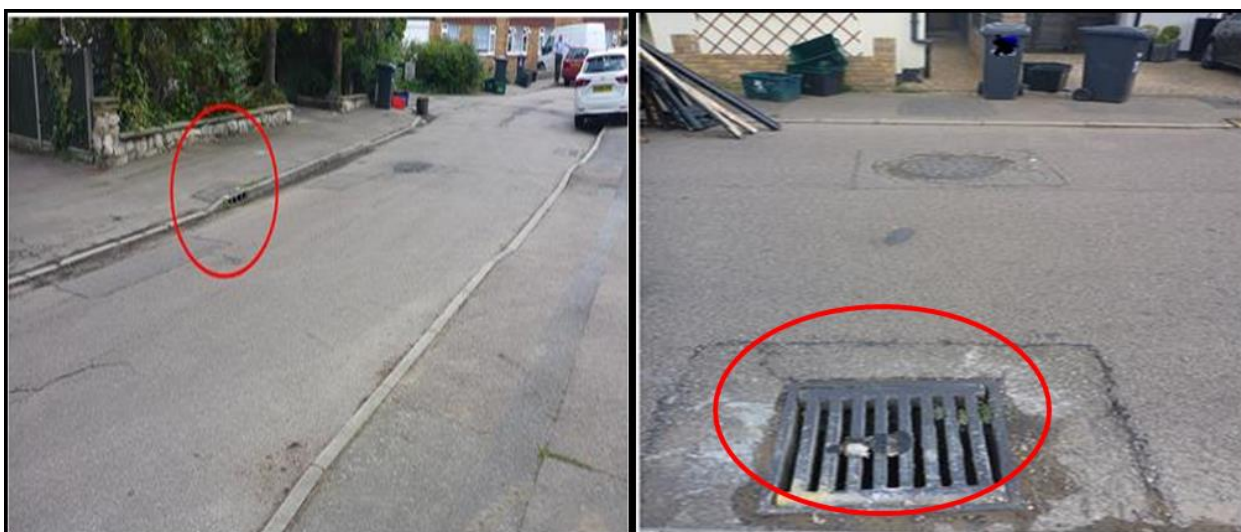
**Figure 10: Origin of flooding to the highway in Admirals Walk investigation area**

The changing of pipe sizes (smaller outfall pipes than the incoming) is uncommon in urban drainage and usually attributed to holding water back as a storage mechanism, as it can cause a throttling effect. However, in this catchment, the hydraulic constriction of the flow will impede the ability of water to drain from the highway as water will back up within the surface water pipe network, where the highway drainage discharges. This surcharging will occur in the lowest available point, which is the gully next to the junction that is located outside properties in Admirals Walk (see Figure 10). This gully is also located at a lower level compared with the surrounding gullies, which increases the risk of surcharging and flooding occurring.

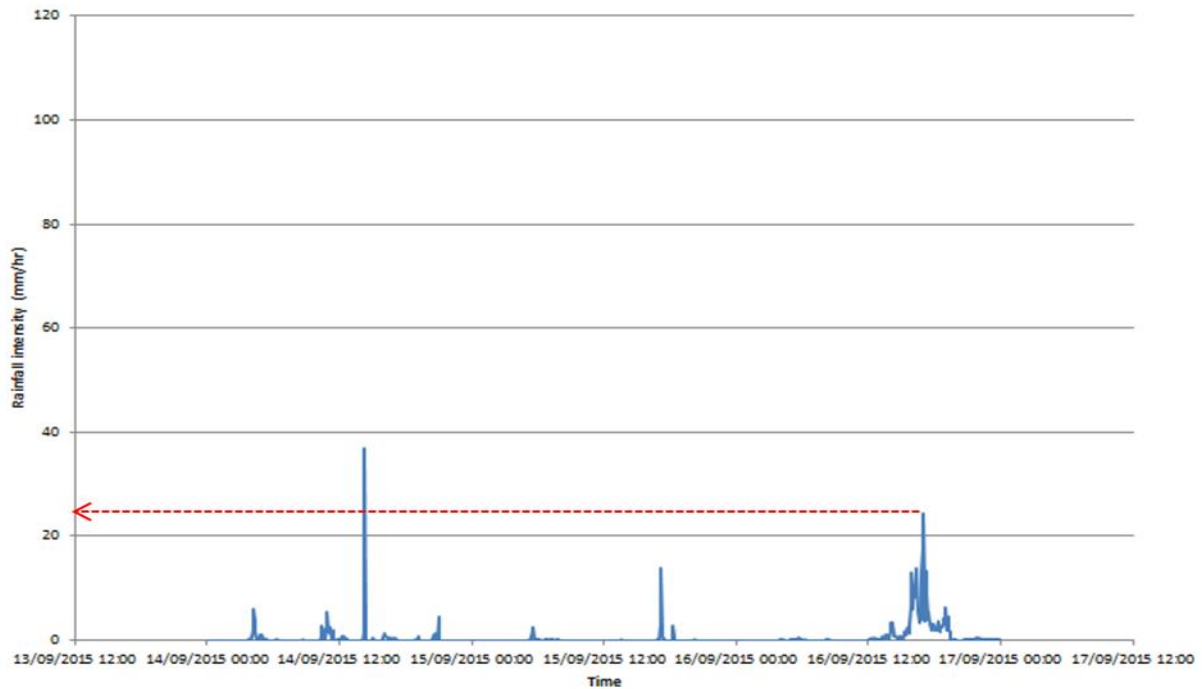
**Figure 20: Rainfall intensity graph for Admirals Walk on 16 September 2015**

The flood event occurred on 16 September 2015 registered a peak intensity of 24.25 mm/hr (see Figure 20). Rainfall can be further defined as a return period or likelihood of occurring in a given year, which is an industry standard of attempting to rank flood events. According to the Flood Estimation Handbook (FEH), this rainfall event corresponded to a return period of approximately 1 in 3 years which is considered a low return period. This can be further expressed as a percentage, known as Annual Exceedance Probability (AEP). For this flood event, it is likely that the probability of this rainfall occurring in a given year was approximately 33.3% (AEP). However, it is important to note that this is a statistical exercise to gauge the size of the flood event and does not mean that Admirals Walk will now not flood for another 3 years.

The rainfall intensity graph in Figure 20 related to the 16 September 2015 flooding shows that other rainfall peaks of a higher intensity were registered in the previous days, before the flood was reported on 16 September 2015. This might have influenced the condition of the surface water sewer which could be already partially surcharged and that the surrounding catchment may have been saturated.

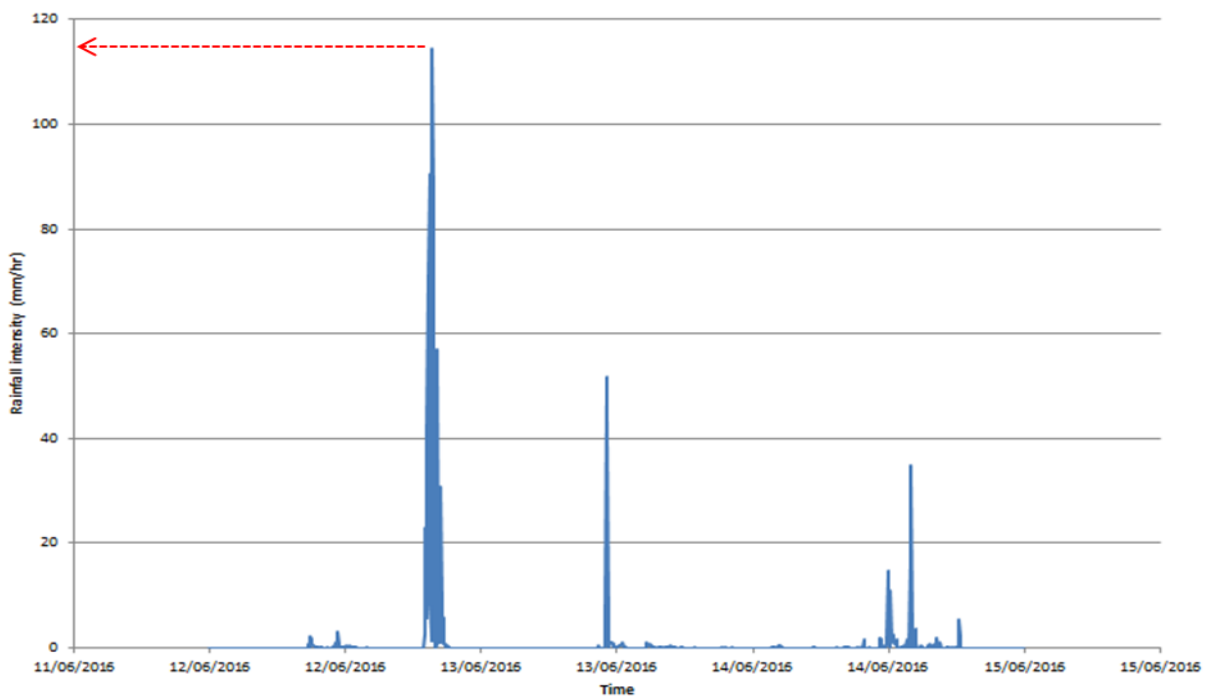
**Figure 21: Rainfall intensity graph for Admirals Walk on 12 June 2016**

Substantial rainfall on 12 June 2016 was recorded in Admirals Walk, with a peak intensity of 114 mm/hr (see Figure 21). This high intensity peak corresponded to an event with a return period of 1 in 50 years, which means that it is likely that the probability of this rainfall occurring in a given year is approximately 2% (AEP).

Such a high return period rainfall event was likely to have surcharged both highway drainage and surface water sewer network system. Considering that highway drainage generally will cater for anything between a 1 in 1 and 1 in 10 year rainfall event and the TWUL surface water sewers are generally designed to cater for the 1 in 30 years rainfall events (but historically might not be to this standard), the event that occurred on 12 June 2016 was likely to exceed the capacity of the drainage network leading to a flood.

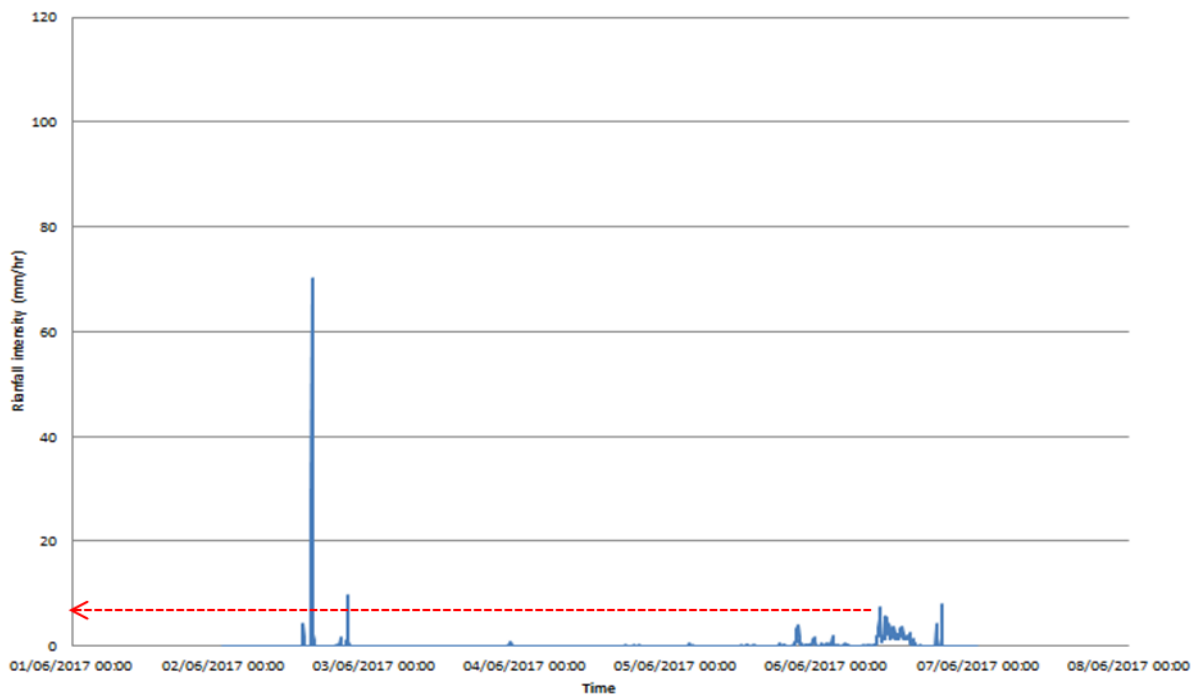
**Figure 22: Rainfall intensity graph for Admirals Walk on 6 June 2017**

On 6 June 2017 flooding was reported in Admirals Walk. The rainfall intensity graph showed a peak intensity of 8 mm/hr for this day (see Figure 22), which corresponded to a 1 year return period rainfall event meaning that the likelihood of occurring in any given year was 100% (AEP). The graph shows a high rainfall intensity peak some days before the flooding event, which might have contributed by saturating the catchment and filling the storage capacity of the ditch which would have led to surcharging of the surface water sewer. Like in the event of 16 September 2015, the previous rainfall event might have influenced the condition of the surface water sewer which could be already partially surcharged. Also it can be considered that the outfall discharge point was already submerged and therefore unable to accept any additional water flow.

The historical rainfall events show that the road flooded in different rainfall events and there was no specific trend identified. There is also evidence that the highest intensity rainfall events did not trigger the flooding events, but they are likely to have contributed to the flooding taking place later by taking up available storage downstream in the receiving ditch.
