BRAGBURY LANE

Bragbury End

Technical Assessment Report to support
Section 19 Flood Investigation

Project No: 0469
Date: October 2014

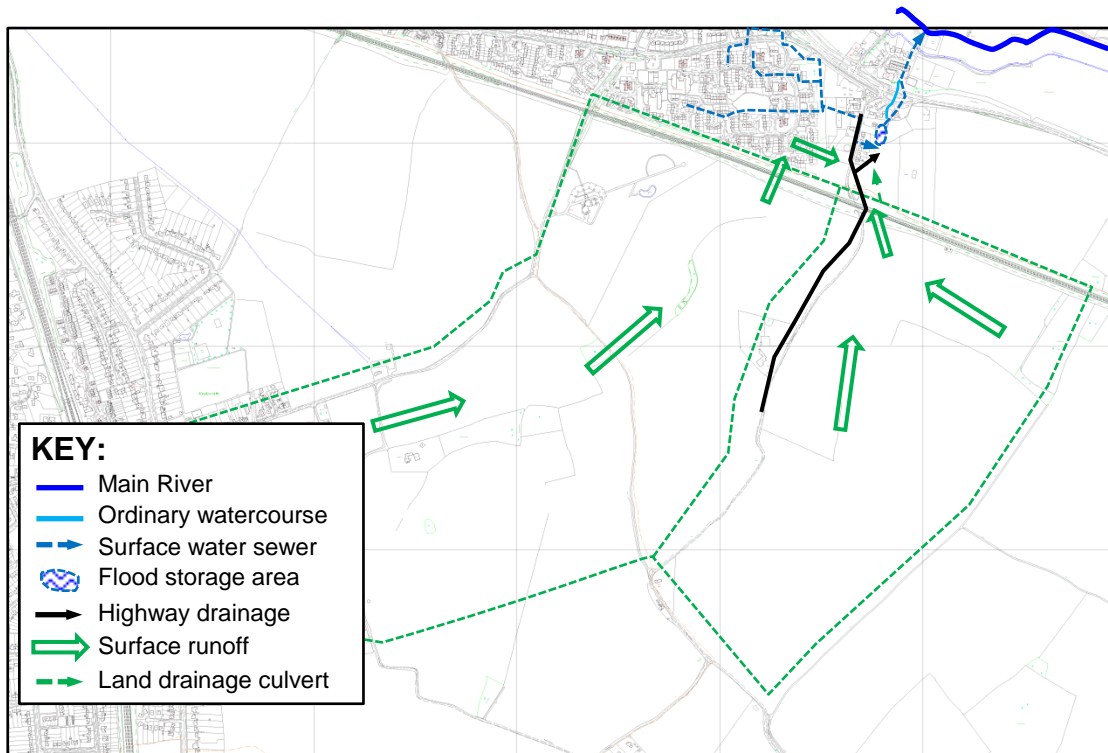
Figure 6.1: Surface Water Drainage Systems

There are three principal surface water drainage systems within the catchment consisting of both natural and man-made. Different bodies are responsible for each system. The different systems are shown in Figures 6.1 and 6.2 below.

- All of the highway drainage system should be cleaned and an internal CCTV inspection carried out to ascertain any structural defects and hydraulic restrictions.

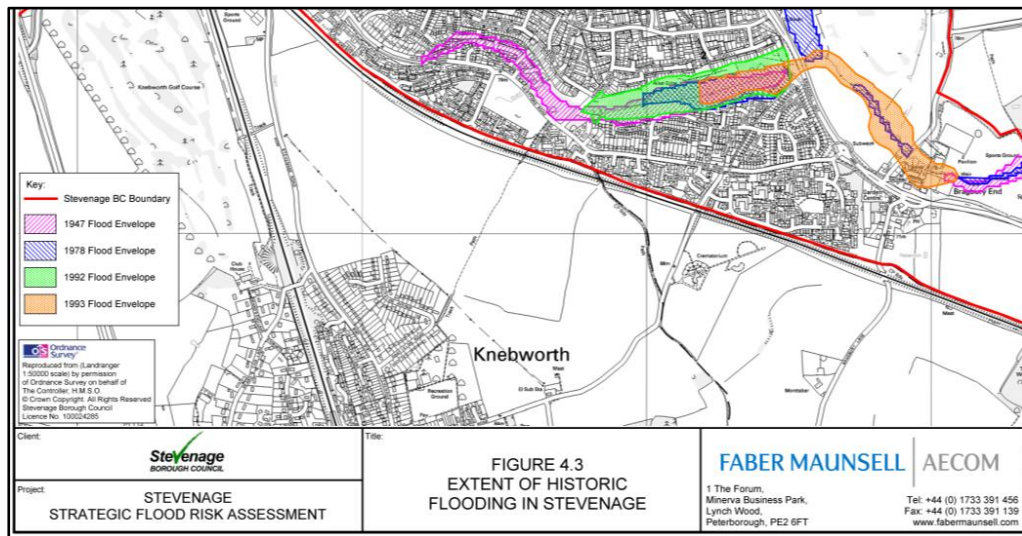
Figure 11: Stevenage Borough Council SFRA - Extract showing historical flooding

A Strategic Flood Risk Assessment was produced in 2008 for the administrative catchment of Stevenage Borough Council. The SFRA included a record of historic surface water flooding. There was no record in the SFRA of any flooding in Bragbury Lane as shown in Figure 11 below. Reference was made in the SFRA to a number of surface water flood storage reservoirs (ponds) within Stevenage, as shown in Figure 12 below, including one at Bragbury Lane. This is the drainage feature described above in earlier sections of this report and which is understood to be the responsibility of Thames Water.
