Hertfordshire County Council

Section 19 Flood Investigation Report

Chapel Lane, Long Marston

December 2018
Version 5

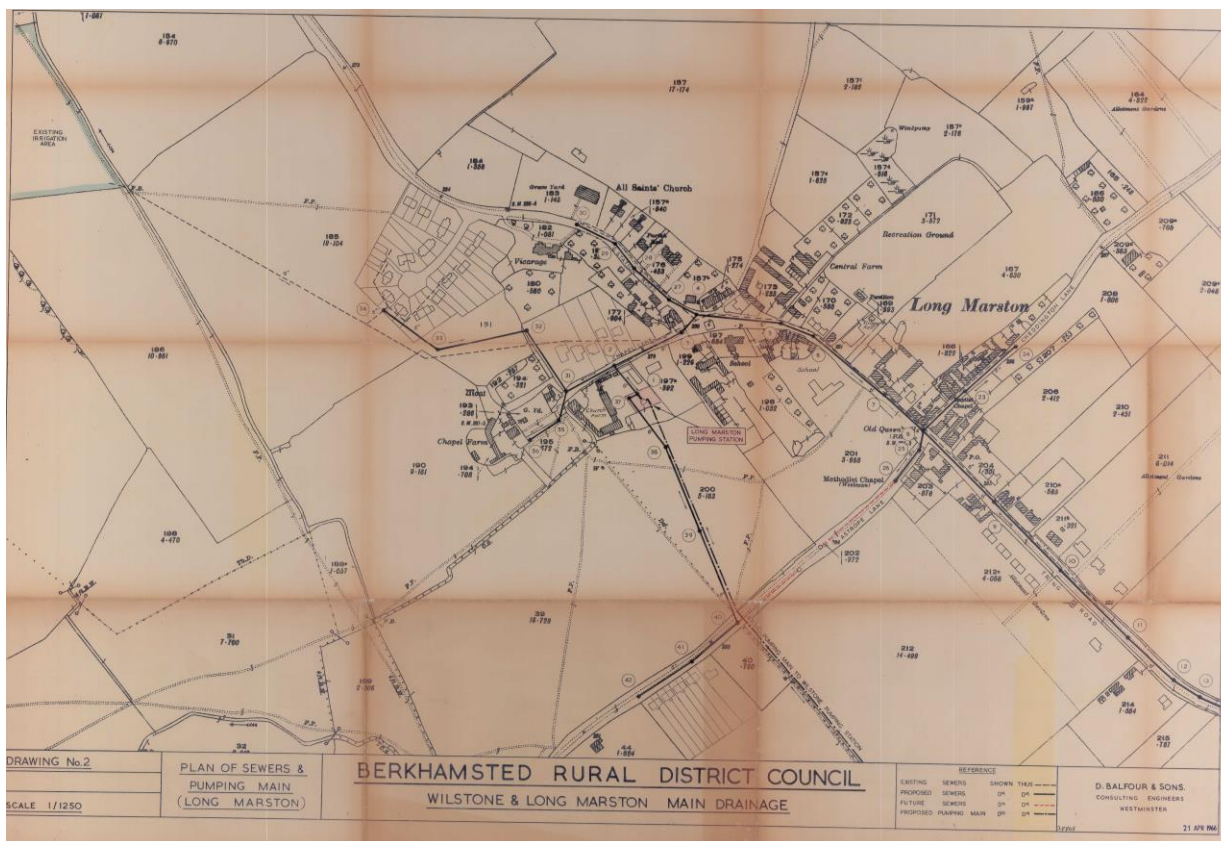
Figure 3 Plan of sewers for Long Marston (1966)

For the purpose of clarity, during the investigation and after all survey work was completed, a map was provided by the Ting Rural Parish Council that detailed a historic sewage pipe that was in the same location as the pipe of this investigation (See Figure 3). The investigation has concluded that the unknown pipe and the focus of this investigation is the historic sewer pipe. It will be referred to as the 'orphaned asset' throughout this report as the status of the pipe is unknown.

There was limited information available to the LLFA ahead of the investigation; however we now know that the orphaned asset was originally serving the community as a sewage waste pipe (see Figure 3). Table 1 will provide the chronological events completed as part of the investigation.

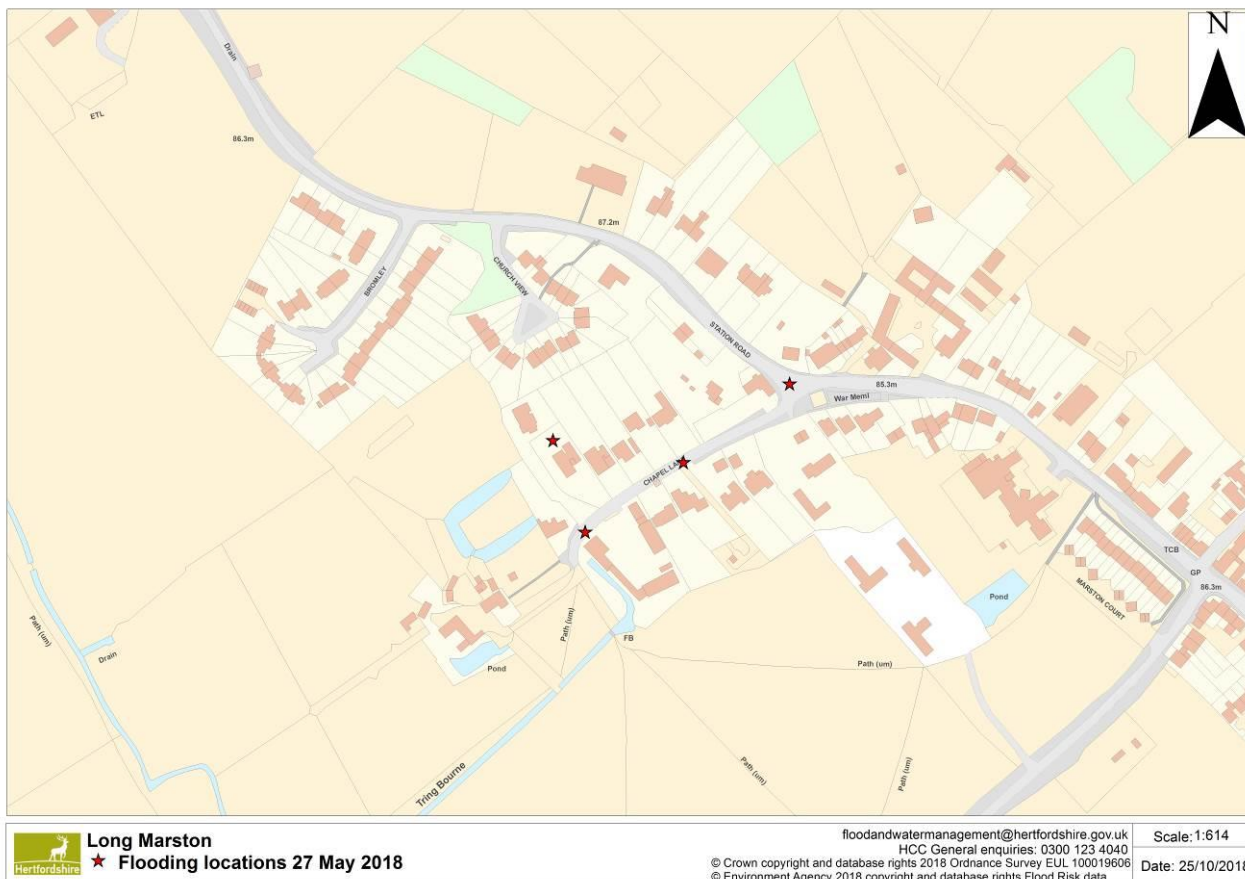
Figure 4 Long Marston map, with flood locations 27 May 2018

Long Marston is a rural village surrounded by agriculture and a network of watercourses and artificial waterbodies. The flood incident occurred in a small concentrated area in Long Marston, which includes Chapel Lane and Station Road (See Figure 4

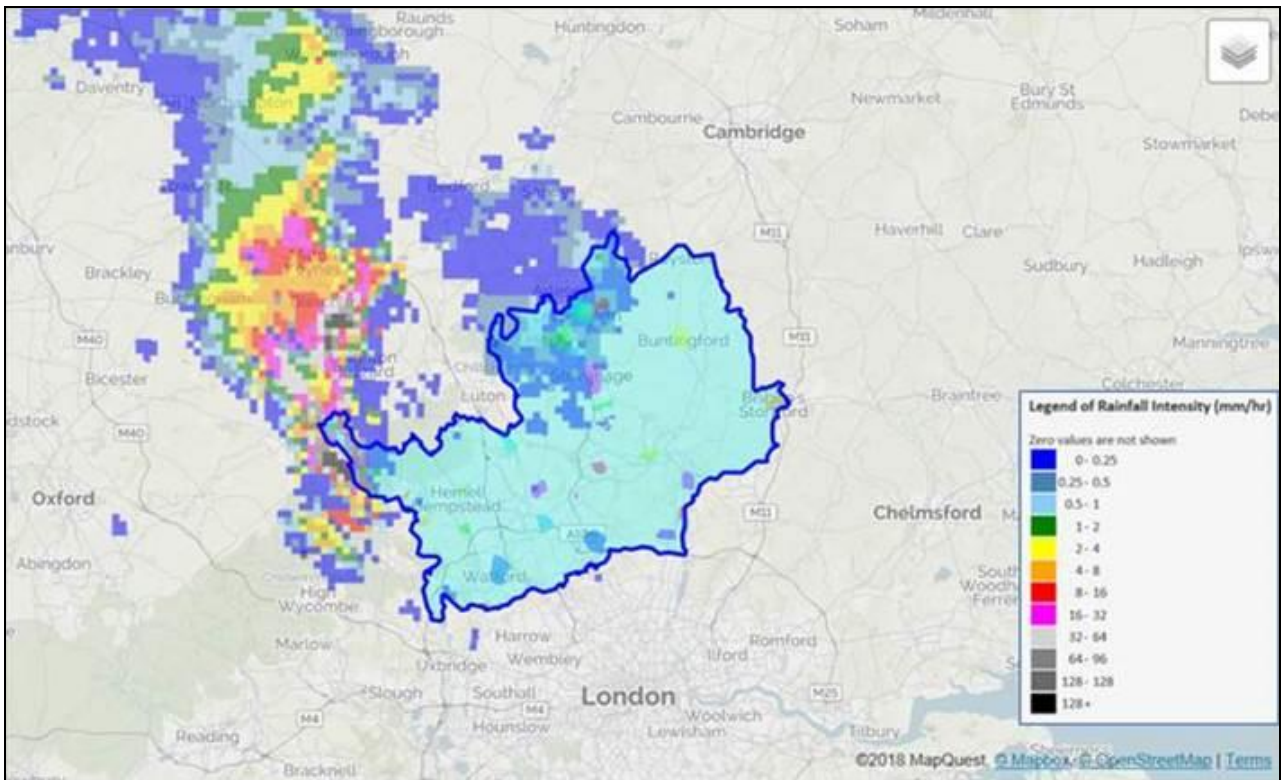
Figure 5 Rainfall Radar of rainfall 27 May 2018 with Hertfordshire shaded in light blue

A severe rainfall event occurred in the most western part of the county; which is where Long Marston is situated (see Figure 5). The LLFA has access to rainfall event data to be able to track weather patterns and provide flood estimation to flood events. The area of Long Marston (circled in red) experienced the highest intensity of the storm, which can be seen in Figure 6 and distinguished by the grey colours of the radar. The intensity of the storm was also great, which peaked at just over 75 mm/hour (3 inches/hour) (see Figure 7).

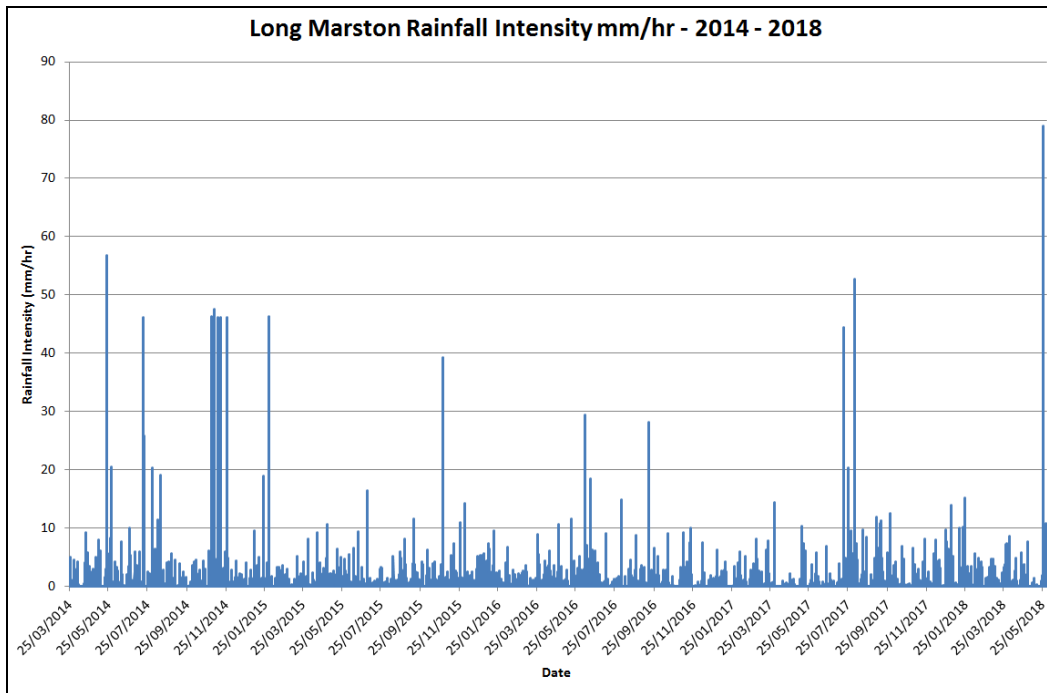
Figure 8 Long Marston Rainfall Intensity Data over a four year period

What can be concluded from both sets of information is that this was a considerable storm, with volumes of water that would have exceeded urban drainage networks in Long Marston. Over the past four years, this event was clearly the biggest in terms of intensity (see Figure 8 and the last bar on the chart), and considerably bigger than the rainfall event in February 2014 which triggered the winter flood event.

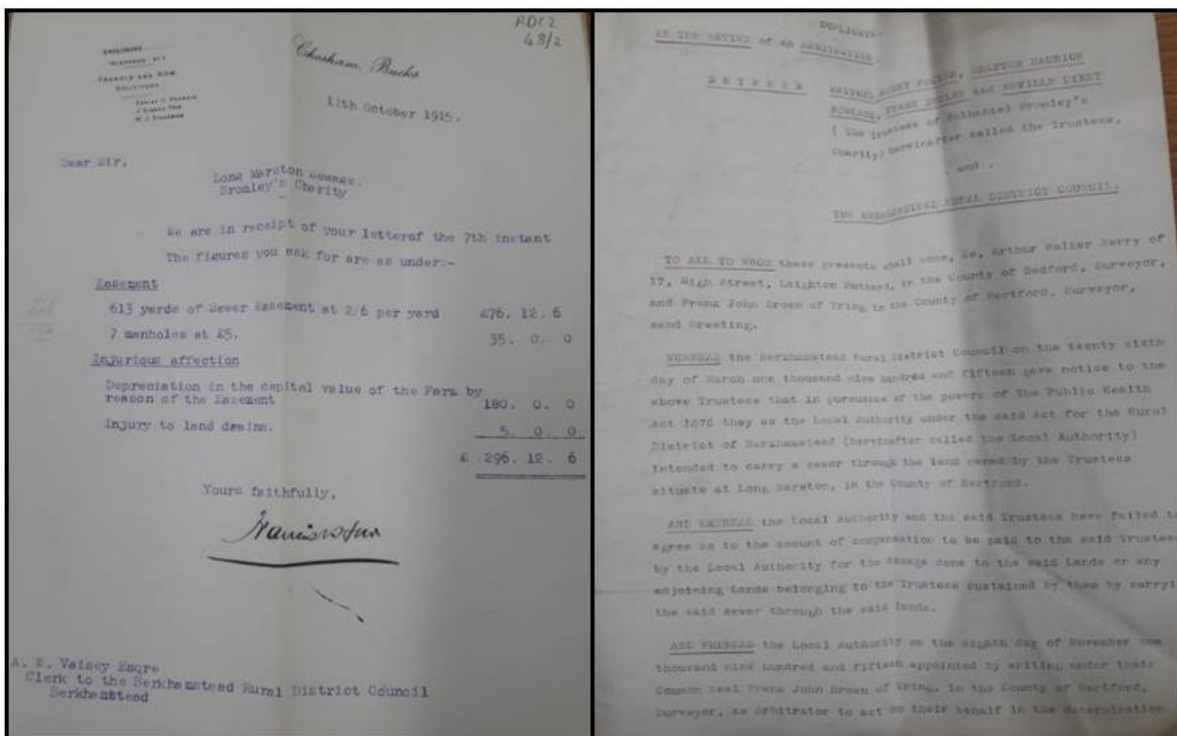
Figure 9 Correspondence circa 1915 held at the County Council

Initial desk studies tried to ascertain ownership of the orphaned asset to establish the upstream and downstream extents; however it was not plotted on the TWUL asset register and was not previously known to HCC. After searching through historic HCC records, only correspondence from the local land owners and the serving of Notice by Berkhamsted Rural District Council under the powers of the Public Health Act (1875) proposing to lay the sewer through their land could be found (see Figure 9).

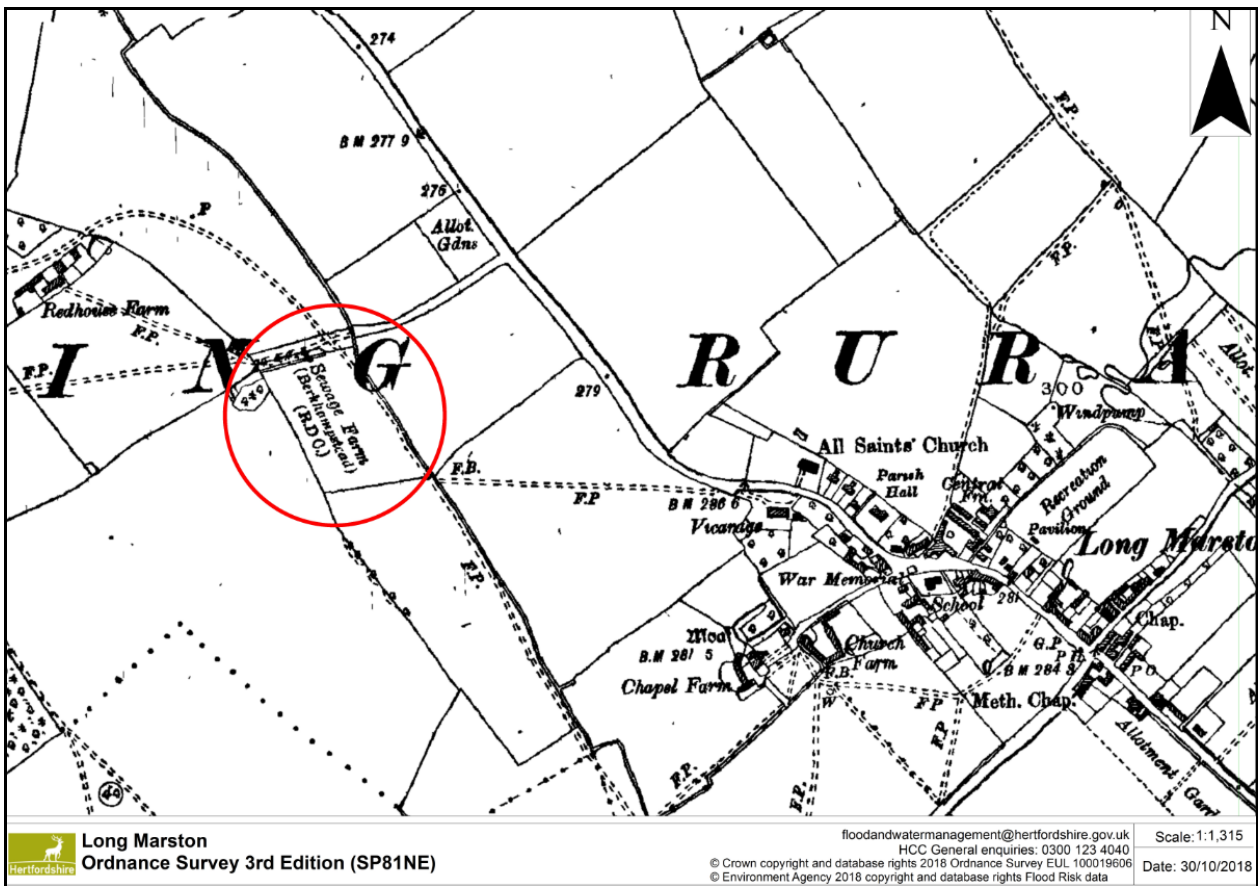
Figure 11 1926 OS map identifying Sewage Farm in red circle

After talking with other local residents, it was identified that the downstream route discharged to the Tring Bourne, as it used to carry sewage to a defined sewage farm. This is later confirmed and evidenced on the 3rd edition Ordnance Survey map (see Figure 11). This meant that the pipe crossed a farm to the north-west of the properties on Chapel Lane. After visiting the farm, a number of raised manholes were located (See Figure 12 for an example). It was noted during this site visit that the manholes were not benched in properly; allowing silt and debris able to easily enter the chamber and block flow through the orphaned asset (see Figure 13).

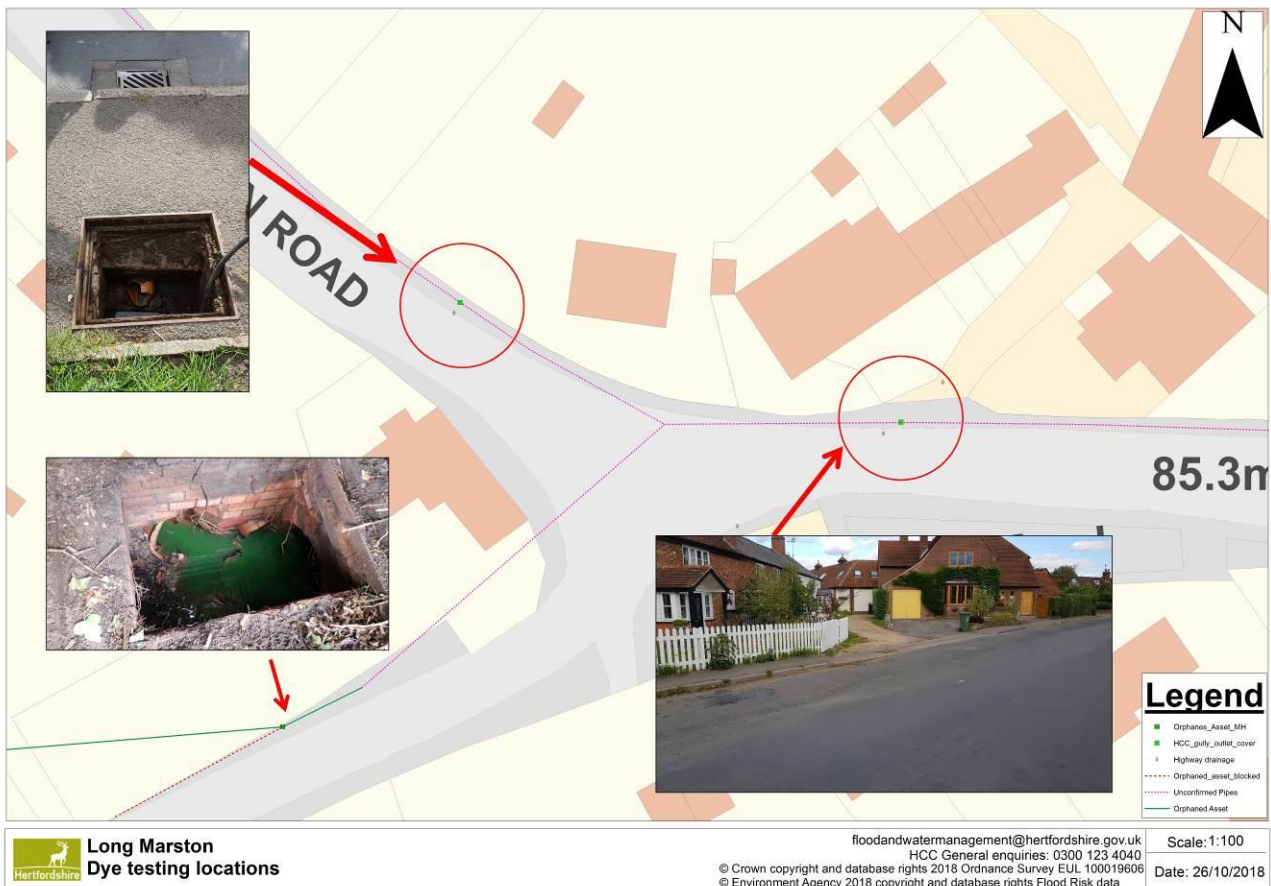
Figure 20 Dye testing locations

As the CCTV unit was unable to travel upstream of the manhole located on Chapel Lane, a dye test was performed in all drainage assets within Station Road to establish if any drained to the manhole chamber identified in Figure 16. This resulted in two roadside gullies being confirmed to drain into a separate pipe network that in some form is connected to the brick arch culvert (see Figure 20 for route and photographs). The dye test could not identify how the pipes were connected, so further investigations are still required.

Highway flooding has only been reported after heavier rainfall events and not on each rainfall occurrence. A site visit was conducted with the Highway Authority to discuss the findings of the dye test survey (see Figure 20). After walking the catchment, it was clear that further investigation would need to take place to ascertain the following:

- Ownership/maintenance responsibilities of the pipes draining the highway gully network on Station Road and how big the catchment is (as identified in Figure 20).
- The connectivity of these pipes under Station Road and how they connect to the brick culvert in Chapel Lane
