Hertfordshire County Council Flood Investigation Report Long Marston, Hertfordshire

Hertfordshire County Council Flood Investigation Report

Friday 24 October 2014
Revision 2 - Draft

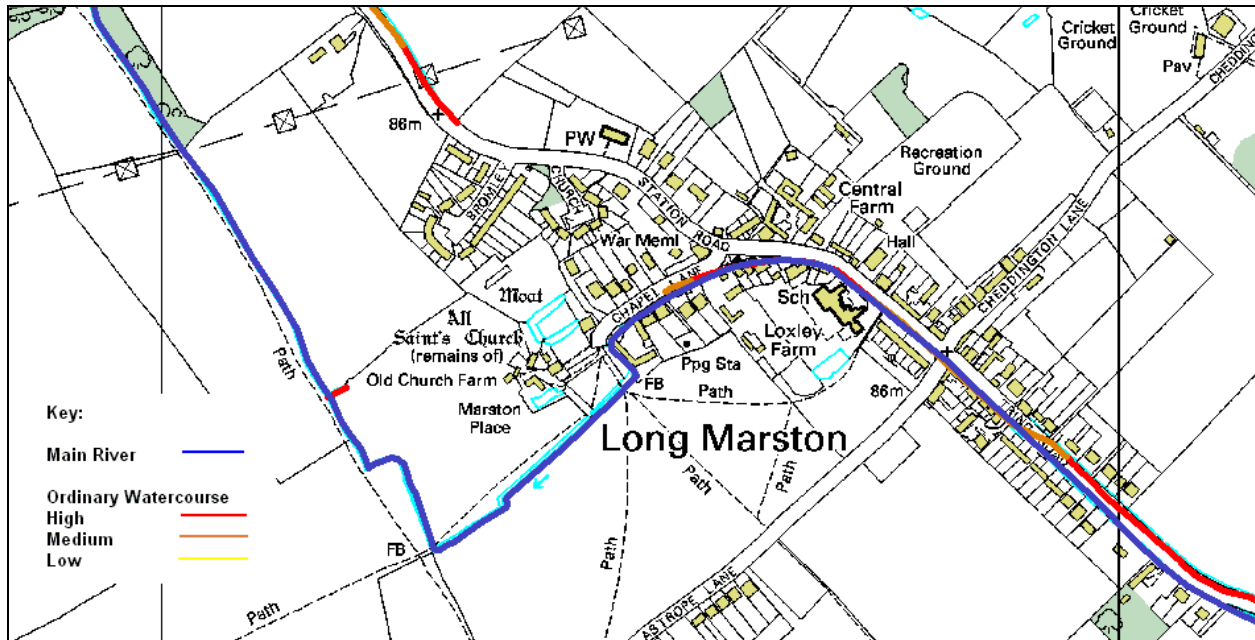
Figure 1.2 Watercourse network in Long Marston

The watercourses in the immediate vicinity of Long Marston are shown in Figure 1.2, below. The dark blue watercourse indicates a main river, the Tring Bourne and the red

The red watercourse to the north of Long Marston flows north and away from the village.
