Technical Assessment Report

to support Section 19 Flood Investigation

Long Marston, Hertfordshire

September 2014

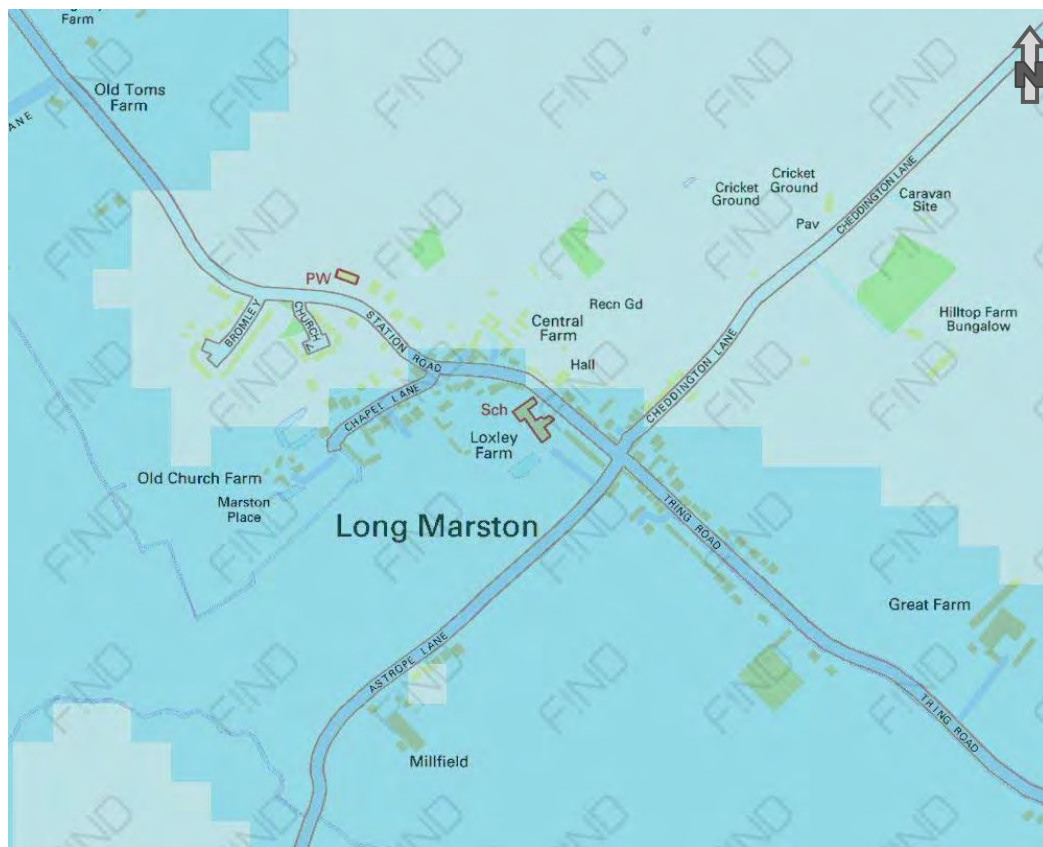
Figure 3.4: BGS Susceptibility to Groundwater Flooding map – Long Marston

Figure 3.4 shows a section of the groundwater flooding mapping centred on Long Marston. The lightest blue areas indicate that susceptibility to groundwater flooding is low. Darker blue areas are designated as being at moderate risk of being affected by groundwater flooding. It can be seen that areas south and west of Tring Road / Chapel Lane are shown as moderate while lands to the north are considered to be of low susceptibility to groundwater flooding.

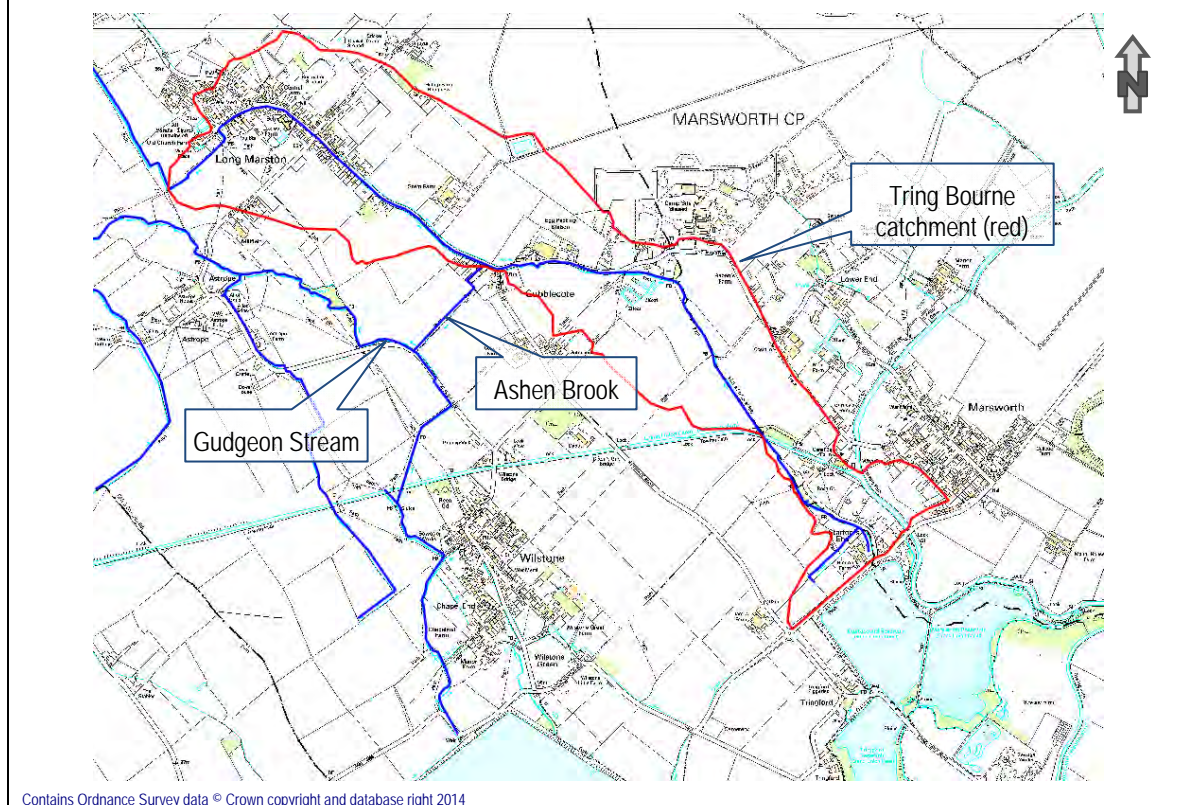
Figure 5.1: Tring Bourne Catchment

The following Figure 5.1 shows the delineated catchment of Tring Bourne that flows through Long Marston. The catchment is approximately 148 hectares (ha) in area; catchment topography ranges in elevation from 102m ODN (Ordnance Datum Newlyn) in the south east to 84m ODN towards the north west resulting in an average gradient along its length from source to Long Marston of 1 in 178 (c. 0.5%).

It is noted that a sluice arrangement at Gubblecote causes a proportion of the flow to be directed to the south west along Ashen Brook shown in the map below. During the site visit, the approximate proportion of flow split or method of operation of the sluice could not be determined. The opening size of the sluice gate relative to the channel indicates that more flow would be passed to Ashen Brook than onto Tring Bourne along Tring Road.

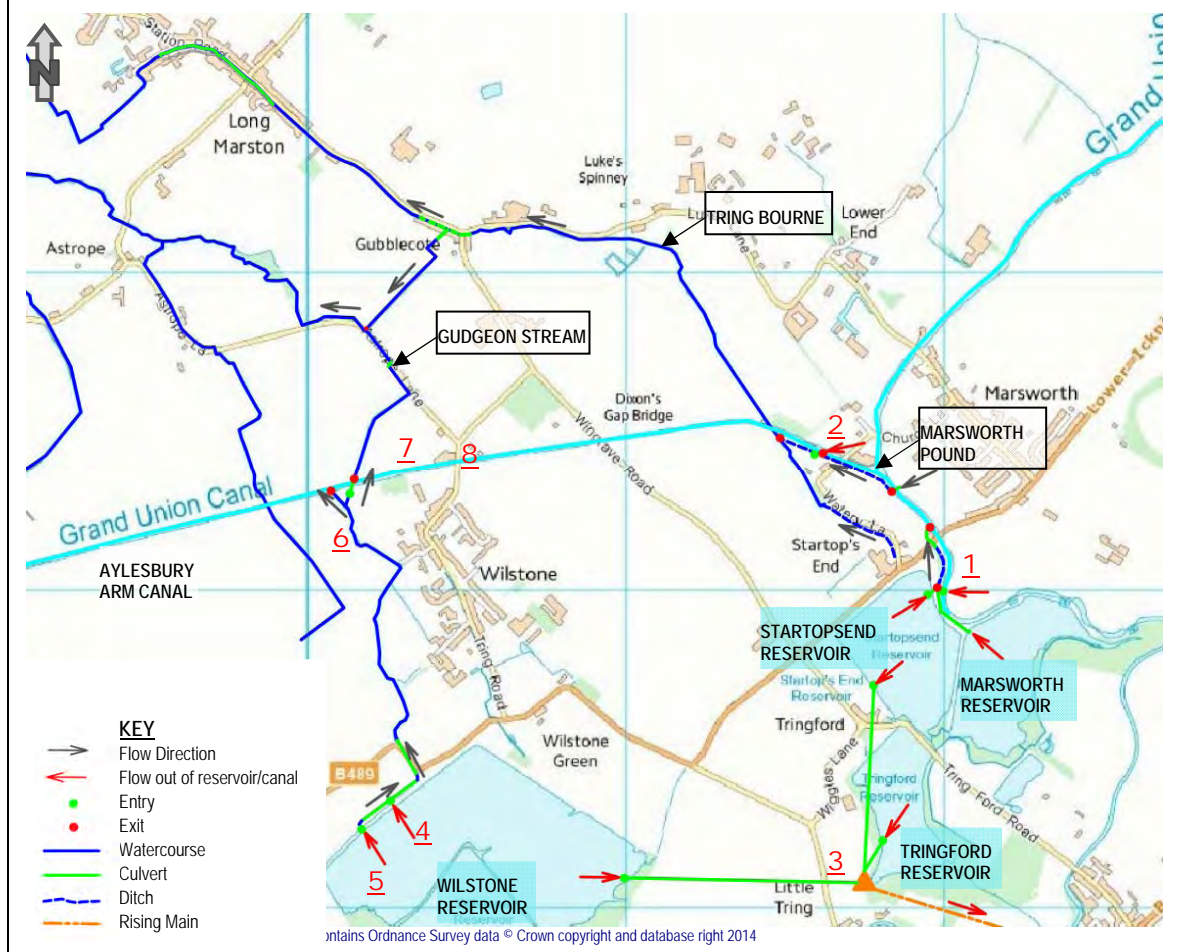
Figure 5.5: Tring Reservoirs Schematic

The operation of the canal and reservoir infrastructure is shown in Figure 5.5; numbers in **red bold** refer to features shown and annotated on this figure. The operational philosophy of the canals and reservoirs when the reservoirs have capacity is:

- A low lying section of canal bank was noted during the walkover survey, the location of which is shown on Figure 5.5 demarcated as location 7. This location corresponds with an area identified as a possible breach of the canal by residents' investigations. Any overspill from the canal in this section would flow into Gudgeon Stream; given the course of this watercourse, lack of channel capacity and localised flooding upstream of Long Marston, it is very unlikely that if a breach of the canal were to occur at this location that flood waters would affect Long Marston. Although this section of bank was visited 7 months after the flooding events of February 2014, there were no signs of past erosion such as ruts, channels or bare earth in the bank and surrounding field areas as would normally be expected from a high volume or high velocity flow caused by a large water body overtopping. There were signs of erosion of the bank forming a shallow pool in the bank but no signs that that top of bank was breached.

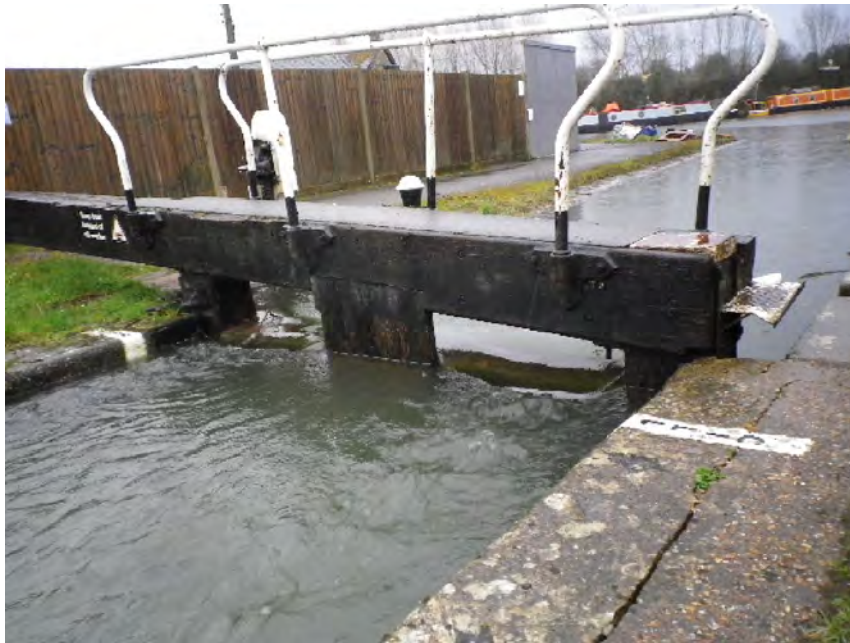
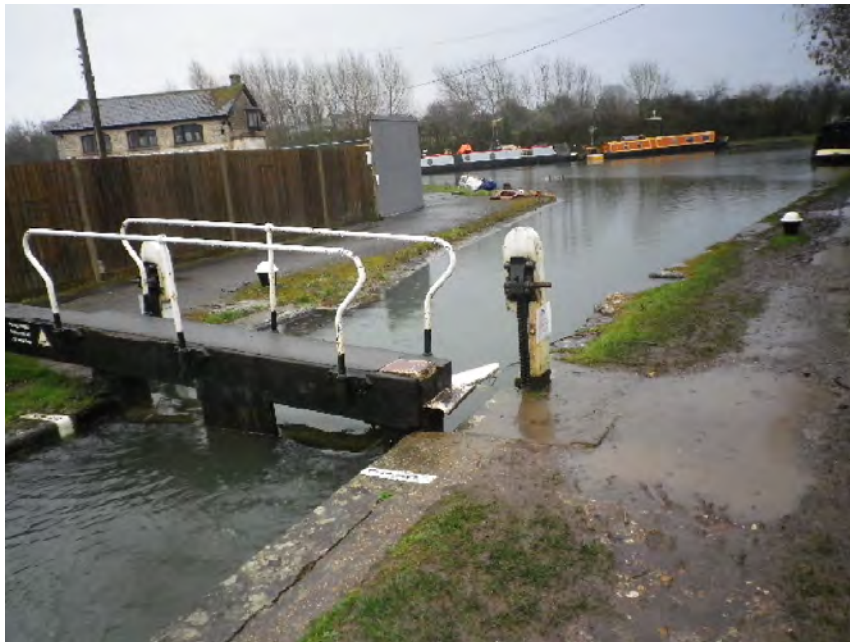
Photographs taken 18th Feb showing similar conditions in the Marsworth Pound as to that on 7th February and the top end of the Aylesbury Arm.

Marsworth Pound/ Aylesbury Arm Lock 1

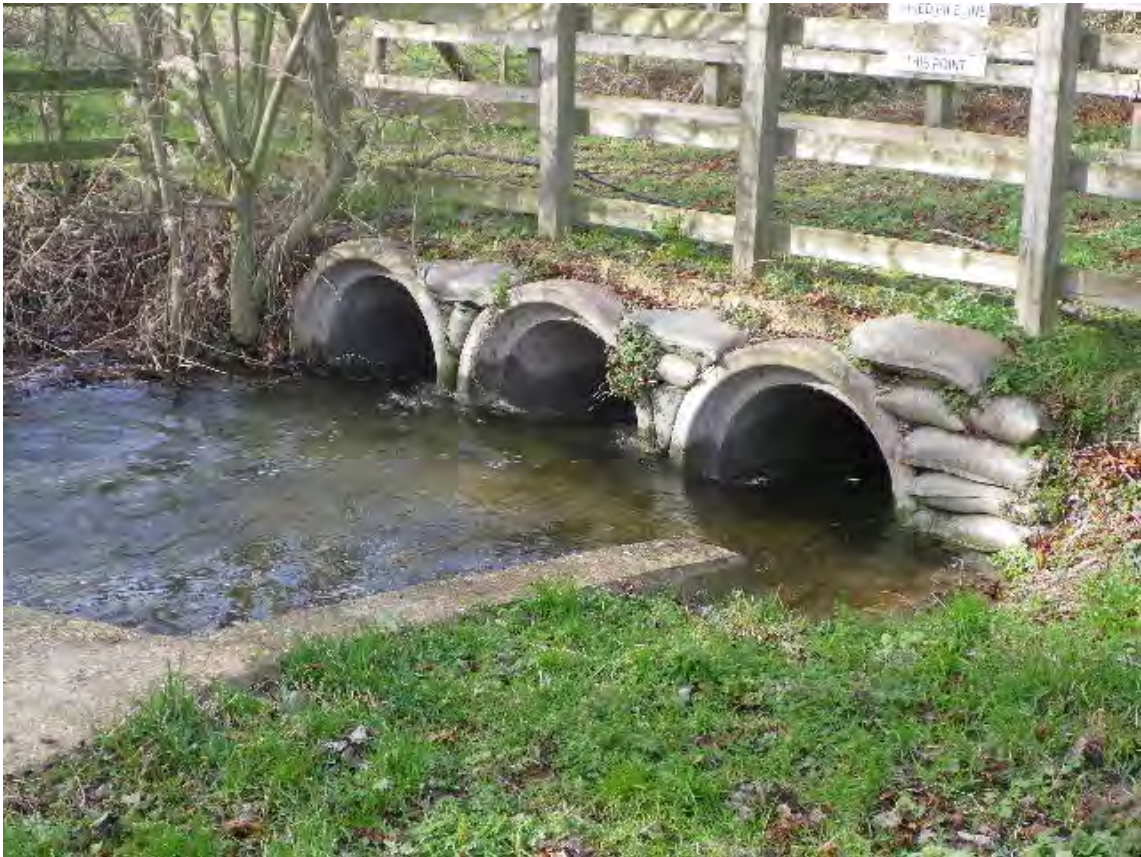
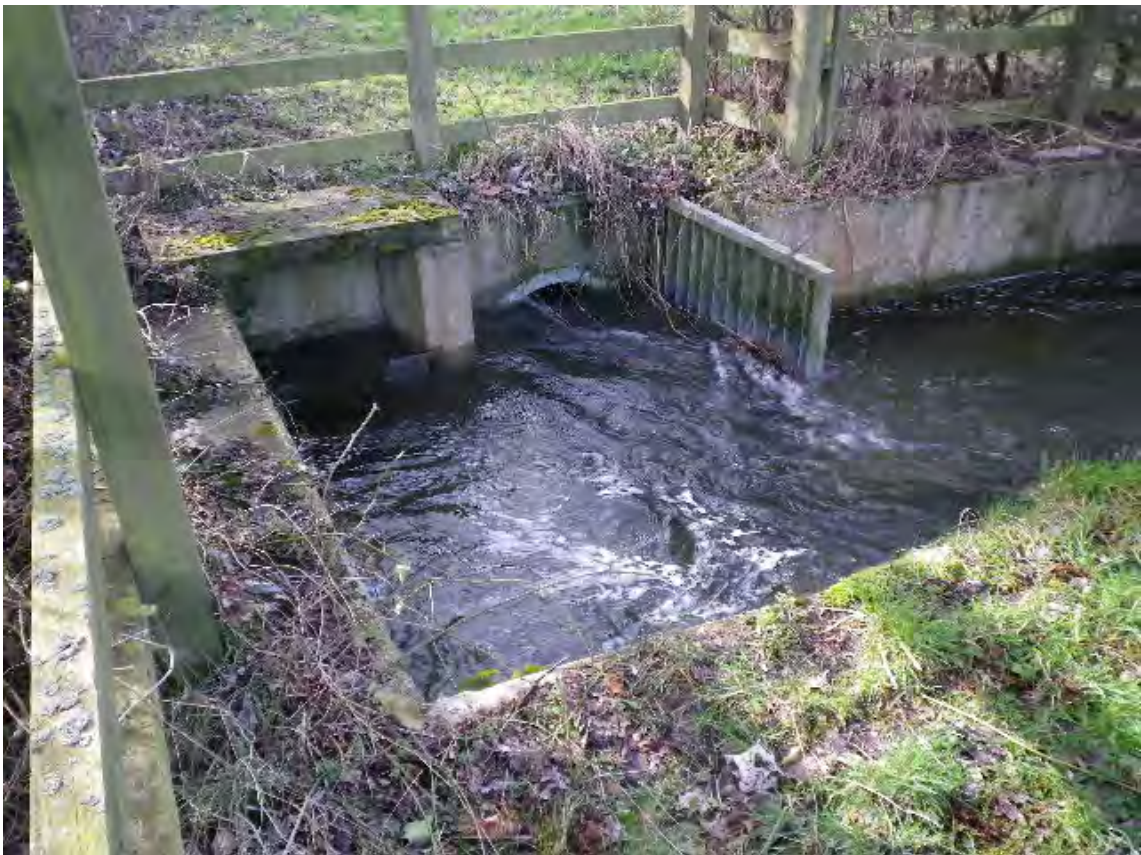
Wilstone Outflow 15/2/14

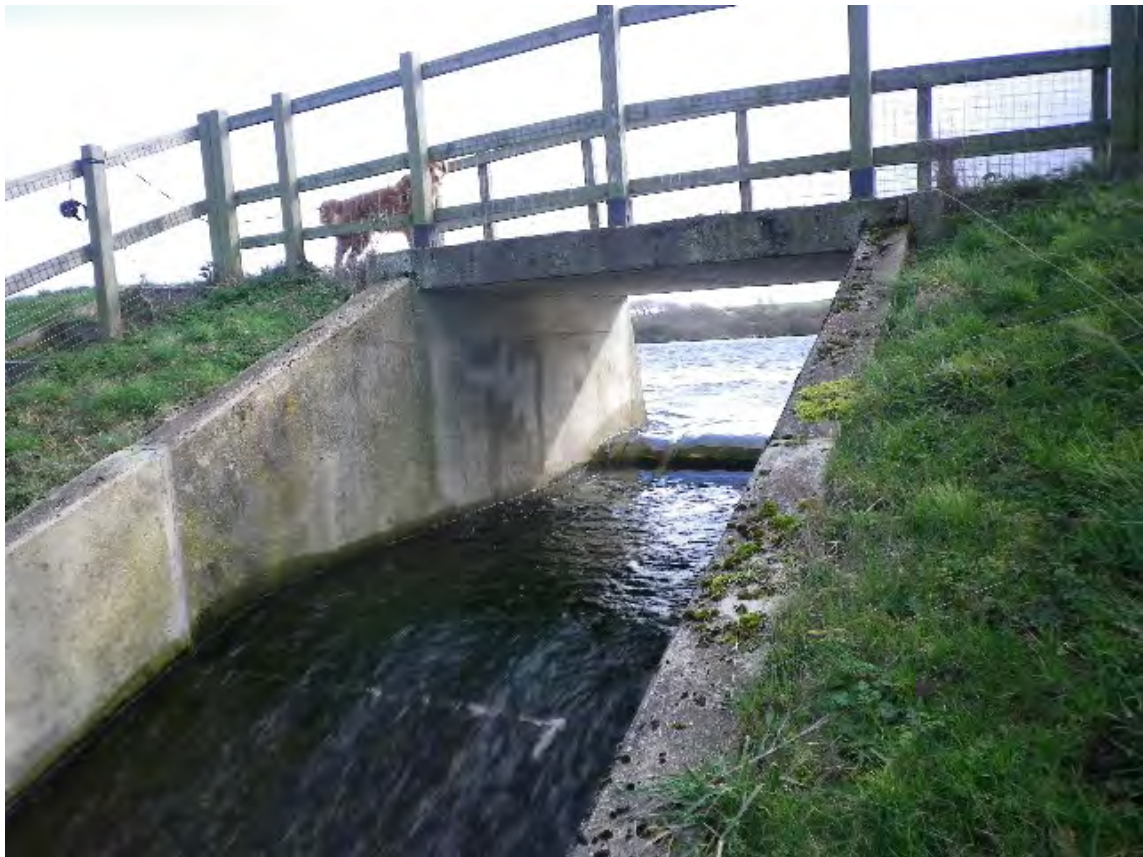
Wilstone Reservoir Overflow Weir 15/02/14

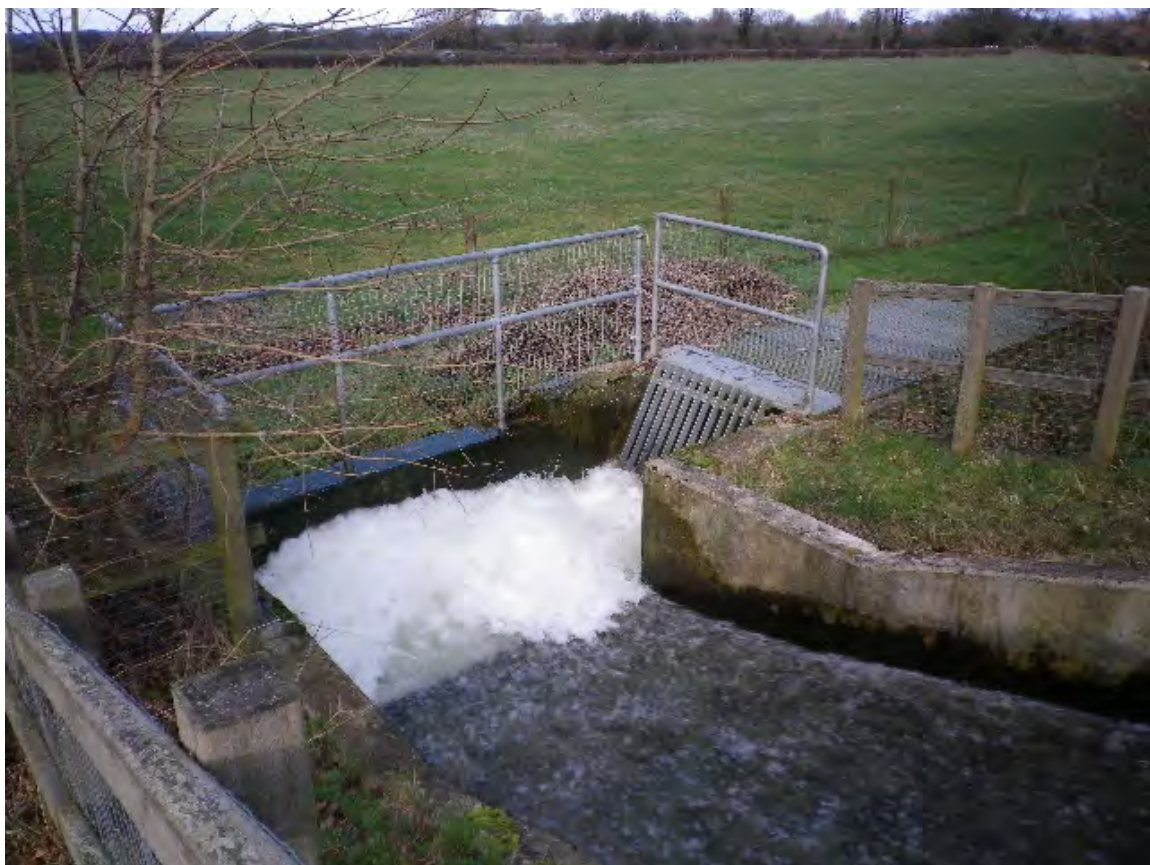
Wilstone Reservoir Overflow Weir Spillway 15/02/14
