Hertfordshire County Council Section 19 Flood Investigation Report Northwood

Hertfordshire County Council Northwood Flood Investigation Report

April 2018
Version 5

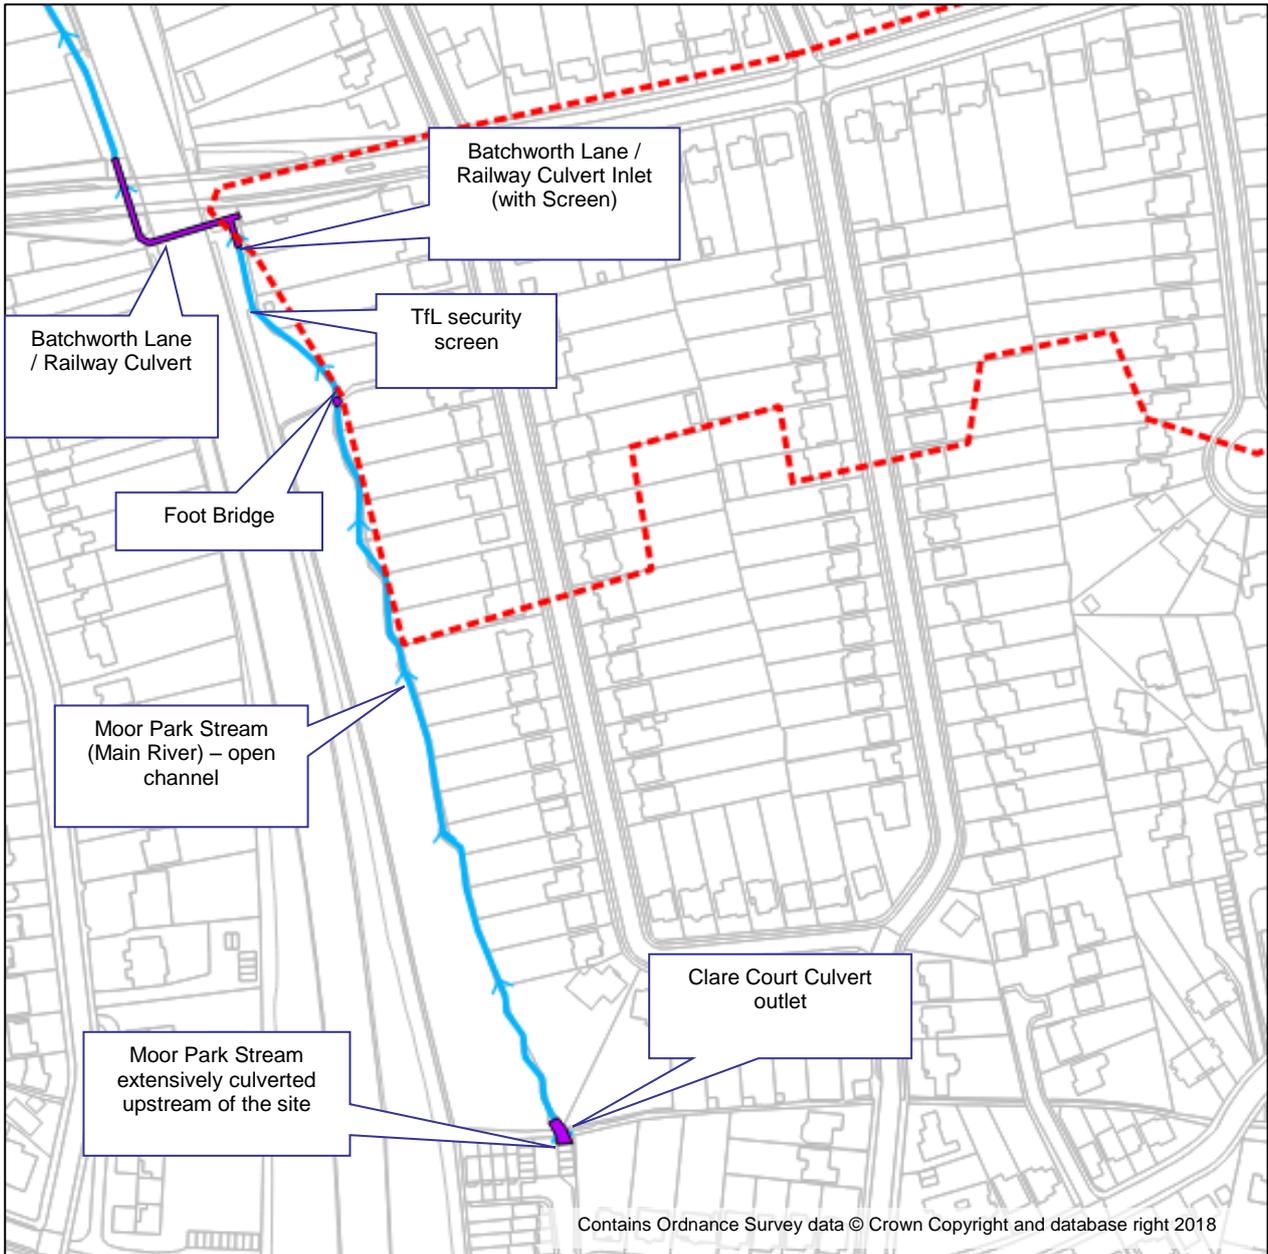
Figure 4: Watercourse map (identifying structures along the watercourse)

The Moor Park Stream flows from south to north along the western boundary of the catchment. This watercourse runs alongside the Metropolitan Tube Line and passes through a culvert beneath the rail line at the crossing with Batchworth Lane. The Moor Park Stream is culverted for a section within the bounds of the investigation area and takes the Moor Park Stream under Batchworth Lane. The Batchworth Lane culvert is managed by Transport for London (TfL) and is fitted with an inlet screen to prevent access and to stop large debris blocking the culvert.

In order to better understand the likely fluvial flood scenario experienced in June 2016, consideration has to be given to a number of structures which alter the flow of water. Inflows to, and outflows from the Moor Park Stream near the investigation area have potential to be significantly influenced by a number of culverts adjacent to the site, see Figure 4, these include:

- **Clare Court Culvert** - Moor Park Stream emerges from a 750mm diameter culvert of unknown length to the north of Clare Court, south east of St Mary's Avenue. This culvert essentially controls inflows to the open channel section adjacent to the investigation area. A continuous impermeable property boundary exists adjacent to (and upstream of) the culvert outlet, and as such any flows in the upper catchment in excess of the culvert capacity would be retained upstream. Local residents raised concerns to the LLFA that a broken pipe, between Eastbury Road and the Claire Court Culvert, may have been the cause of flooding to gardens near the Claire Court Culvert and subsequently to gardens in St Marys Avenue.

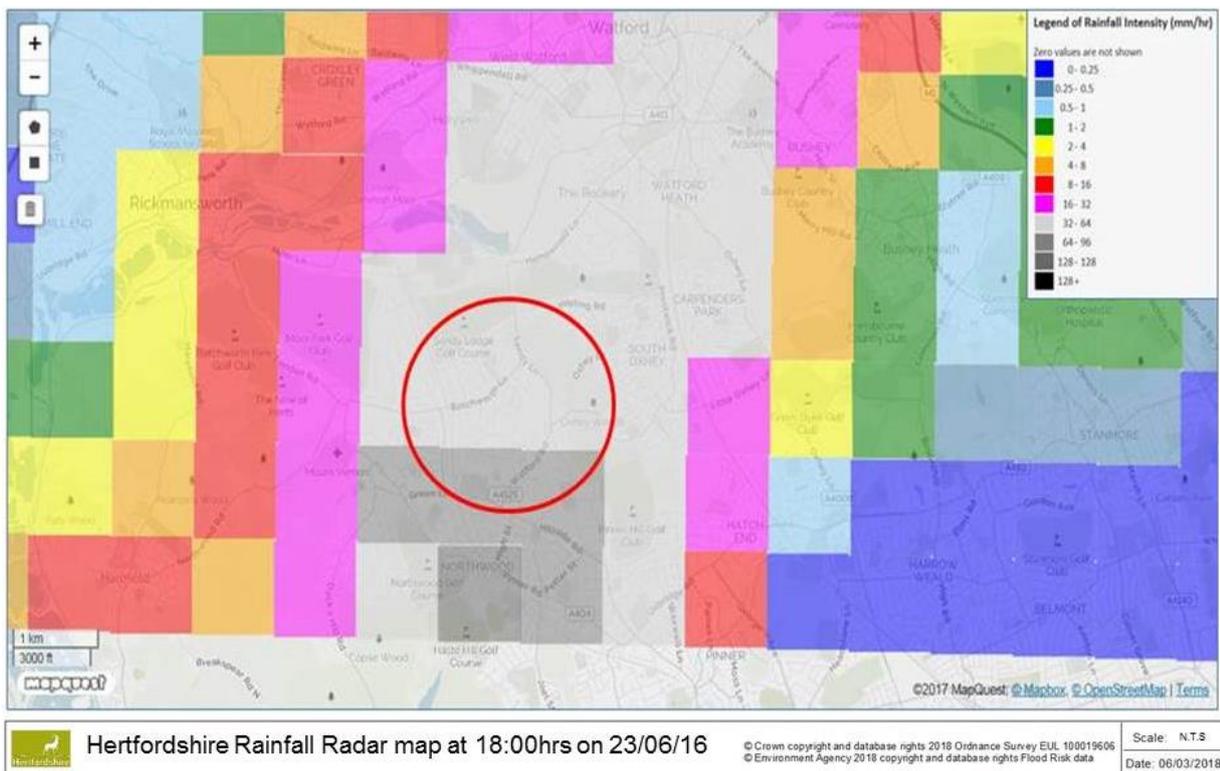
Figure 6: Hertfordshire Rainfall Radar map at 18:00hrs on 23/06/16

The storm tracked north-easterly across the south east of England. It was raining across most of Hertfordshire at the time of the flooding; however as can be seen from the rainfall radar in Figure 6, the areas of most intense rainfall (grey areas) were localised and moving along a narrow band within the storm. The red circle shows the approximate location of Northwood.

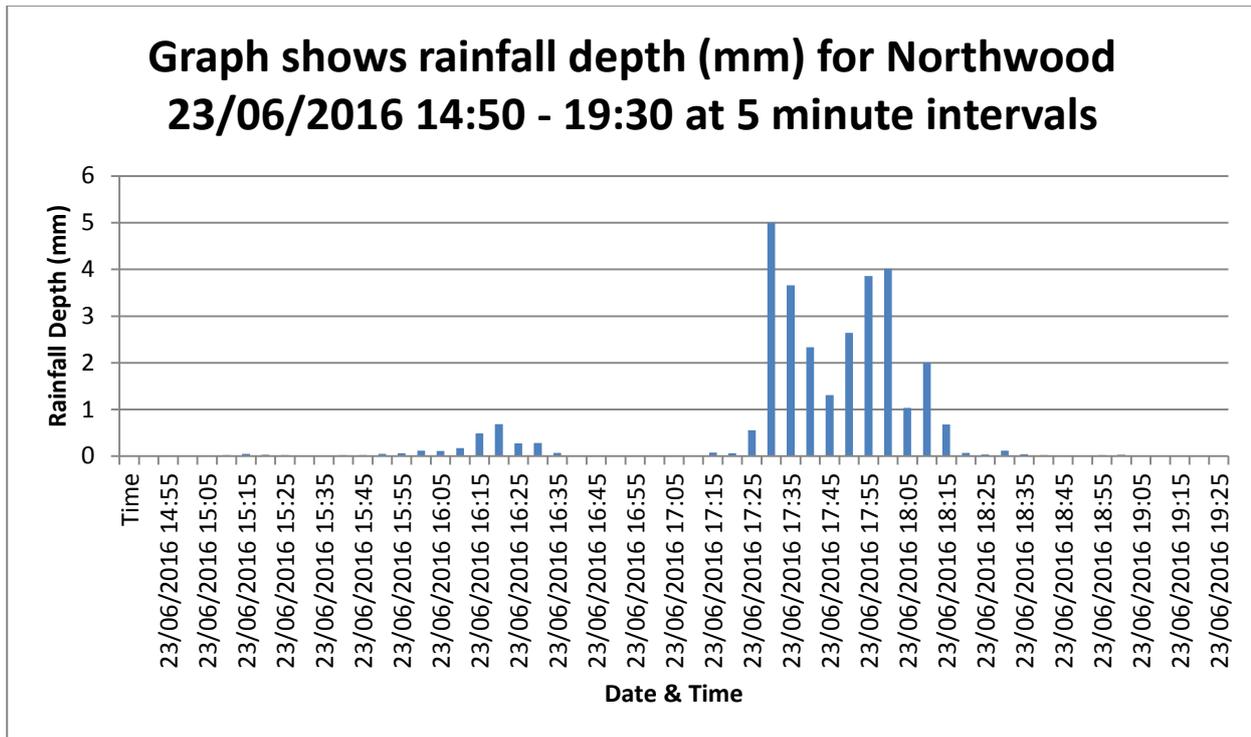
Figure 7: Rainfall depth graph for 23 June 2016

The data, in combination, tends to indicate that the most extreme rainfall experienced was in a relatively confined area in the vicinity of the site. Rainfall was heaviest between 17:00 and 19:00 (see Figure 7) which correlates with flood reports and Hertfordshire Fire and Rescue call-out records. The maximum rainfall rate (rainfall intensity) over any 15-minute period was extreme and recorded at 36mm/hr.

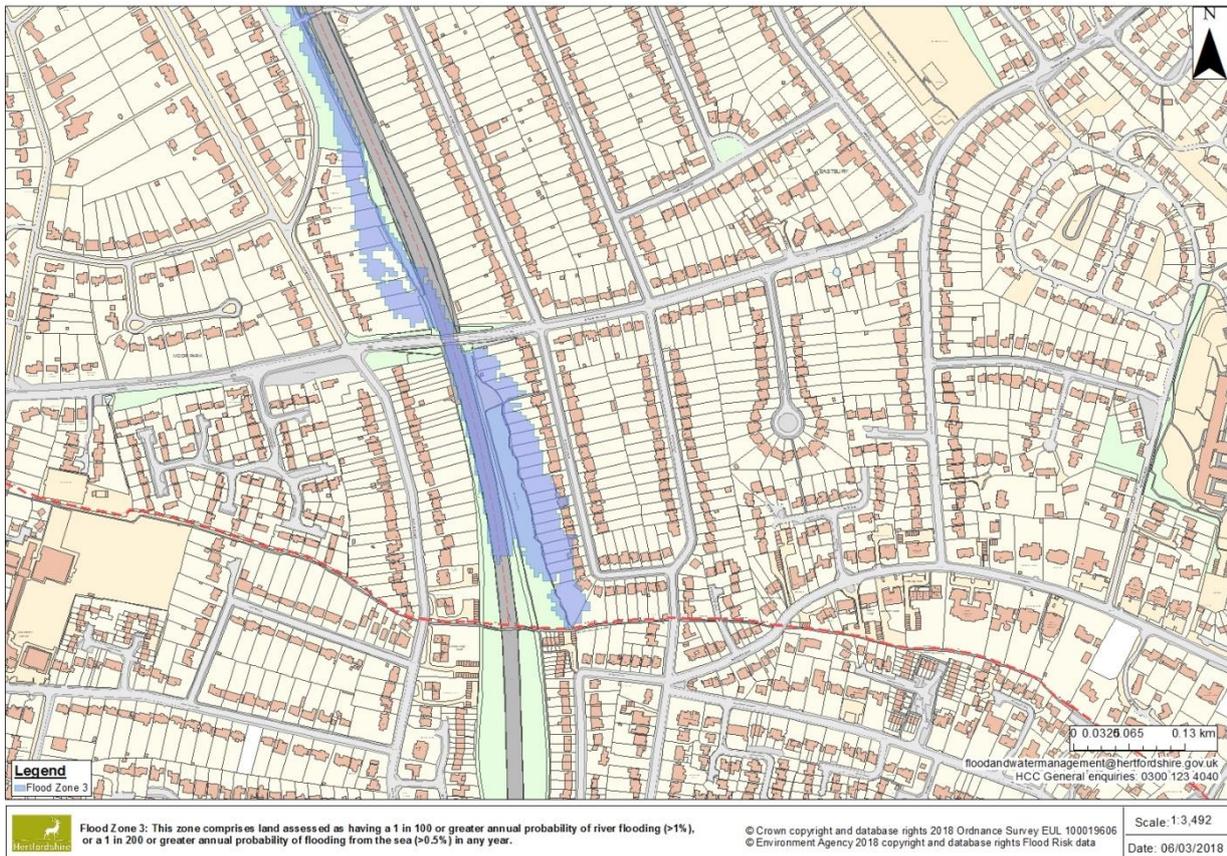
Figure 8 : EA Flood Map for Planning (Rivers and Seas) – Flood Zone 3 (1% AEP)

Exceedance Probability (AEP) of flooding from rivers, a 1% chance of flooding within any given year) in the Eastbury area. As can be seen in Figure 8, fluvial flooding is predicted along the western boundary of the investigation area, coinciding with the rear gardens of houses along the west of St Mary's Avenue for a 1% AEP magnitude event.

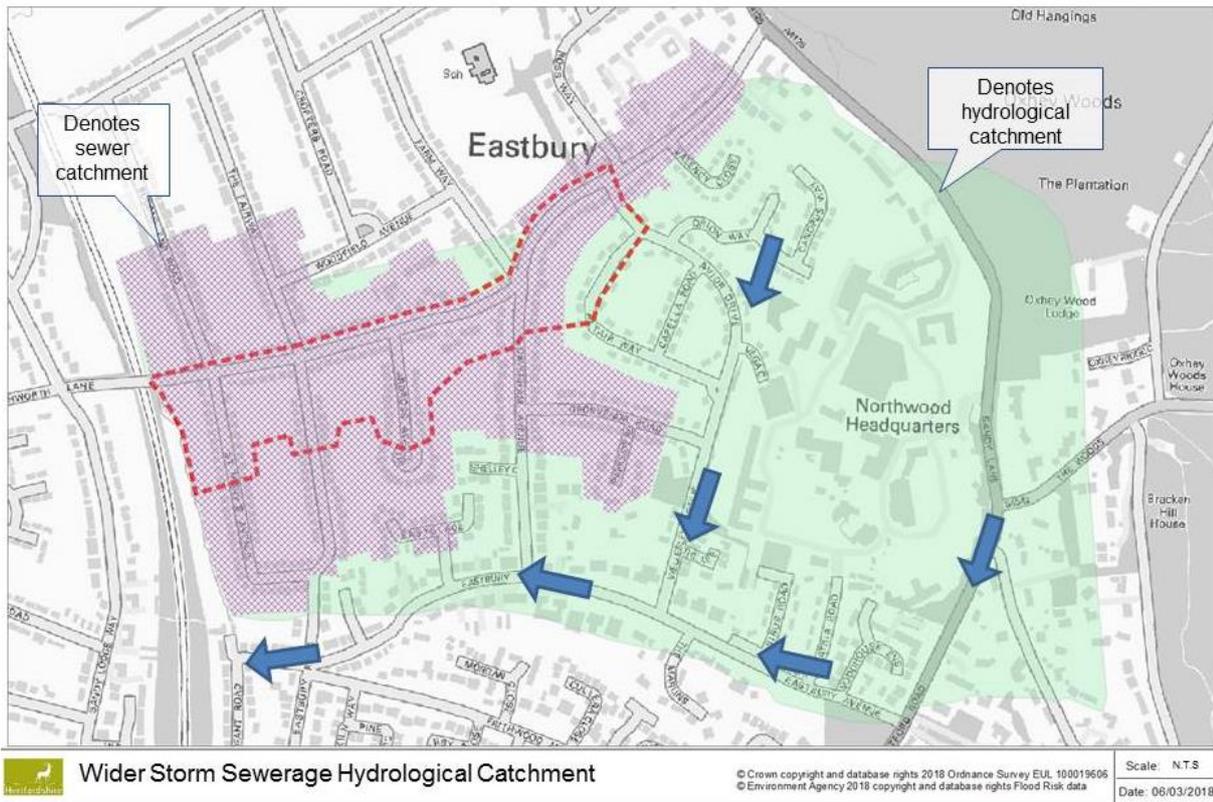
Figure 14: Wider storm sewerage hydrological catchment

The TWUL surface water sewer catchment includes lands outside the natural topographic / hydrological catchment in the immediate vicinity of the investigation area, and this will tend to bring water from outside catchments toward the site, as shown in Figure 14. The green shaded area shows that water will drain towards Claire Court Culvert, increasing the river levels in the Moor Park Stream.

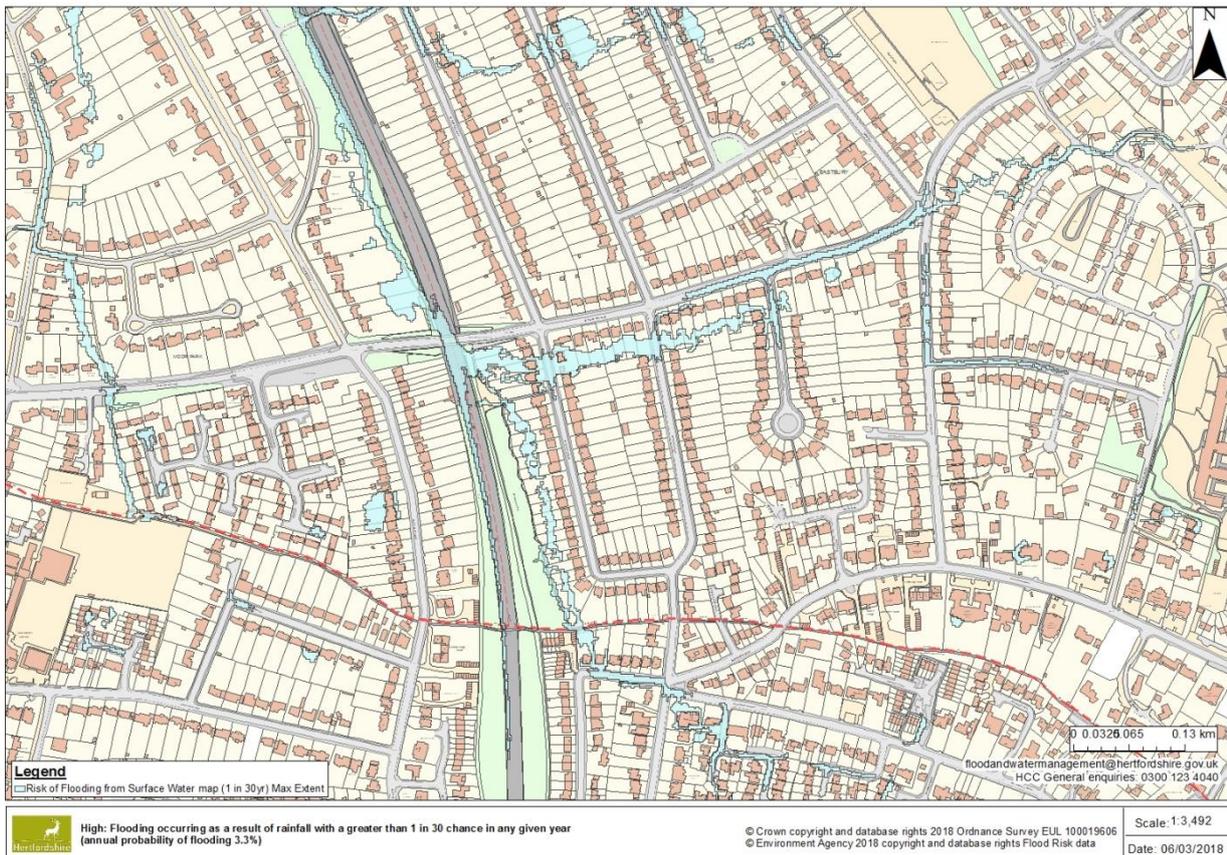
Figure 16: EA's Risk of Flooding from Surface Water Map (RoFfSW) (3.3% AEP)

Surface water runoff was the main mechanism by which flooding occurred in the area of this Section 19 Flood Investigation. The topographical drainage routes correspond with the properties that reported flooding. The reported observed flooding and the RoFfSW correlate with each other, see Figure 16 which shows the risk of flooding from surface water for the 3.3% AEP event, taken from the EA's mapping.

Surface water flooding following flow routes are likely to have been locally exacerbated by obstructions to flow paths, such as fences and walls between buildings, which would have caused water to be held back, causing locally raised water levels. Where drainage system surcharging occurred, emerging water or water which would otherwise have been captured would have contributed to surface water flows. Runoff in excess of sewer capacity would have followed the flow routes indicated by the EA surface water flood map (Figure 16).
