**Service Road at High Street Green,
Hemel Hempstead
Hertfordshire, HP2 7AA**

**NDT/Geophysical Investigation
of Surface Cracking to Road**

Final Report - 4644

Hertfordshire County Council

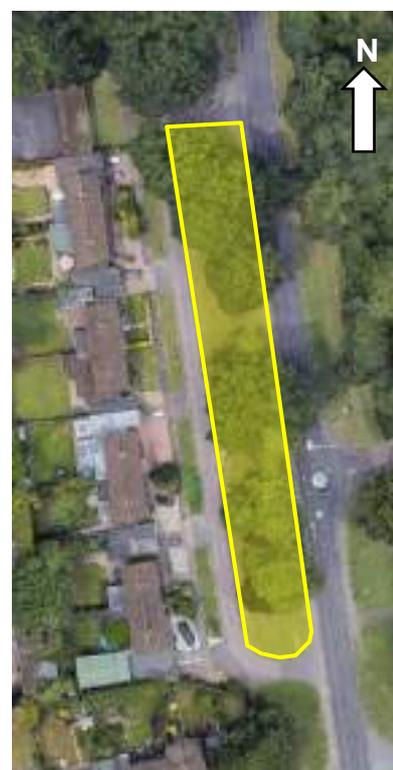
The option to include this area within the single day survey was proposed to Dacorum Borough Council by Hertfordshire County Council, but this was declined. Its inclusion in the original GBG proposal was due to the c.2.5m² area of ground subsidence highlighted above in section *1.2 Background* of this report. The Client requested

Image showing the grassed area removed from survey by Client.

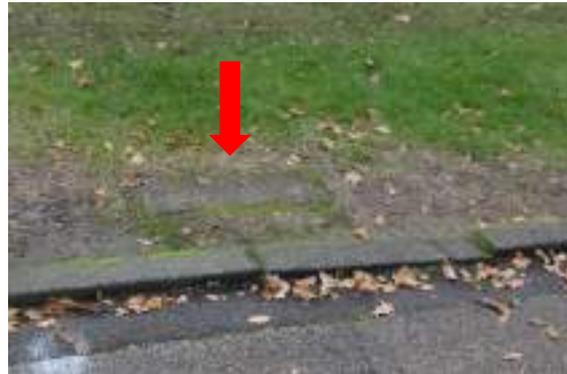
The radar data identifies a further material boundary at a depth of c.680-700mm. The composition of the material beneath the concrete cannot be confirmed without performing intrusive investigations, however the response is consistent with Made Ground/Fill, which is likely to consist of subbase materials and reworked clay once belonging to the Lambeth Group. Underlying the Made Ground/Fill the response is consistent with Chalk Formations.

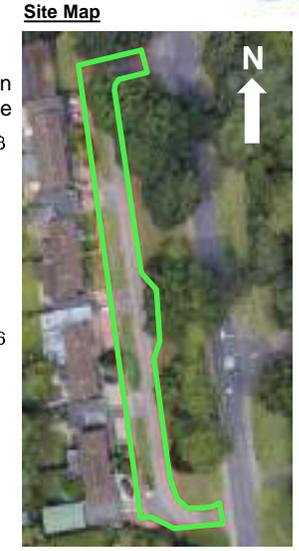
An additional subsurface anomaly (Feature G) has been identified adjacent to the area of subsidence as highlighted at Fig.13 & 14 on drawing 4664-6. Feature G is c.1.8m North-West from the area of ground subsidence.

Figures 13: Satellite image showing location of Feature G adjacent to area of subsidence.
 Figure 14: Plot of radar data slice taken at c.410mm depth; Feature G highlighted.

Fig.13: Satellite Image showing radar overlay and CAT scan results in red.

We recommend that further investigations are conducted within this area to determine/clarify the extent and nature of Feature G.
